Guildford Street Section 19 Report

**Location: Guildford Street, Staines,
Spelthorne**

SURREY
COUNTY COUNCIL

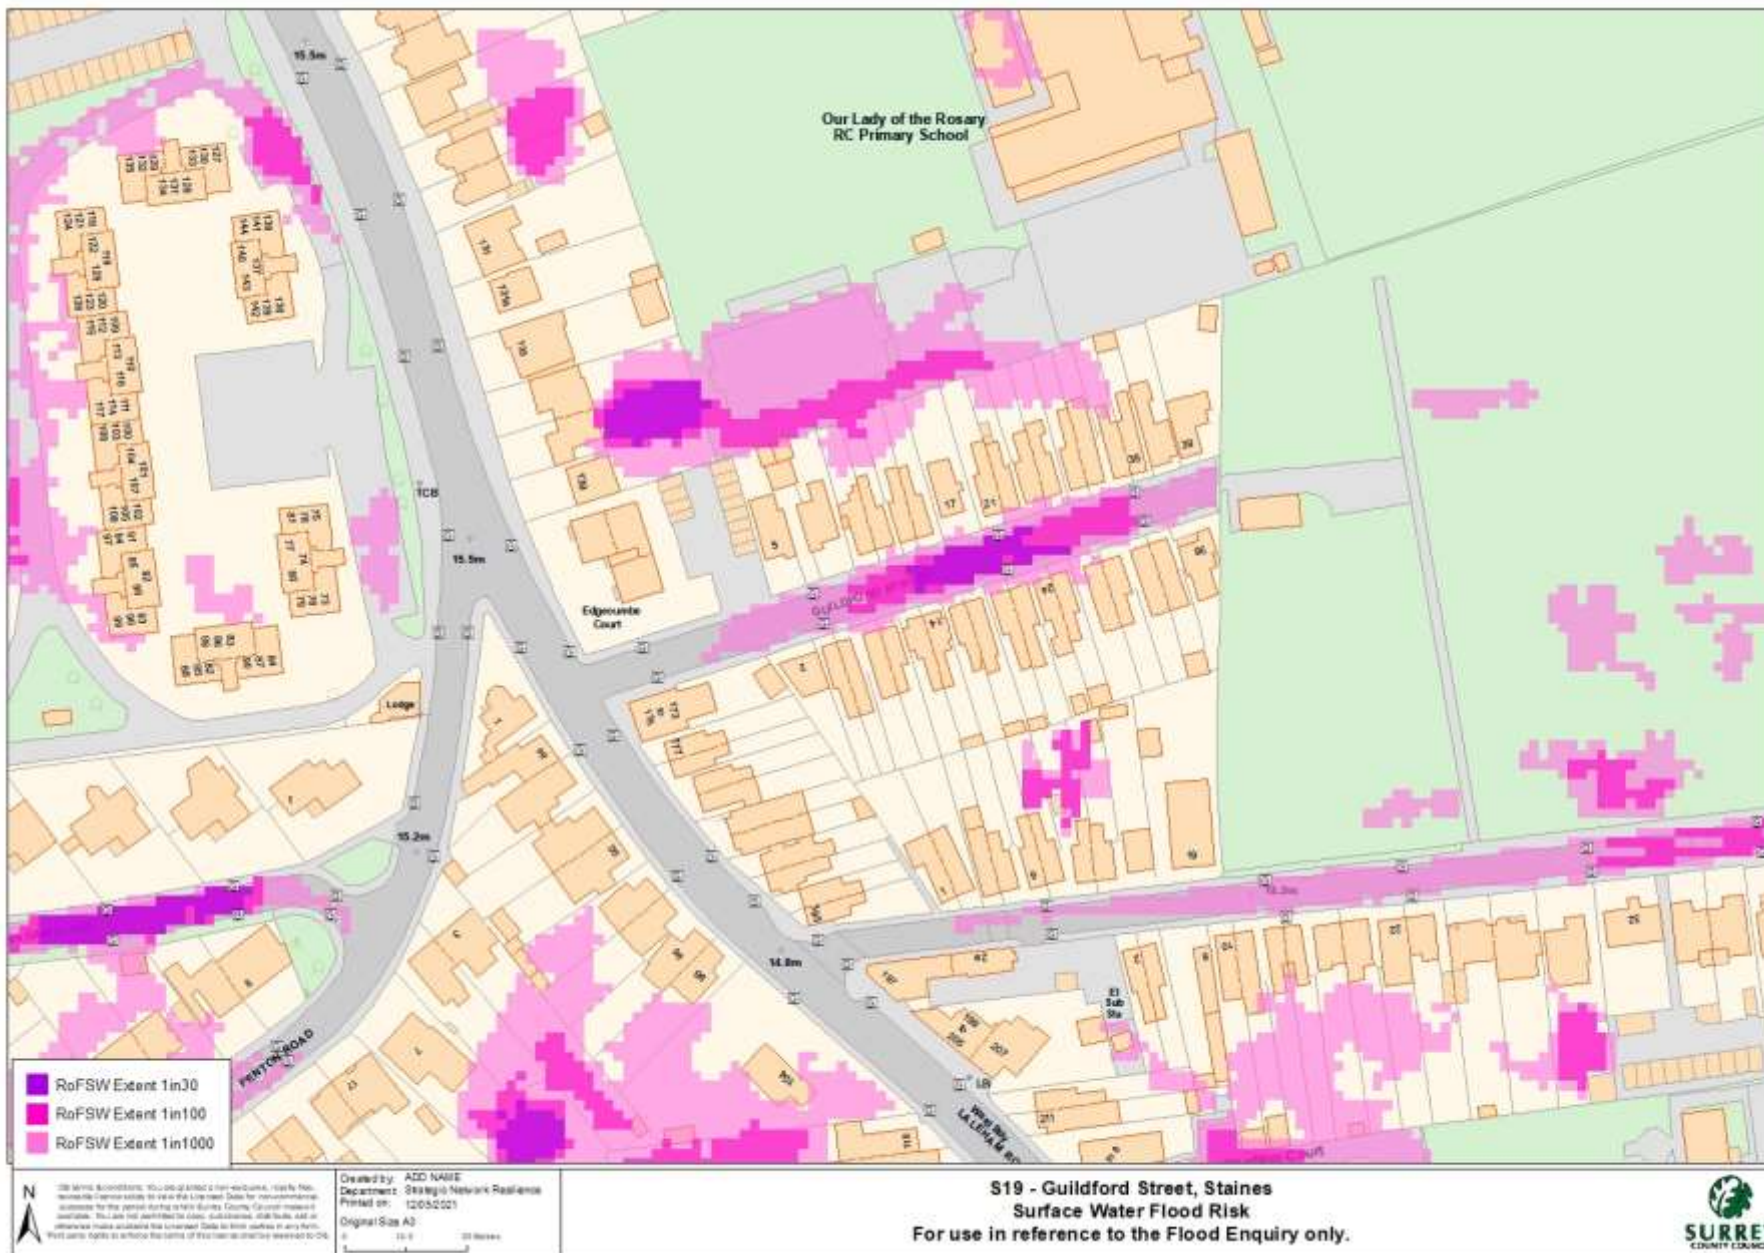
Annex C – Surface Water Flood Risk data for Guildford Street

A review of GIS data was carried out for this area and found that a low point exists on Guildford Street, between 14 and 24 Guildford Street, which is vulnerable to a 1 in 30 year flood event with most of the road being susceptible to the 1 in 100yr flood event. Photos provided by residents show that this is where water pooled.

storage capacity of the soakaway reduced, surface water falling on the highway cannot drain away. As such, it will flow overland and pool at the low point as shown on the surface water flood risk map in Annex C.
