Surrey Fire & Rescue Service
Report of Fire

Incident No.:
007905/2015

Address:
Clandon Park The Street
West Clandon, GU4 7RQ

Prepared by
Group Manager Bryn Strudwick
Fire Investigation Officer

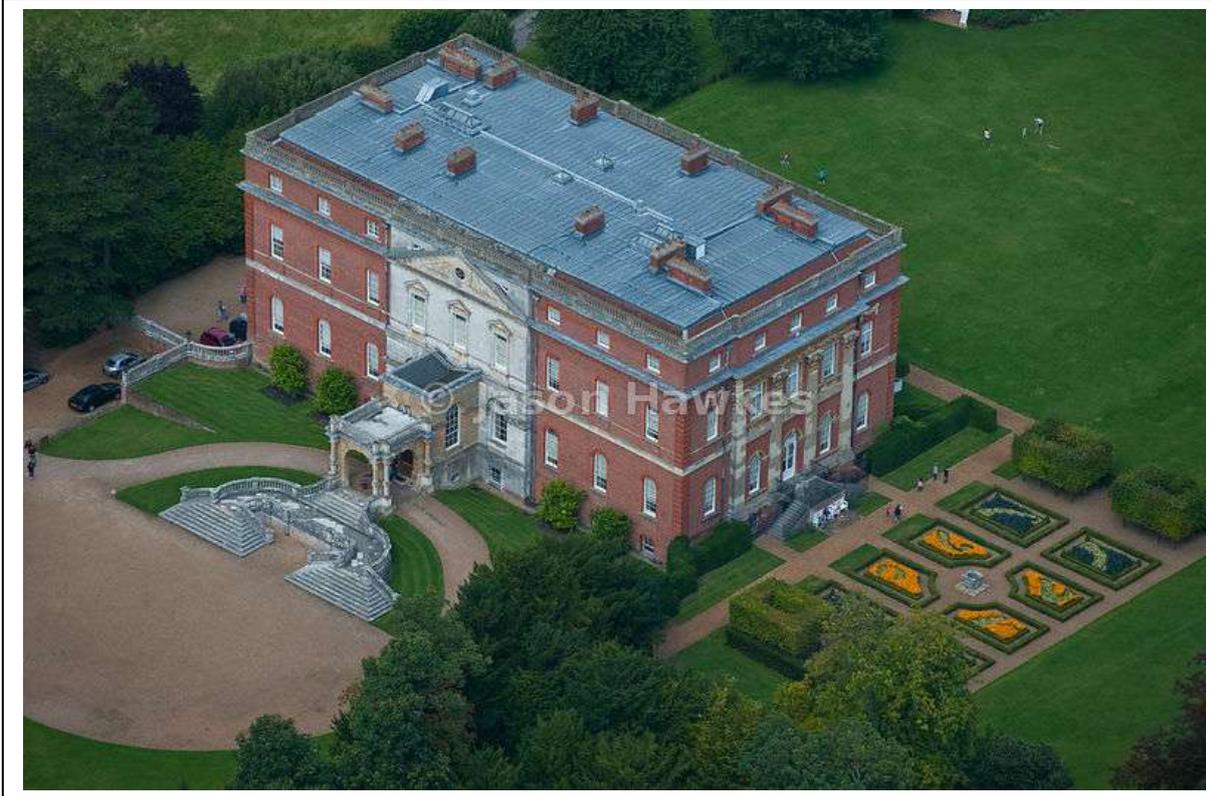
Photograph 1. Ref: From Internet – Copyright to Jason Hawkes

Description: Clandon Park before the fire showing the lead covered roof

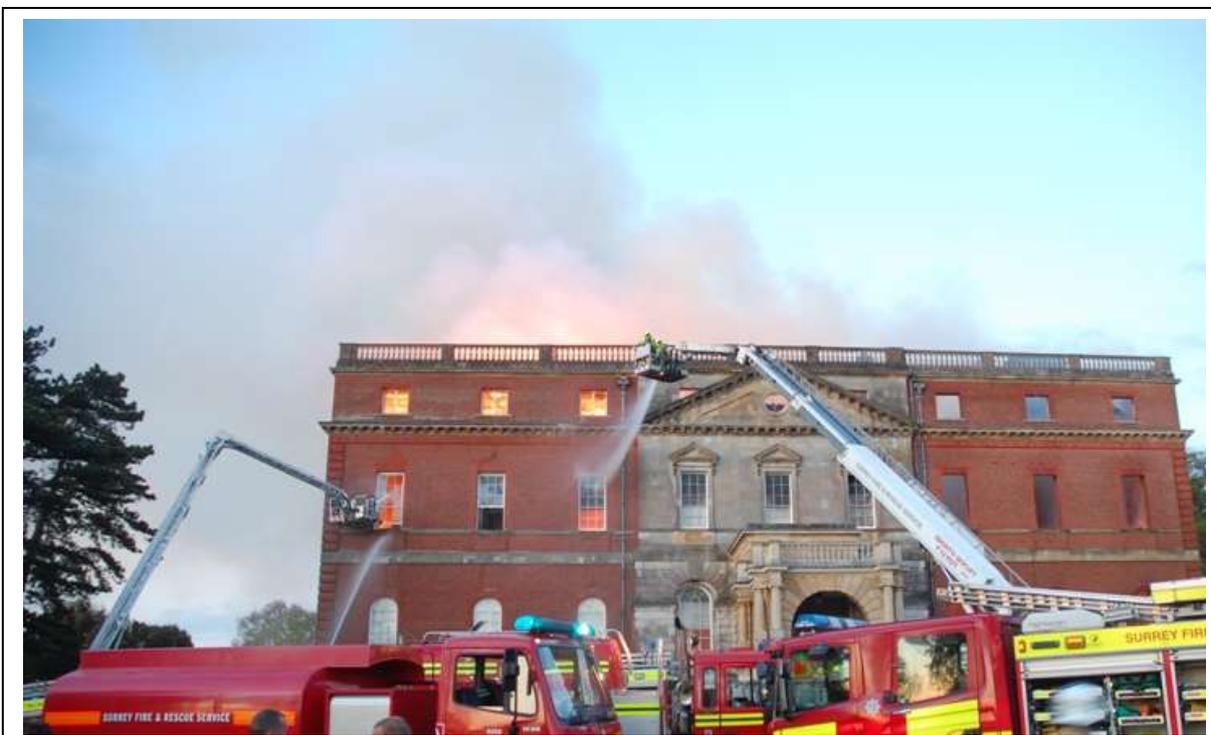
Photograph 2. Ref: DSC_0006

Description: Firefighting operations

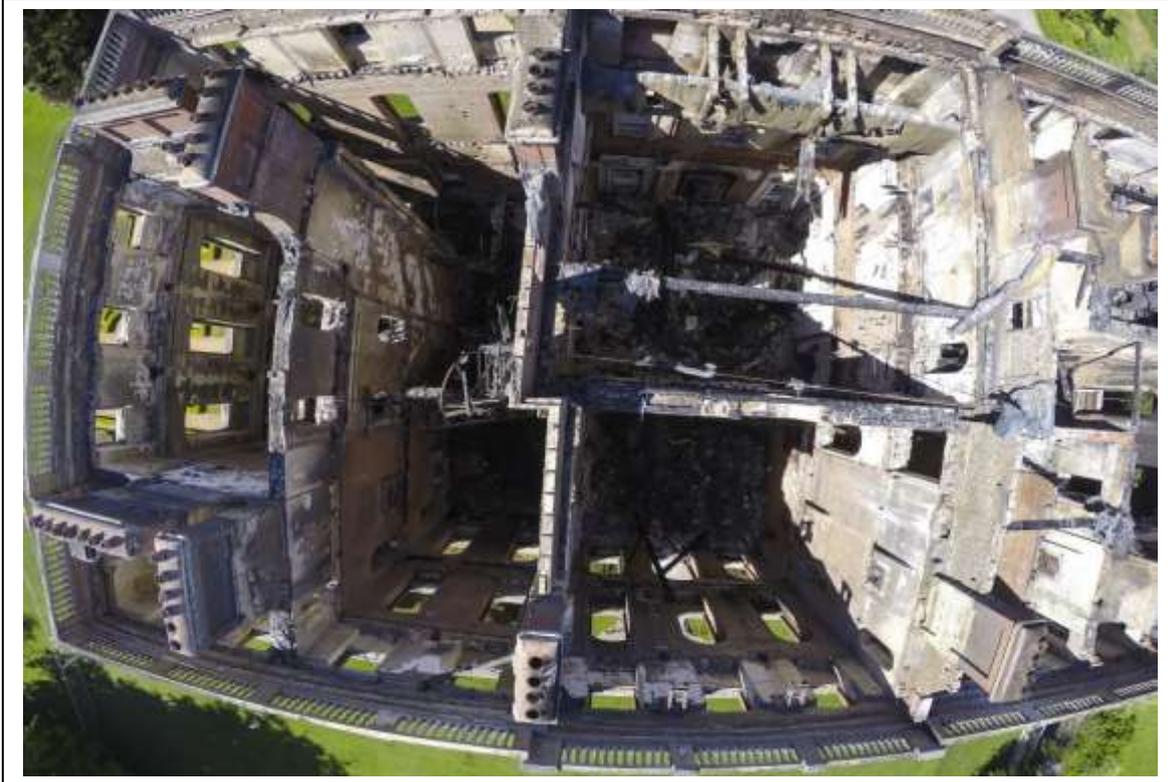
Photograph 3. Ref: From National Trust

- 4.1 Clandon Park was 95 % damaged by fire leading to the collapse of the roof and 95% of the internal floors.

Description: Aerial view following fire

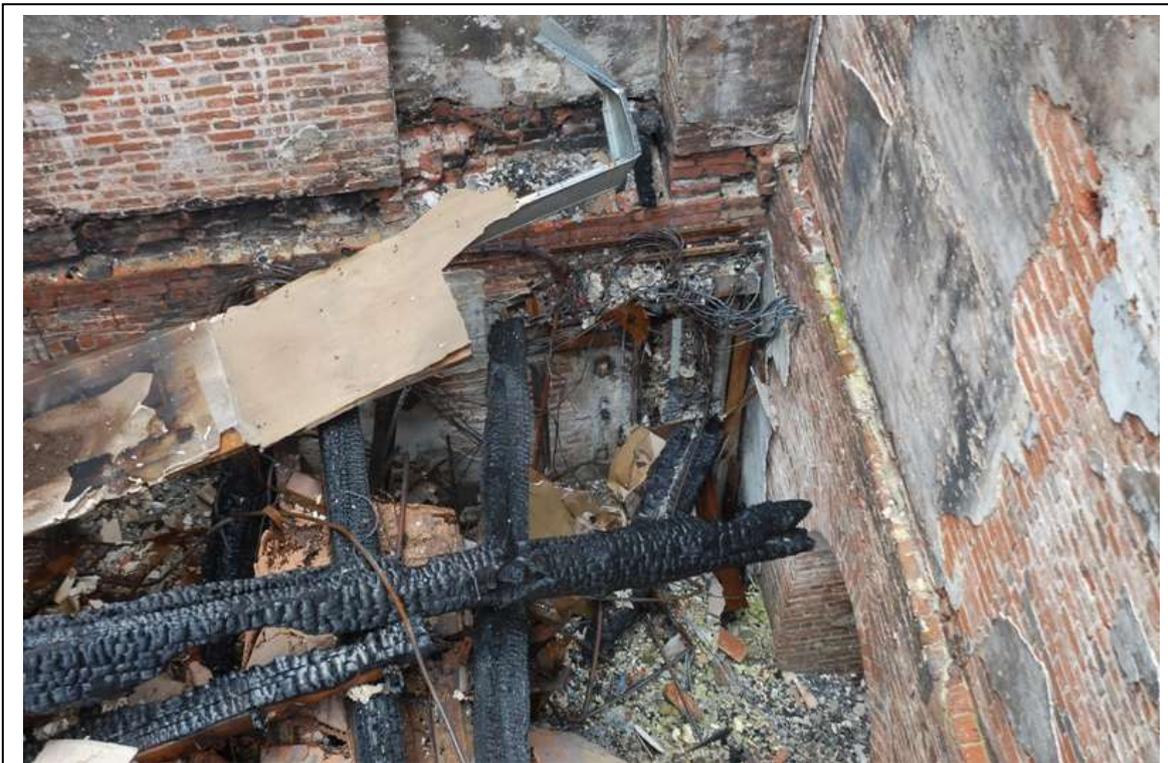
Photograph 4. Ref: DSC_0019

- 6.2. Based on the evidence gained from witness statements, the fire started in the electrical fuse cupboard at the entrance to the museum.
- 6.3. The forensic examination of the distribution board shows evidence that there has been resistive heating on the connection between the two lower left hand side neutral bars that serve fuses numbered one to thirty six.

Description: View of distribution board location

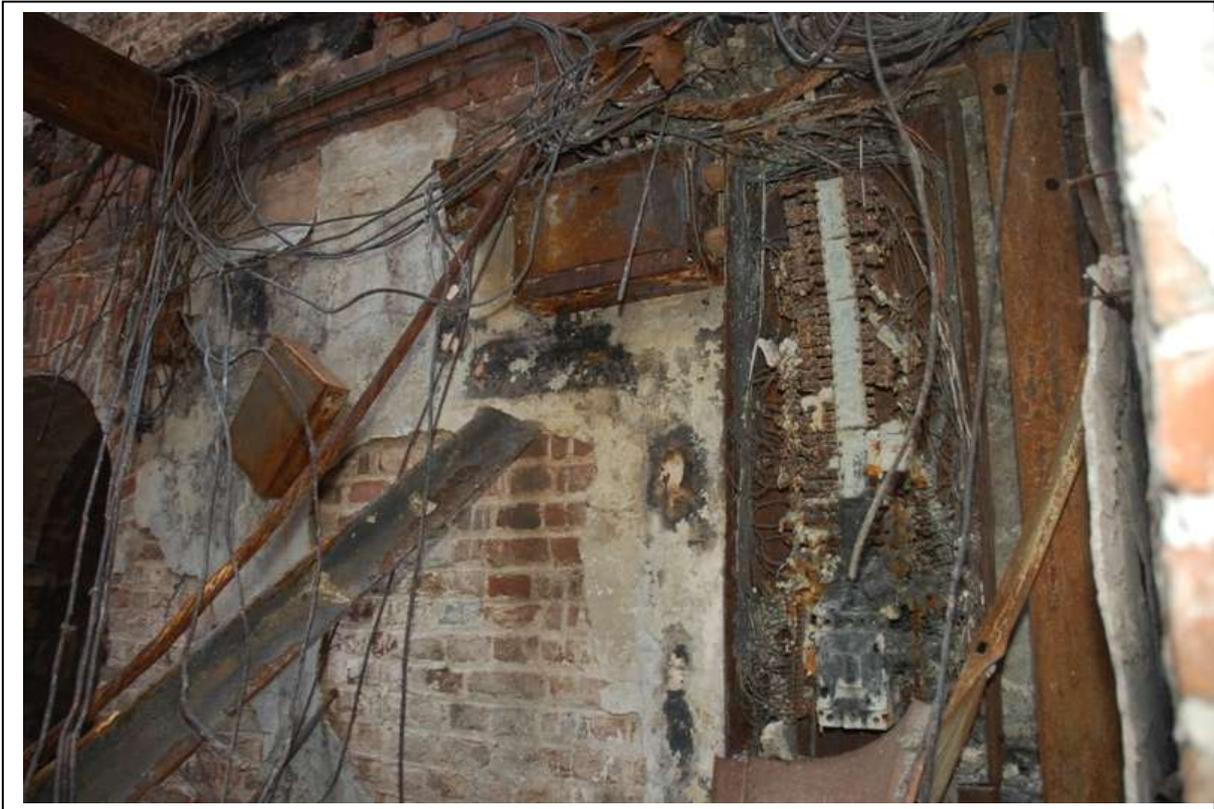
Photograph 5. Ref: DSC_0004

- 5.2. The electrical distribution (fuse) board was located, recovered and removed from the site for forensic examination at Hawkins, the forensic fire investigation company assigned by the National Trust's insurance company.

Description: View of distribution board prior to removal

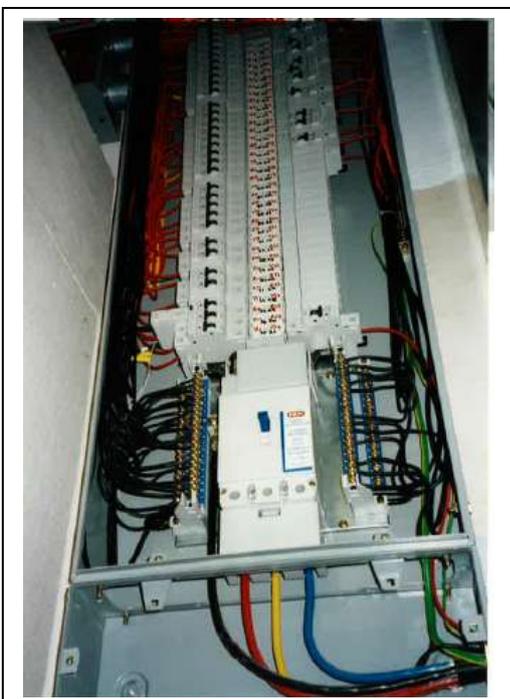
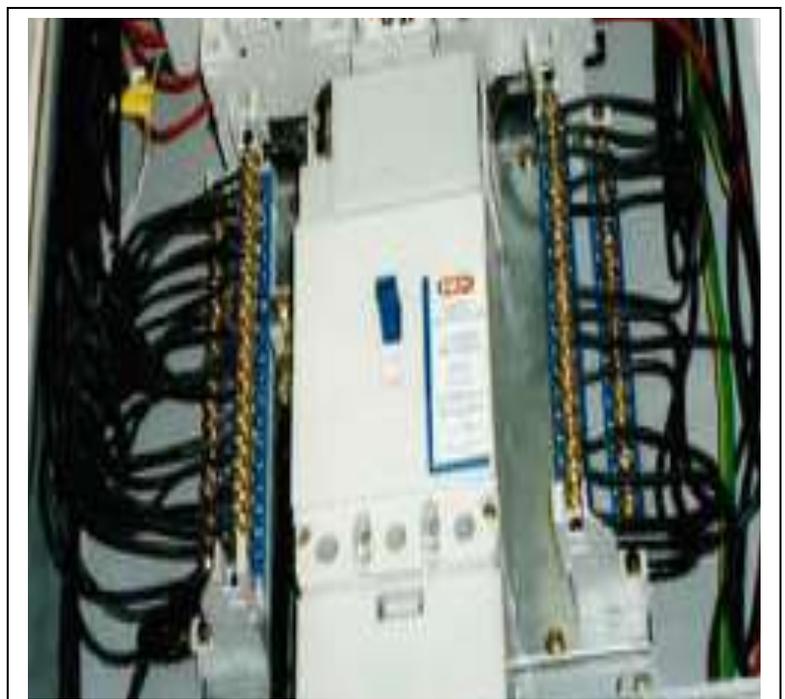
Photograph 6. Ref: From National Trust

It is believed the fire was able to spread in to the room above the distribution board cupboard due to a lack of fire compartmentation above the board.

An electrical contractor's report in 2010 noted a lack of fire stop/barrier to the ceiling recesses of the distribution board cupboard.

Description: View of distribution board prior to fire

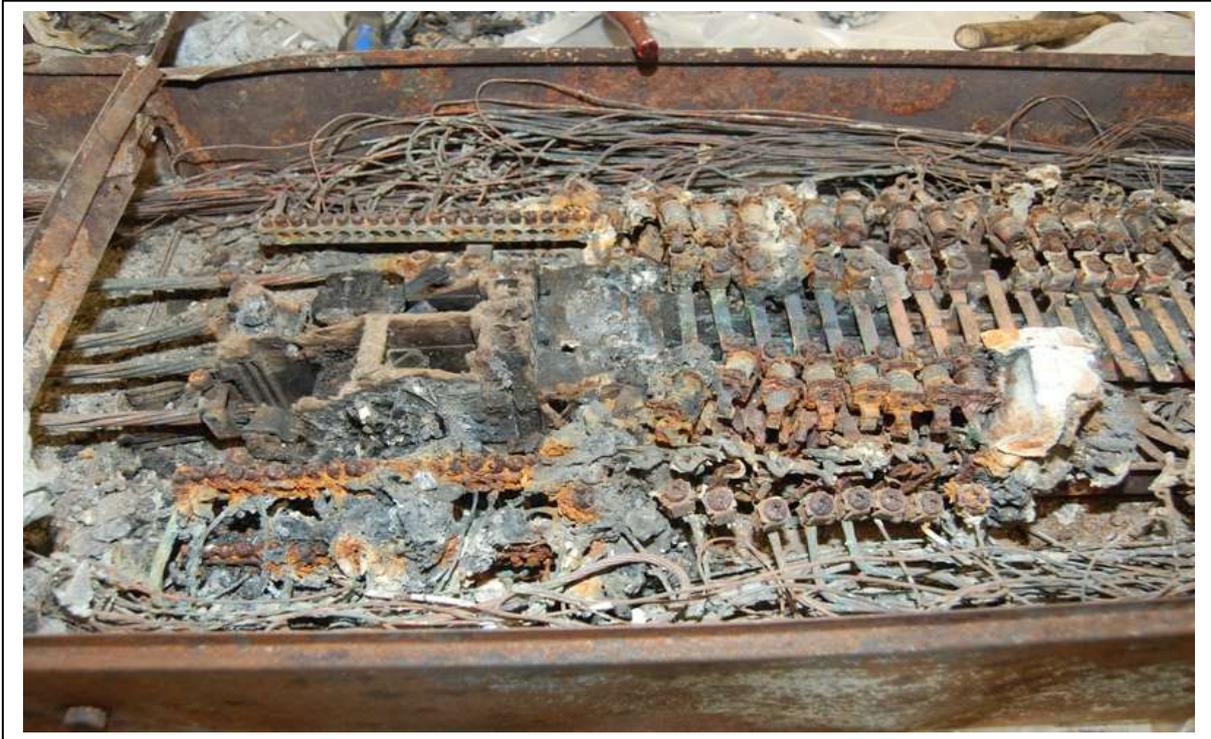
Photograph 7. Ref: DSC_0022

- 5.5. The forensic examination of the distribution board shows evidence that there had been a connection fault on the lower left hand side neutral bar.

- 6.4. The affected connection was found to be considerably tighter than others on the same component and in comparison with those on the right hand neutral bar which serve fuses thirty seven to seventy two. This over tightening has caused a deformation of the wiring and over time caused the connection to loosen hence increasing the resistance of the wiring and subsequently the generation of considerable heat. This heating process has degraded the connection, including its insulation, continuously until full combustion (in the form of open flame) has occurred.

Description: View of neutral bars in distribution board

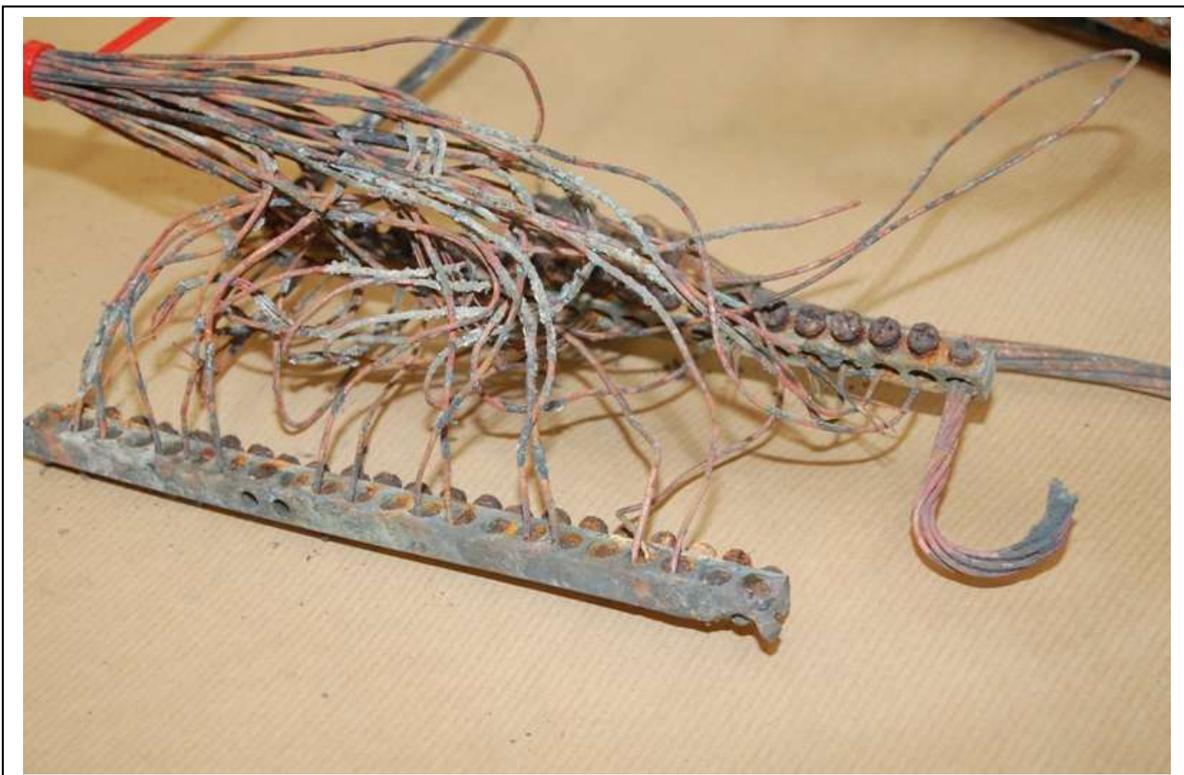
Photograph 8. Ref: DSC_0042

Description: View of neutral bars after removal from distribution board

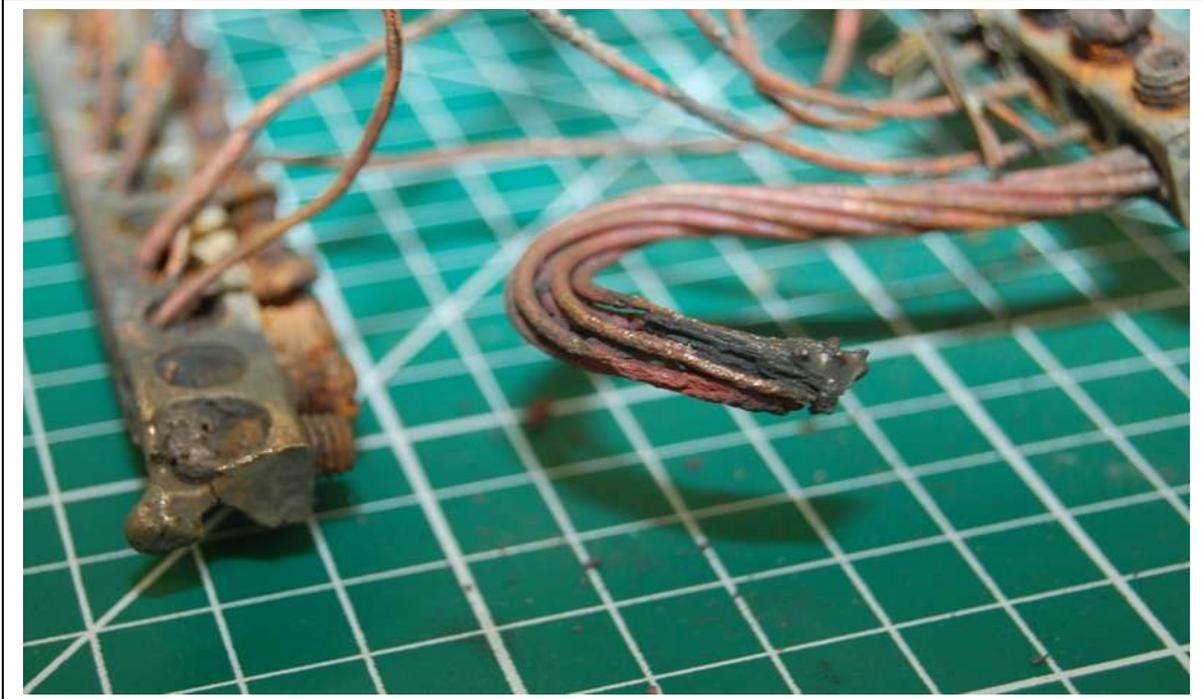
Photograph 9. Ref: DSC_0047

Description: View of neutral bars after removal from distribution board
