SURREY
COUNTY COUNCIL

Tongham Section 19 Investigation Report- Flood Event 4th January 2024

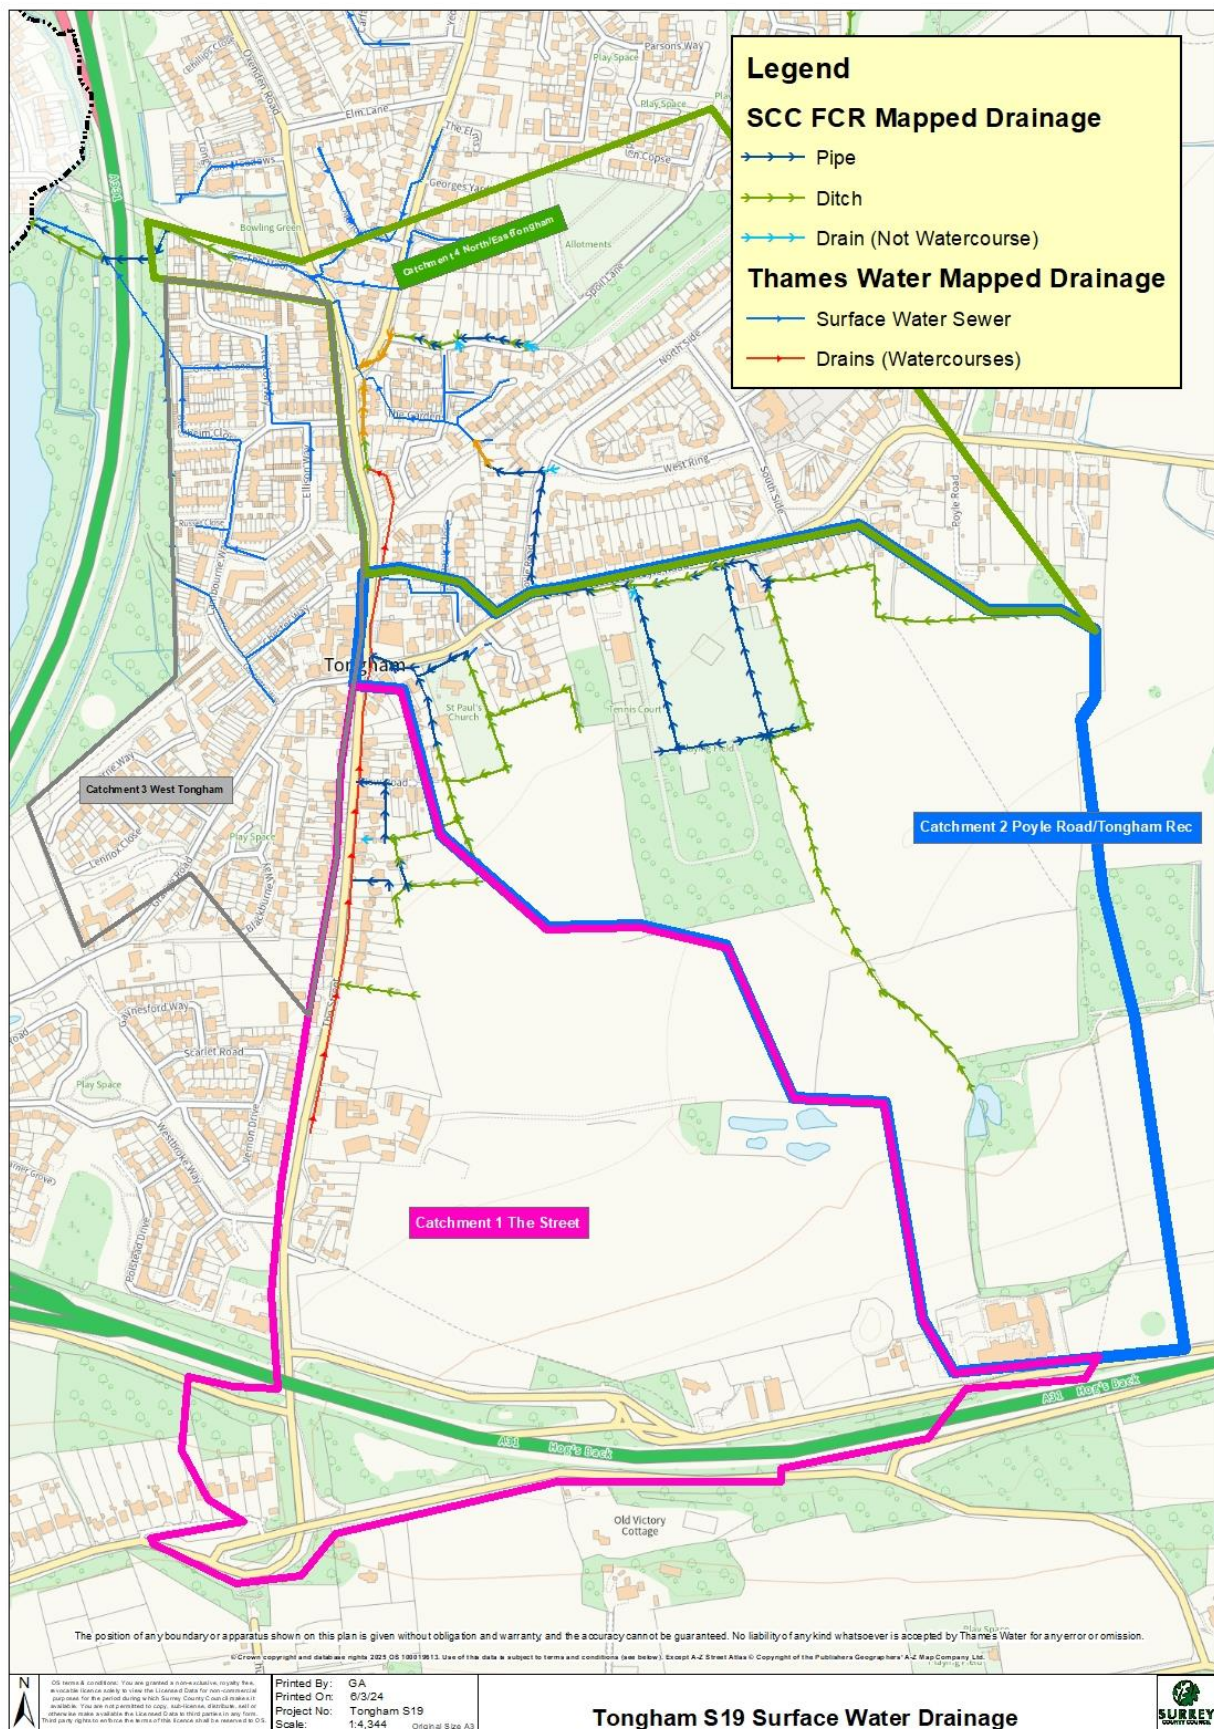
Map 1: Catchment Map

Map 1 in Annex A shows the area of investigation which includes most of Tongham. For ease of description, it has been broken into 4 drainage catchments, though these are not distinct, and both drainage systems and surface water flows cross between these catchments in certain places, as shown on Map 2 in Annex A.

The 4 sub catchments in Map 1 Annex A are described in more detail below:

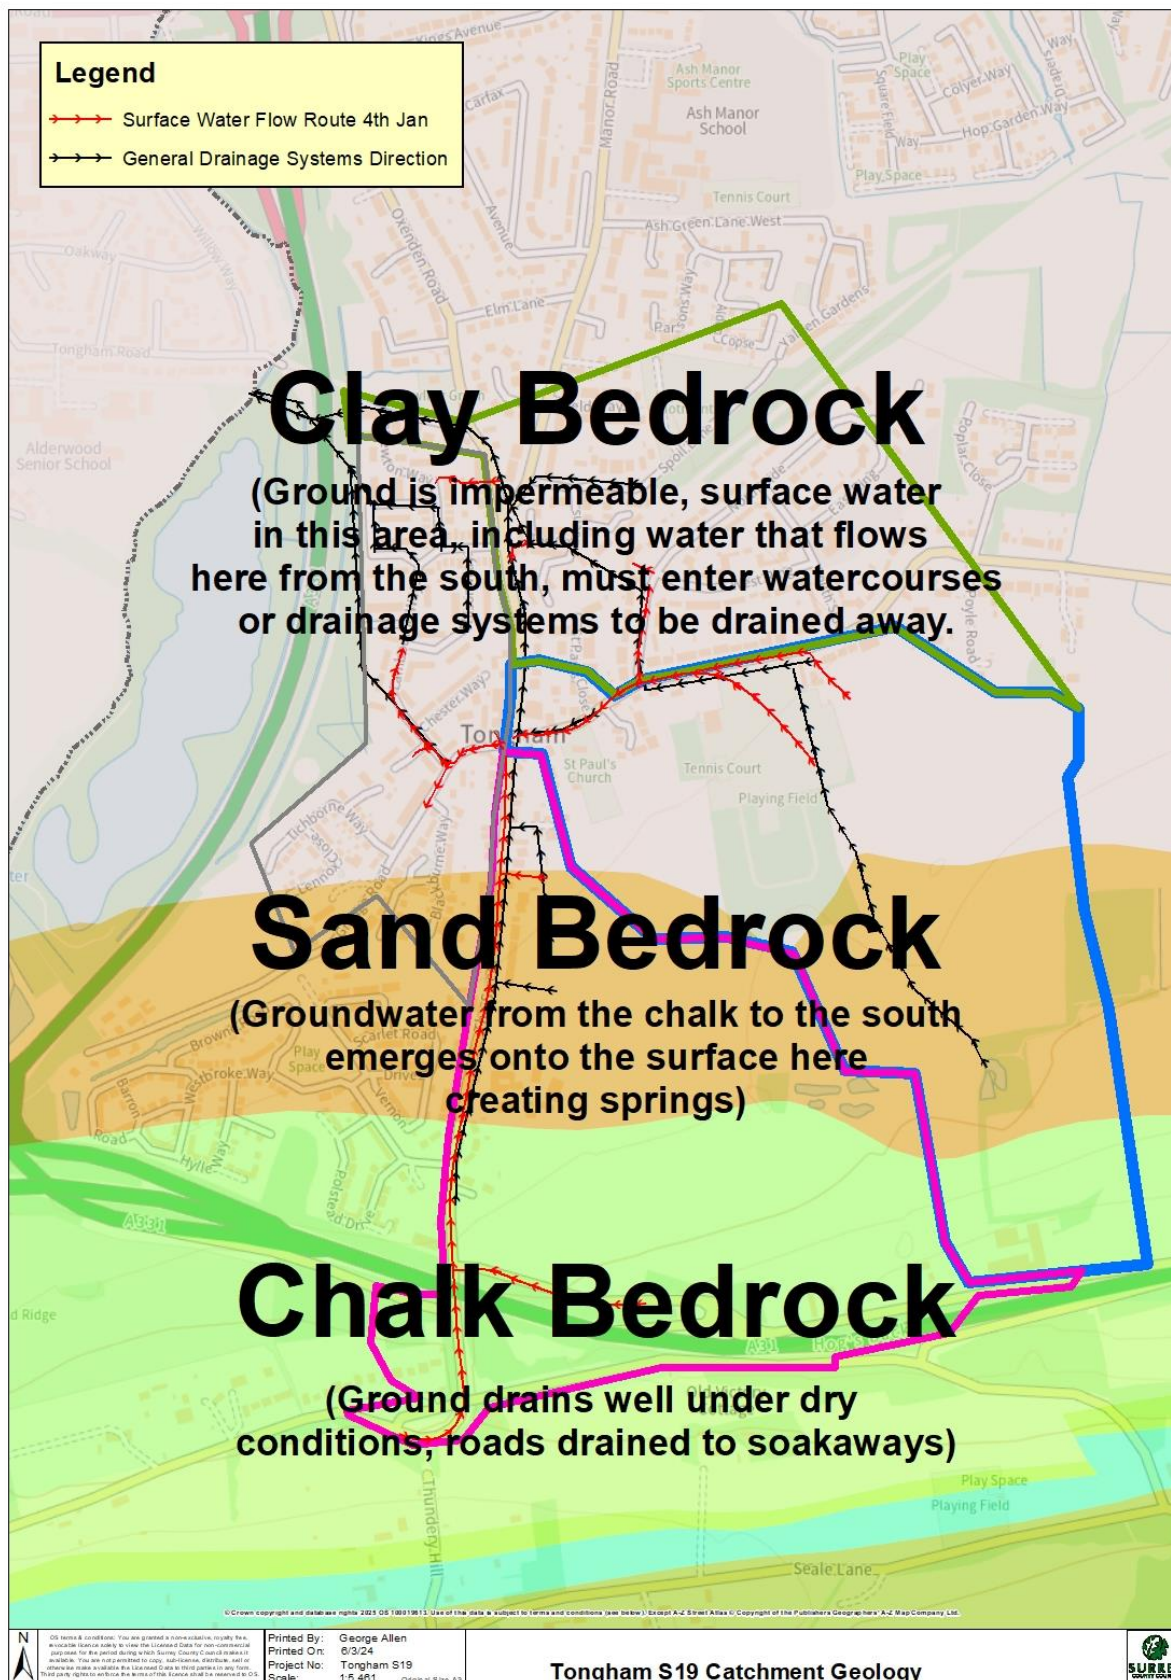
Annex B: Geology of Tongham

Tongham sits on a geological boundary. The Hogs Back is a chalk ridge where drainage by infiltration into the ground is possible, however further north, down the slope of the Hogs Back, the bedrock changes to sand and then clay. The sand layer acts as a spring line and many spring fed watercourses run through the fields east of The Street, northwards into Tongham and its drainage systems. Annex B shows the geology of Tongham and the watercourses and the general drainage layout.

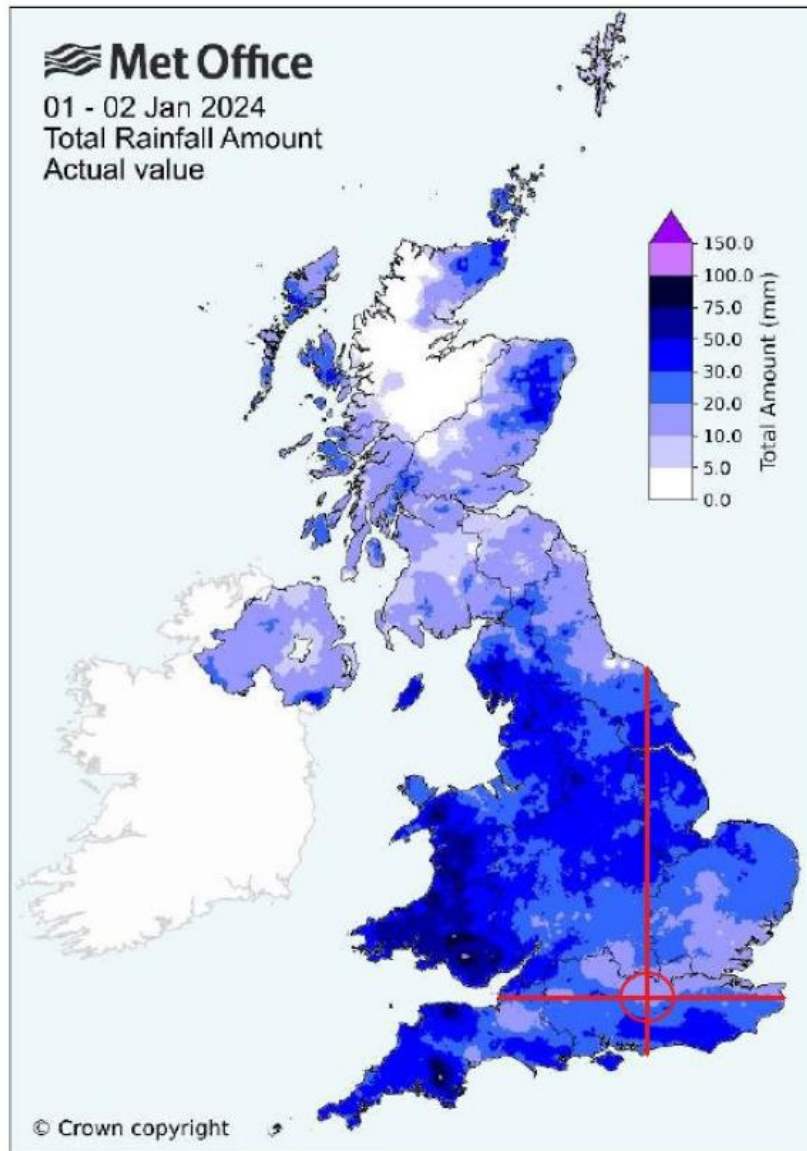
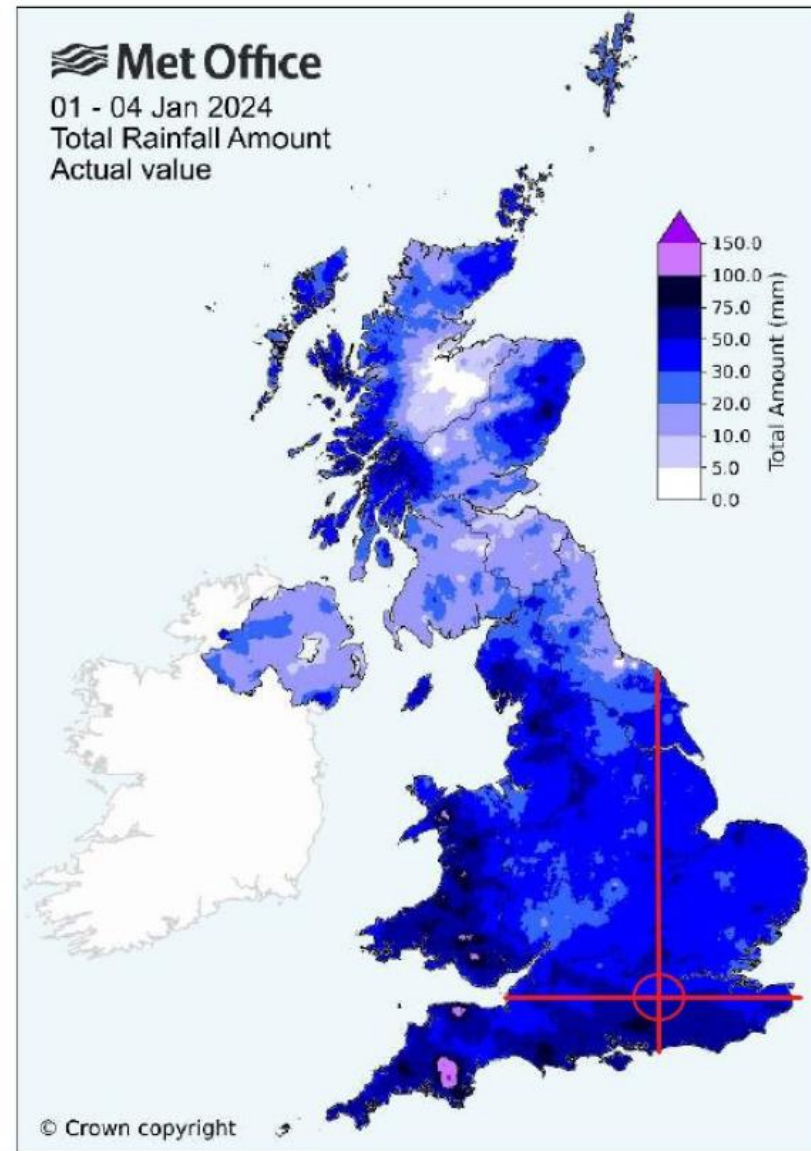
Annex C: Storm Henk Met Office Rainfall Data

The flooding that occurred in Tongham came at the tail end of Storm Henk. A storm which affected most of the UK between the 1st and 4th of January. Met office analysis showed that in

this period 50-75mm of rainfall fell in this area, most of which fell in the last two days. (Met Office records state that Surrey's monthly average rainfall in January is 65.29mm.) See Annex C showing rainfall data across the UK with Tongham's approximate position indicated.
