SURREY
COUNTY COUNCIL

Lingfield Section 19 Report: 1 August 2024

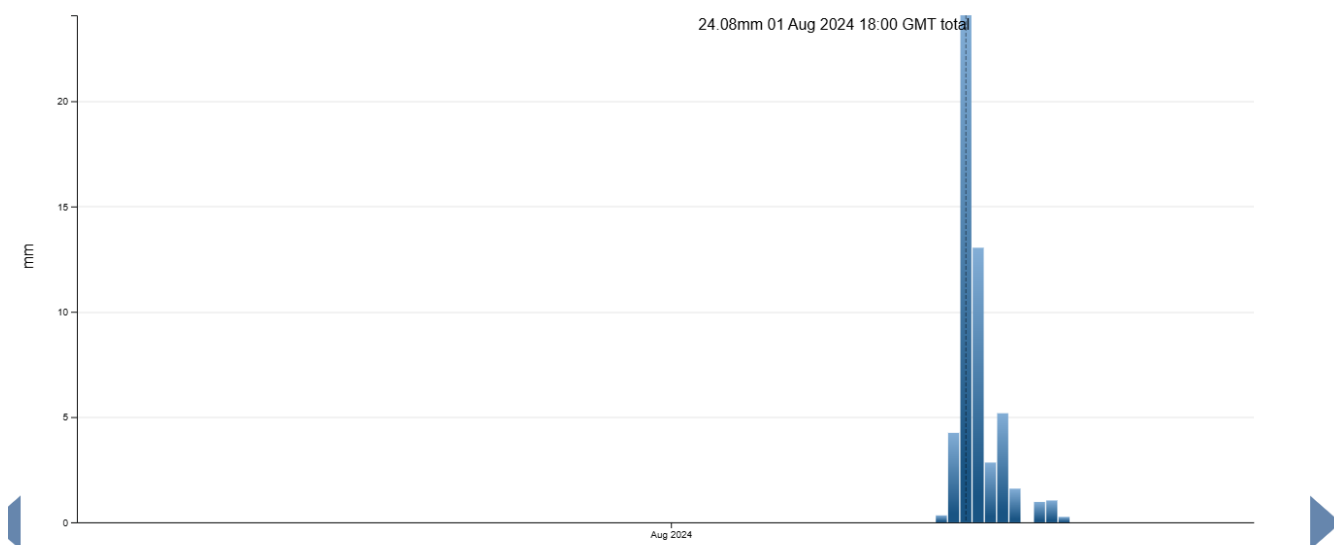
Figure 1. Godstone gauge: Rainfall data for 1 August 2024

On the evening of 1 August 2024, Surrey experienced a storm event that prompted the Met Office to issue a yellow weather alert. Between 1730- 2000 approximately 54mm of rainfall was recorded, based on average data from local gauges at Godstone and Eden Vale. Approximately 95% of the monthly average rainfall occurred within this 2.5-hour period.

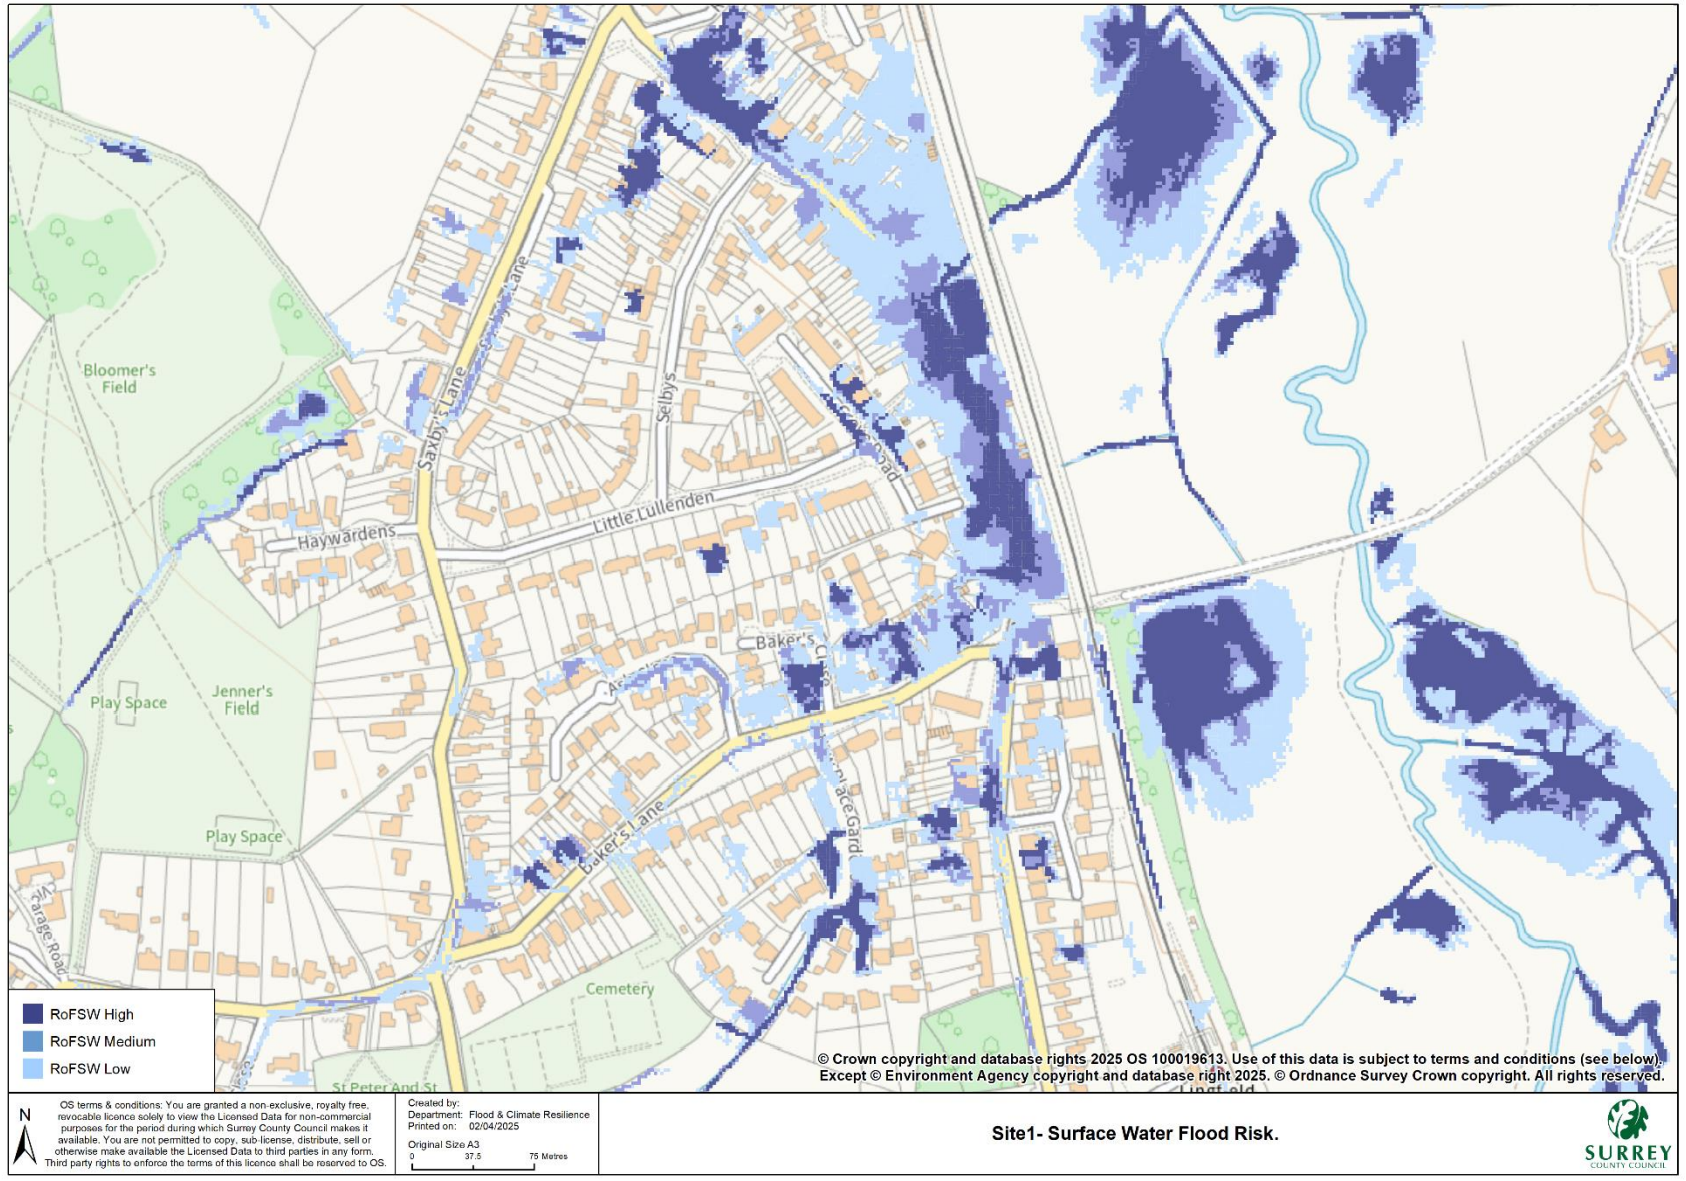
Annex B. Site 1- Surface Water Flood Risk

Lingfield is situated in the southeast of Tandridge District, Surrey, UK. Both sites sit within the Eden Brook Catchment - a tributary of the Medway, with Site 1 draining east and Site 2, north: see Annex A. The properties within both sites range in flood risk from low (1 in 1000) to high (1 in 30) of surface water flooding: see Annexes B and C. The updated National Flood Risk Assessment models indicate that some properties are at high risk to flooding of up to a depth of 300mm.
