Annexes: Summary Reports of Guildford S19 Investigations

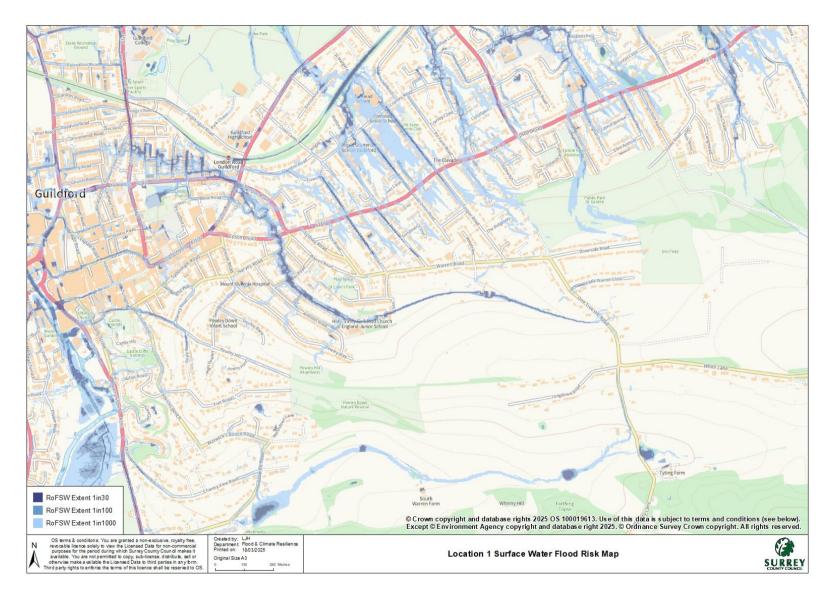
Annex A: Location 1 (Enquiry Reference: 171343)

Flooding is caused by the area's position along a major surface water flow route with steep topography. High rainfall, private drainage discharge onto highways, and water velocity bypassing gullies result in pooling in low-lying areas and overwhelmed drainage systems.

Landowners: May wish to implement property flood resilience to protect their property from the impact of flooding, with advice sought from a suitability qualified professional.

Landowner: To continue regular maintenance of drainage asset

SCC Highways: To continue regular maintenance of highway assets

Thames Water: To continue maintenance of their drainage assets.

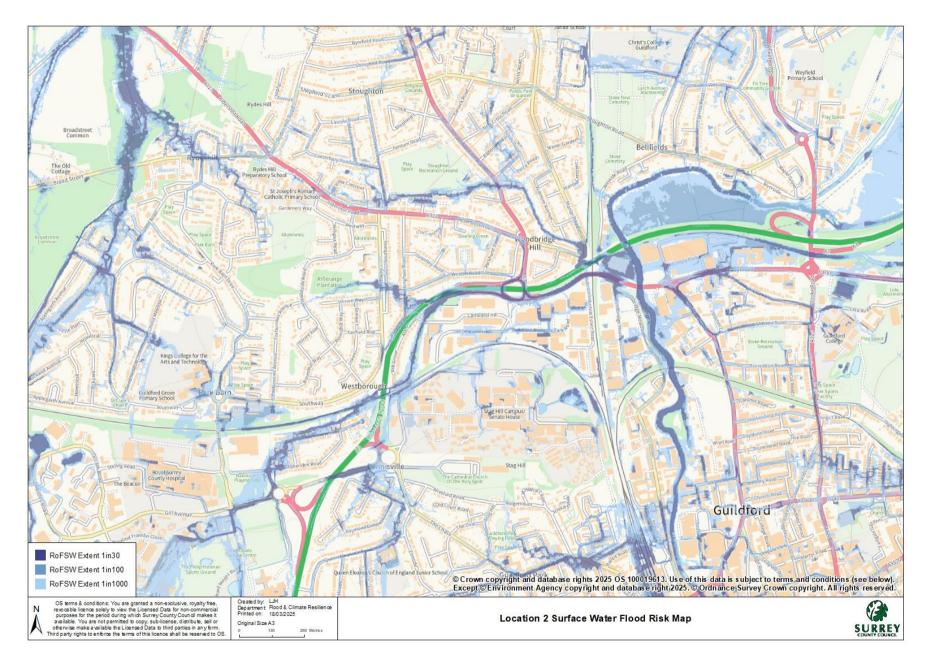
Annex B: Location 2 (Enquiry Reference: 168751)

Flooding was primarily caused by blockages in a watercourse, often due to upstream fly-tipping. Regular maintenance and enforcement are recommended to prevent future obstructions and mitigate flooding risks.

Landowner: to regularly monitor and clear the trash screen from any obstructions to ensure free flow of water of the ordinary watercourse as per riparian responsibility.

Landowner: to carry out regular maintenance of the ordinary watercourse adjoining their land and remove any obstructions within the channel to ensure free flow of water as per riparian responsibility. Might also consider maintenance of drainage within the car parking area.

Thames Water: to consider assessing the condition of the Thames Water surface water sewer that the ordinary watercourse feeds into, to ensure this asset is free from obstructions to allow for free flow of water.

Guildford Borough Council: might consider reviewing the mechanism of rubbish ingress into the watercourse and offer mitigation in the form of resilience amongst residents and business to not fly tip, to ensure unimpeded flow of the watercourse.

National Highways: might consider clearance works of the ordinary watercourse to increase capacity of highway drainage.

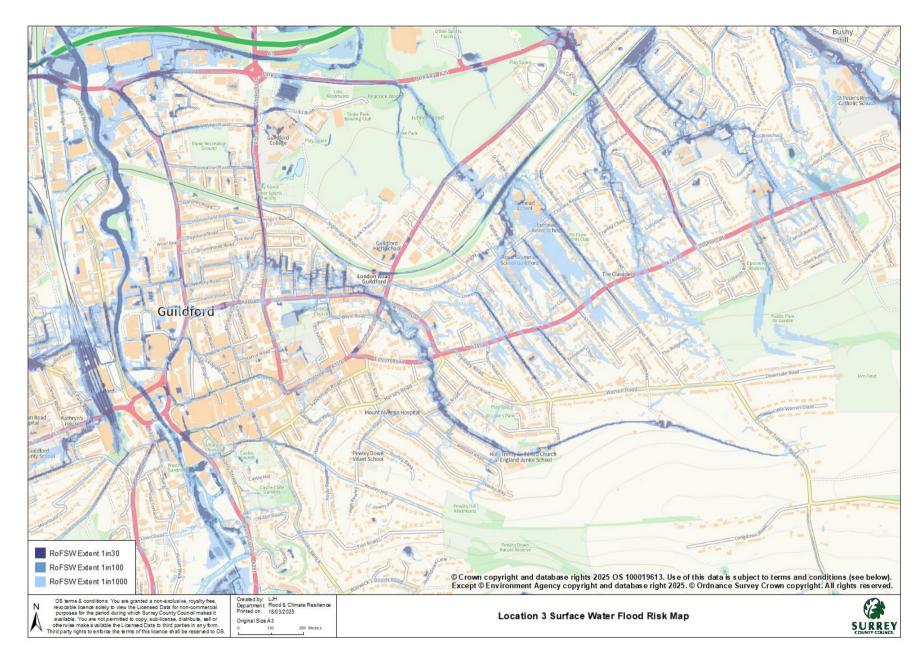
Annex C: Location 3 (Enquiry Reference:171335)

Blocked soakaways were the main cause of flooding, particularly during a severe incident in September 2024, additionally properties are situated on a large surface water flow route, increasing the likelihood of flooding occurring. After maintenance interventions cleared the blockages, no further flooding has been reported. However, the area's susceptibility to surface water still requires monitoring.

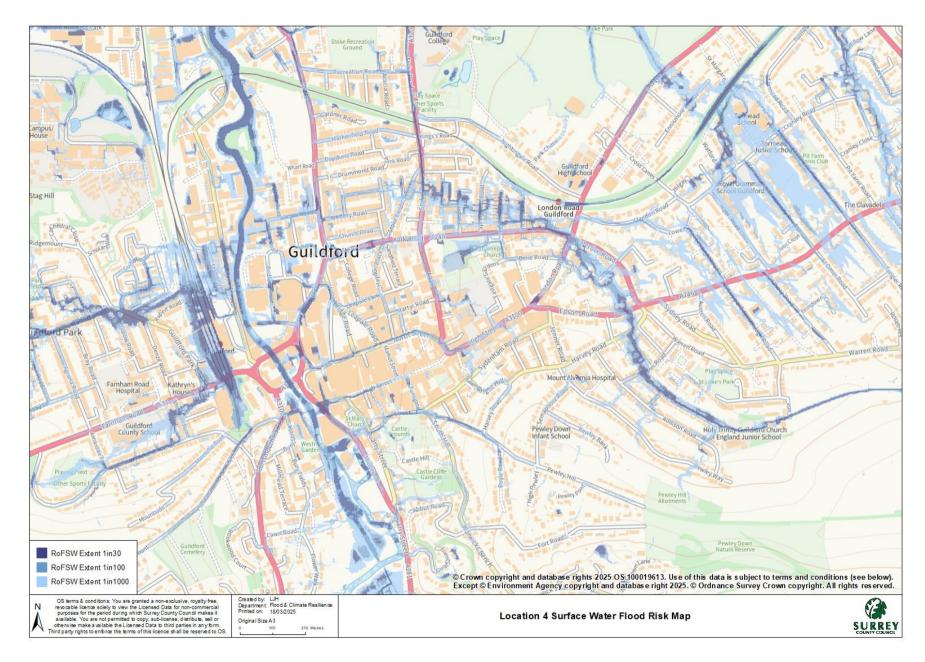
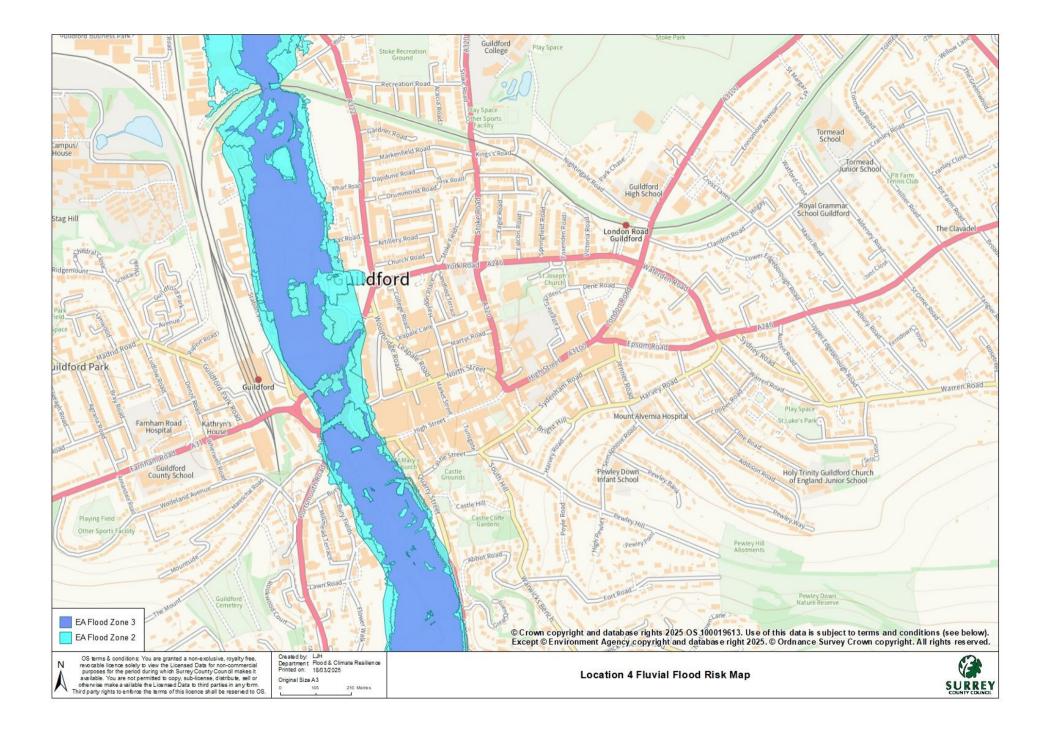
Annex D: Location 4 (Enquiry Reference: 163249)

Flooding occurred due to surface water flowing down a slope and being redirected towards the building. The pavement's slope and fast-moving water bypassing gullies caused water to accumulate. Cracks in the building allowed water ingress, exacerbating the issue.

SCC Flood & Climate Resilience Team: To liaise with developers regarding planning applications in this location to influence implementation of suds that may help reduce the impact of flooding to buildings.

SCC Highways: To continue regular maintenance of the highway gullies.

Landowners: May wish to consider making changes to the slope of the entrance to reduce the impact of flooding to the property internally. Advice sought from a suitability qualified professional.
