# Section 19 Flood Investigation Report Hengest Avenue

**Incident: 23<sup>rd</sup> June 2016**

**Published: 20<sup>th</sup> March 2017**

# Section 19 Report

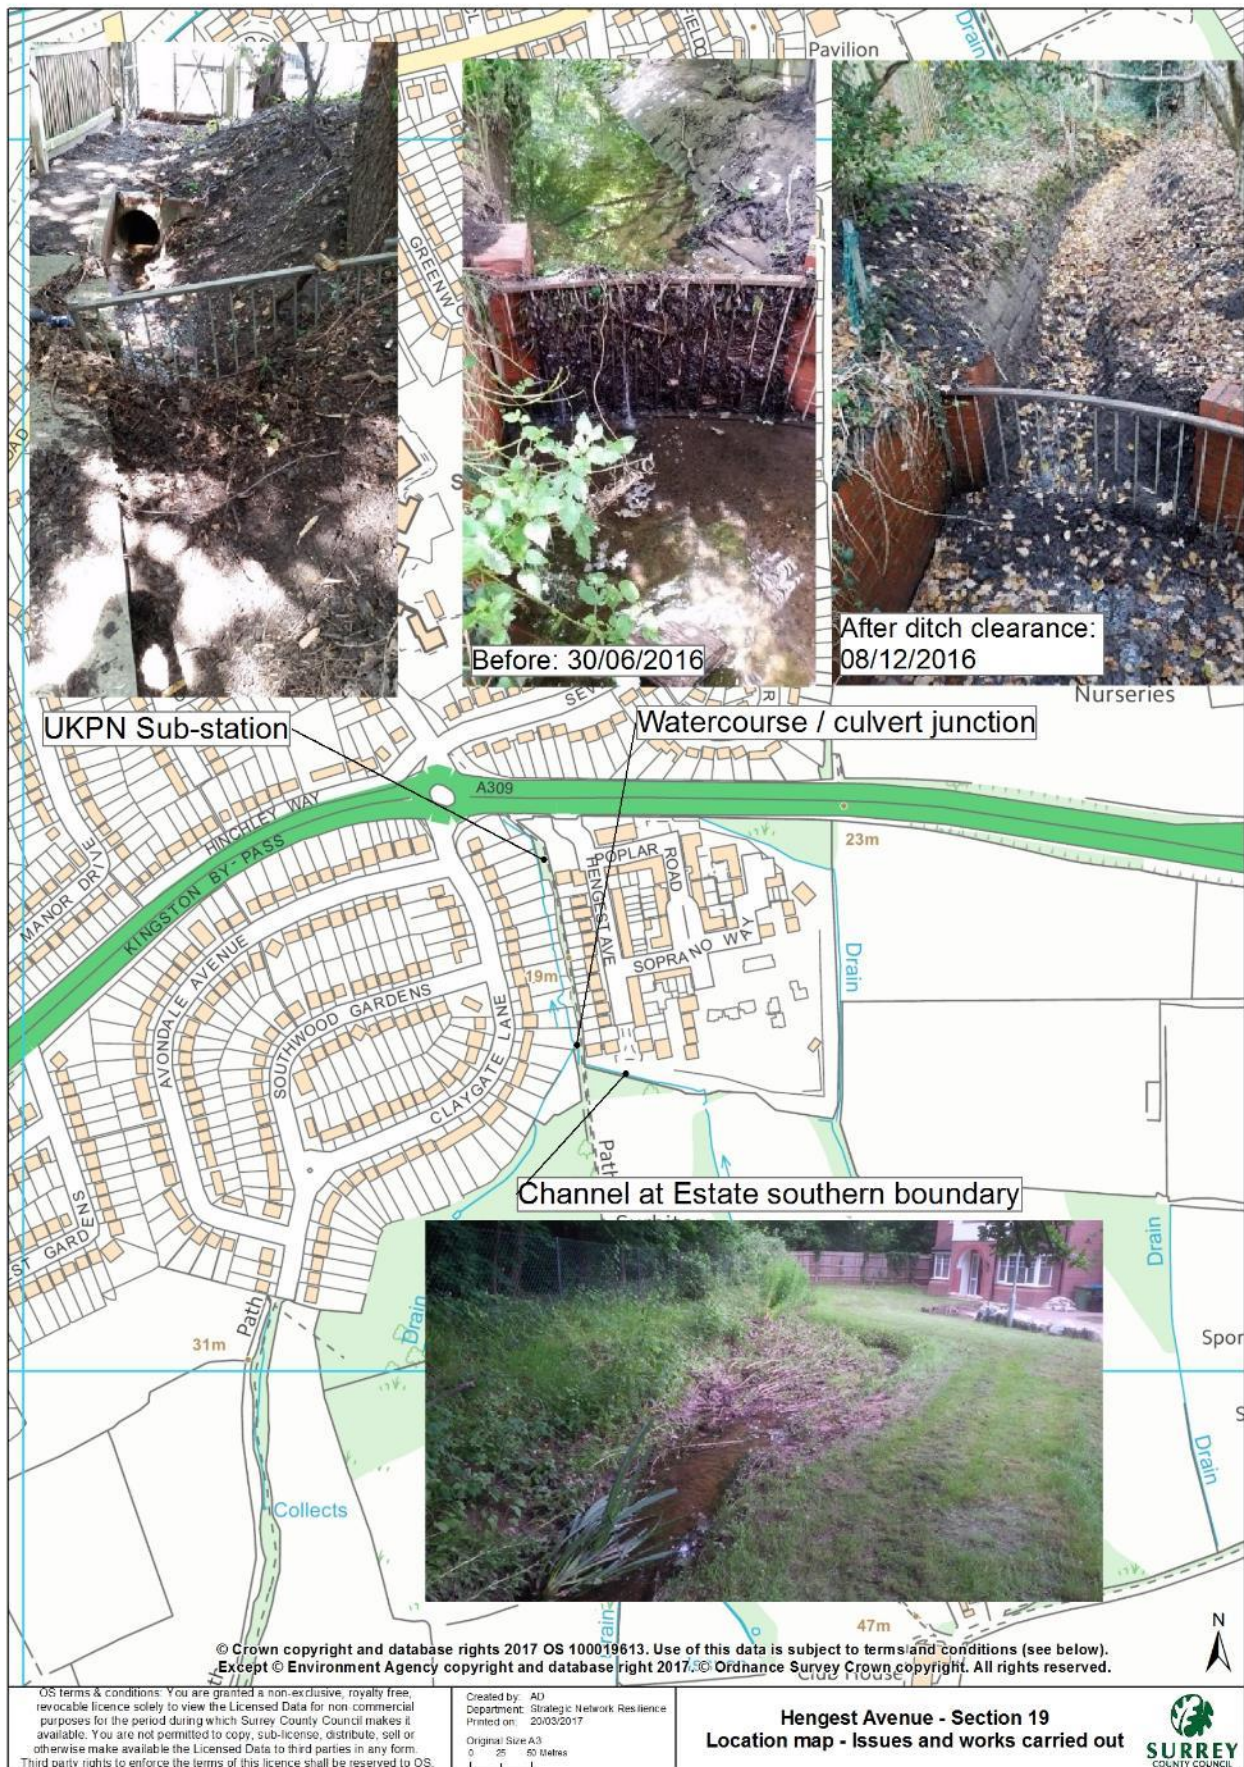
Initial survey of the watercourse and drainage network neighbouring Hengest Avenue indicated a number of issues (see Figure 6, Appendix 2). These are summarised below:

- Southern boundary: the ditch along the southern boundary of the estate was silted to the point that the width had been reduced to approximately one third of the upstream area. This meant that water would spill out of the banks and flow down Hengest avenue, resulting in flooding to the front of the properties.

- Watercourse / Culvert junction: A blocked trash grille located next to a footpath behind the fence of the west side of the estate caused water to back-up from this blockage and run onto the footpath and under the fence into gardens. This caused flooding to the rear of the Hengest Road properties (see before and after photos in Appendix 2).

- Twin pipe culvert at the northern most section of the watercourse had blockage within one of the two pipes. This severely reduced the capacity that could be taken by the culvert, causing water to back up and flood gardens along Claygate Lane.

- Surbtion Golf Course, located to the south of the estate, has a series of ditches that connect to the watercourse at Hengest Avenue. The watercourse here was not able to accept the run-off from the golf course ditches during the high rainfall event.

**Figure 6. Location map summarising watercourse issues and works carried out. Photos taken as part of the SCC ME-252184 flood enquiry including before and after photos of the ditch clearance west of Hengest Avenue.**

- SFRS attended the area following reports of internal and external flooding.
- SCC contractors Kier attended area following reports of flooding on carriageway.
- Elmbridge Borough Council contacted residents regarding reports of flooding.
- Flood investigation carried out by SCC Strategic Network Resilience identified sections of the drainage network that required maintenance.
- Investigation identified maintenance responsibility of ordinary watercourse and culverts.
- Maintenance has already been carried out to improve the capacity of the ordinary watercourse and culverts.
- Trash screen (watercourse / culvert to the west of Hengest Avenue) cleared and ditch section dug out.

- Riparian owners to monitor watercourse and maintain.
