Caterham-on-the-Hill Surface Water Management Study Surrey County Council

April 2016

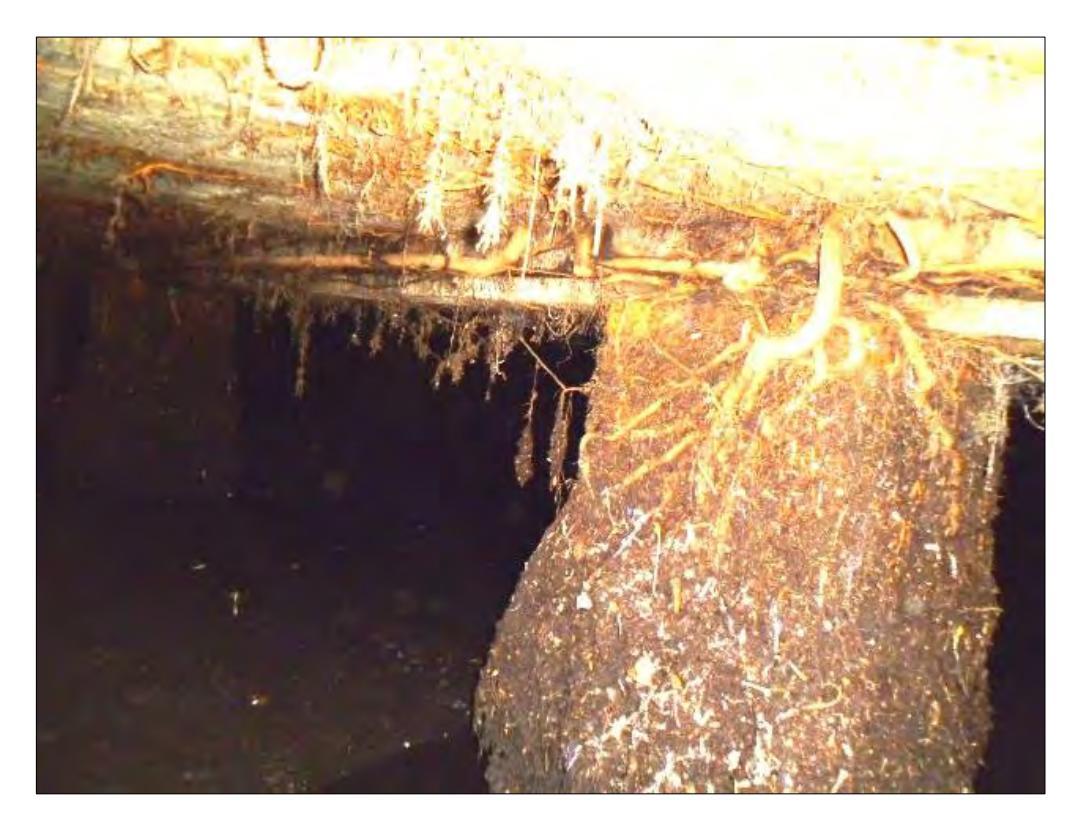
Access covers were found to be rusted, although not to a dangerous state. At the time of the survey, approximately 80% of the slab over the Money Pit was covered with vegetation, including brambles and small shrubs and trees. Soil and roots had to be cleared to access the covers. The vegetation growth meant that the survey team was unable to assess the condition of the slab surface. There was evidence of root ingress into the chamber from the stab above, as illustrated in Figure 2-2. The chamber wall and brick piers all seemed structurally sound with no evidence of cracking or displaced brickwork. The mortar joints seemed in good condition.

Figure 2-2 Root ingress through the Money Pit slab and onto one of the chamber's piers

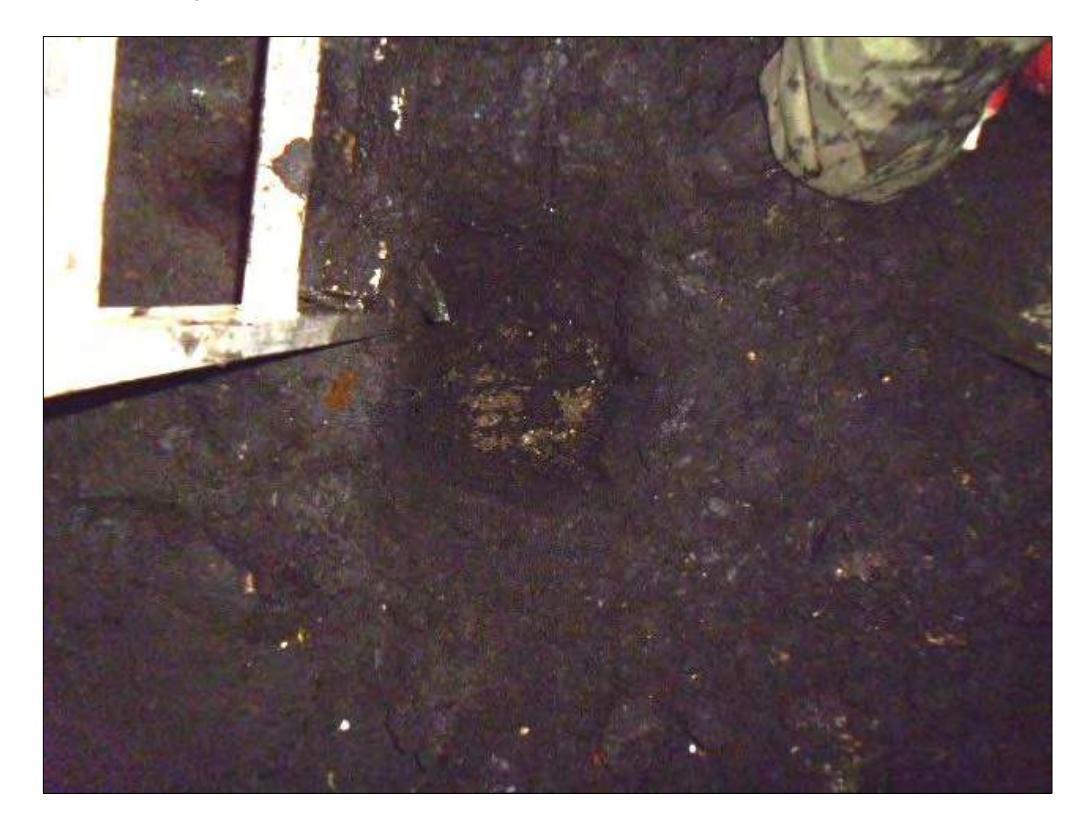
There was an average of 400mm of silt at the base of the Money Pit (see Figure 2-3), though in some areas this was considerably more, particularly in the northern corner of the asset where silt was seen to be piled up against the chamber wall (see Figure 2-4). Due to the levels of siltation, the survey team were unable to leave the base of the inspection chamber area to assess the wider condition of the asset.

Figure 2-3 Silt levels at base area of access cover D

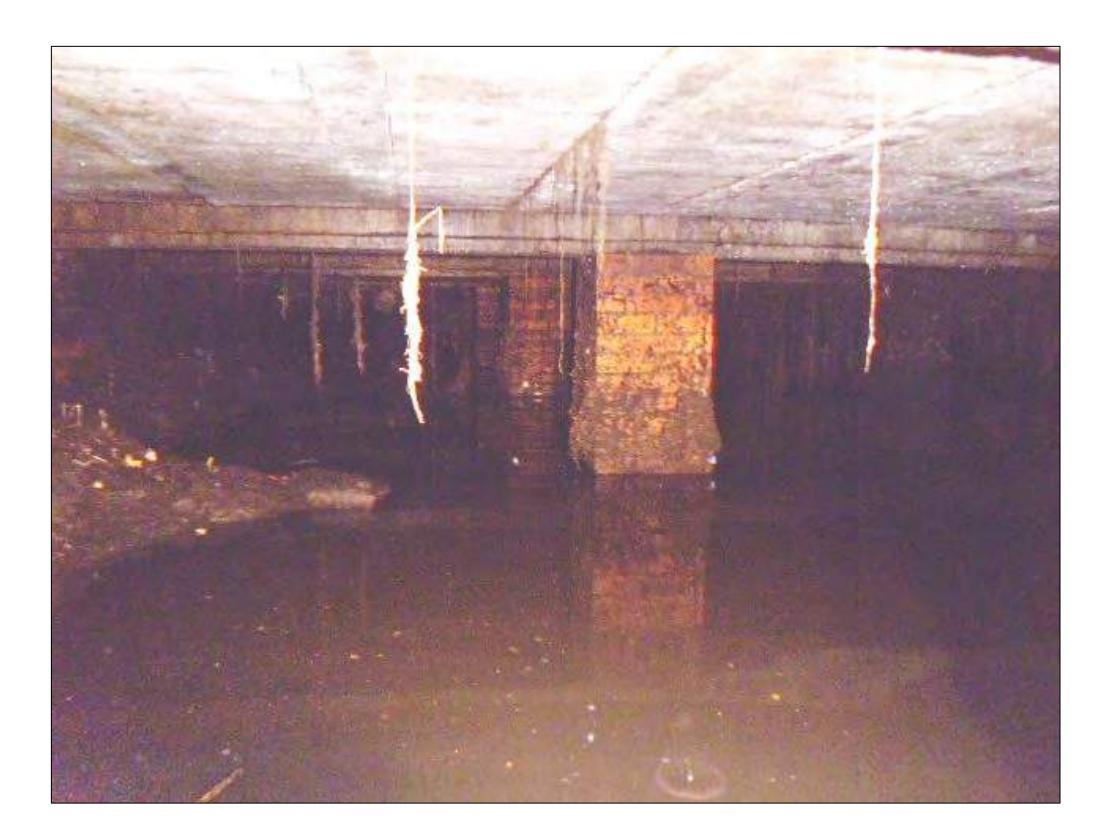
Figure 2-4 Photo from Access A showing area of considerable sedimentation and standing water

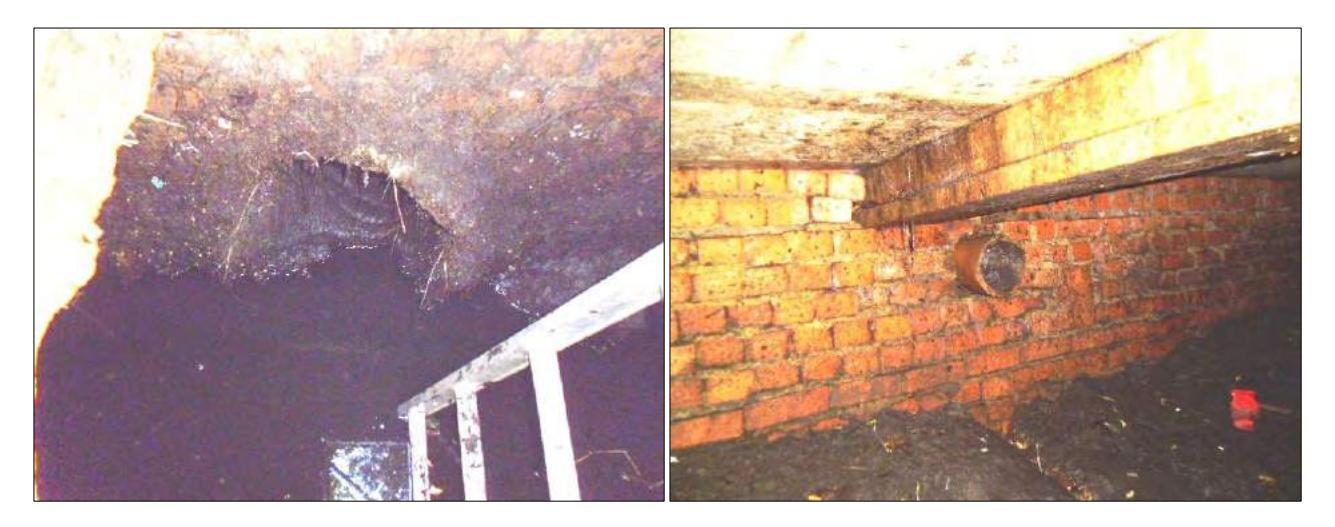
- A mid-level (0.4m from base) 450mm conduit with an invert level of 166.5m AOD along the southeastern side of the chamber, close to Access E (see Figure 2-5 and 2-6); and
- A high-level (1m from base) 150mm conduit with an invert level of 167.1m AOD along the northwestern of the chamber, close to Access A (Figure 2-5).

The mid-level 450mm incoming conduit is the main storm drain. The high-level 150mm incoming conduit is believed to be a private connection.

Figure 2-5 Money Pit incoming pipes (450mm on left and 150mm on right)

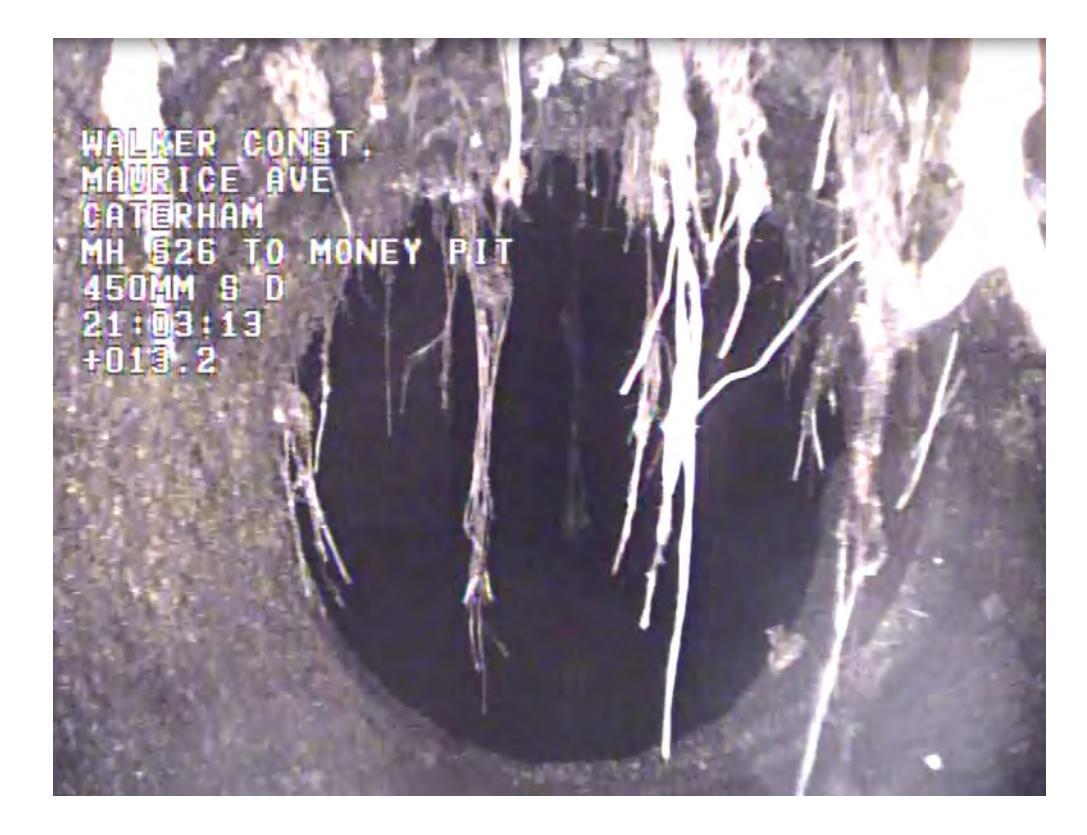
Figure 2-6 2013 CCTV survey of 450mm pipe outfalling into the Money Pit chamber

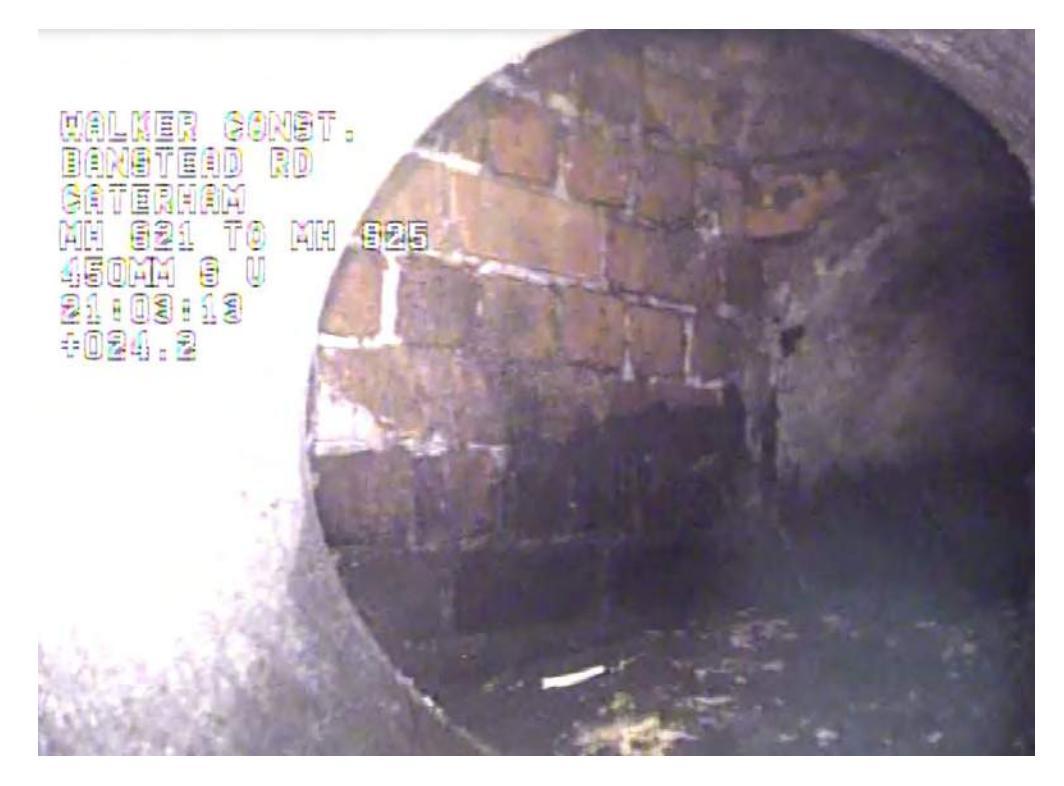
A previous CCTV survey (AB Pipeline Services Limited, March 2013) surveyed a length of sewer on the main storm drain just downstream of the Money Pit. The upstream end of the survey was a manhole chamber in the garden of 99 / 101 Banstead Road, to the north-west of the Money Pit. Looking upstream, the 2013 CCTV survey image (see Figure 2-8) clearly slows a large conduit (approximately 450mm) running from the manhole chamber in the road, towards the Money Pit. Access to this manhole chamber was not available and hence it was not possible to confirm connectivity.

Figure 2-8 2013 CCTV survey showing manhole downstream of The Money Pit

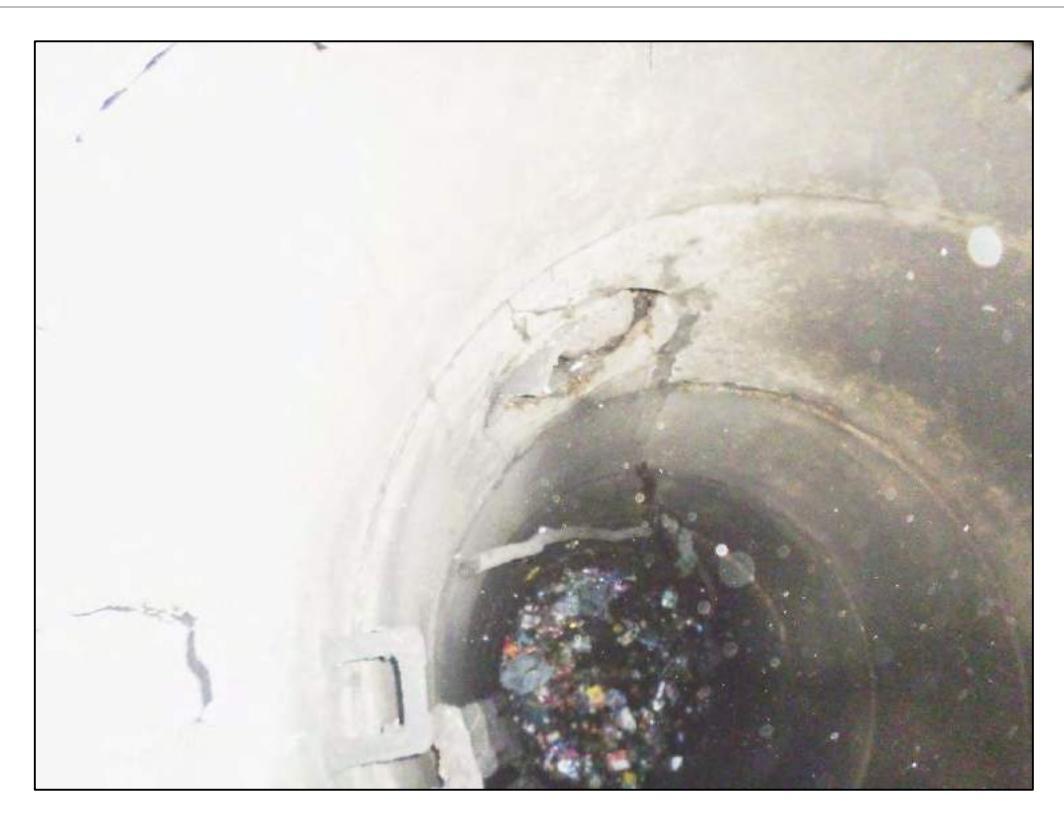
The slab is covered with vegetation. The cover and frame were found to be rusted although not to a dangerous state. The chamber rings and slab appeared to be structurally sound with no evidence of cracking or spalling. The base of the chamber is heavily silted with approximately 150mm of sediment and trash, including plastic drinks bottles, crisp packets and plastic bags. This is illustrated in the photograph in Figure 2-9.

Figure 2-9 Image into soakaway chamber showing trash covering the base

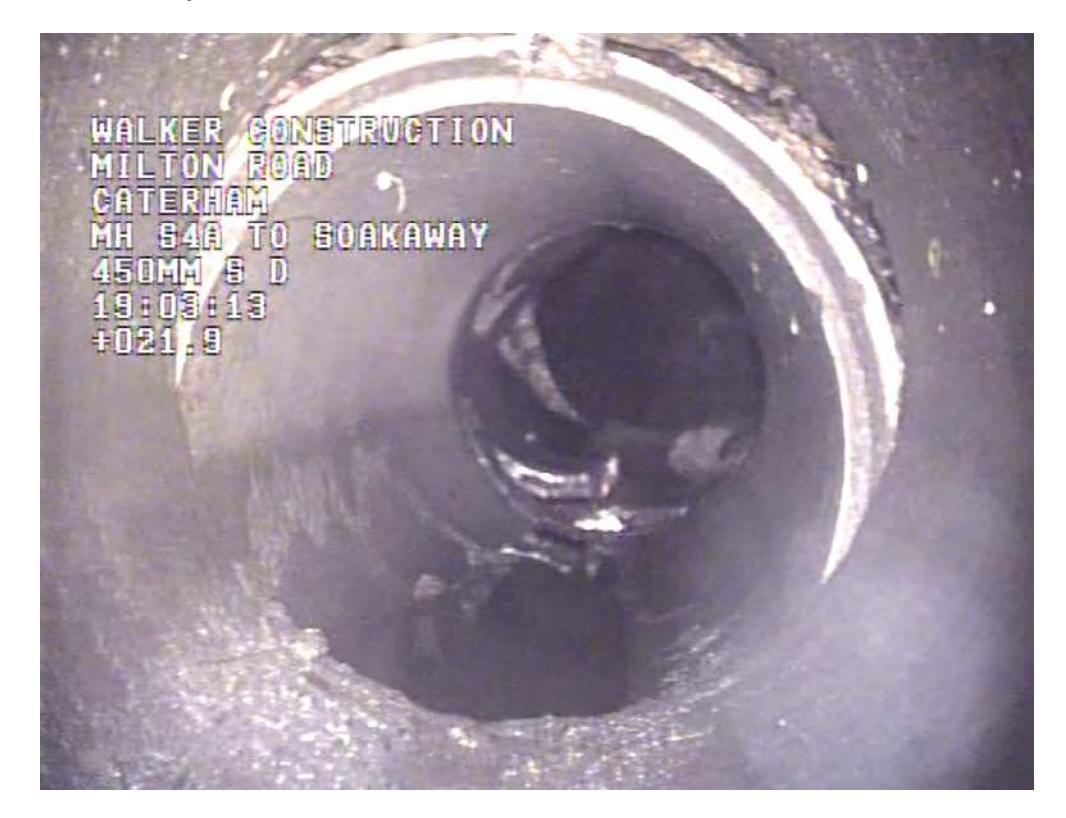
There is a single incoming circular concrete culvert with a diameter of 450mm and an invert level of 150.11m AOD. This is the main storm drain. The CCTV survey (AB Pipeline Services Limited, March 2013) found this pipe to be fractured and deformed, as illustrated on Figure 2-10. No other pipes were located in the chamber, and hence with soakaway has no formal overflow mechanism.

Figure 2-10 2013 CCTV survey showing fractured and deformed pipe, ending in the soakaway

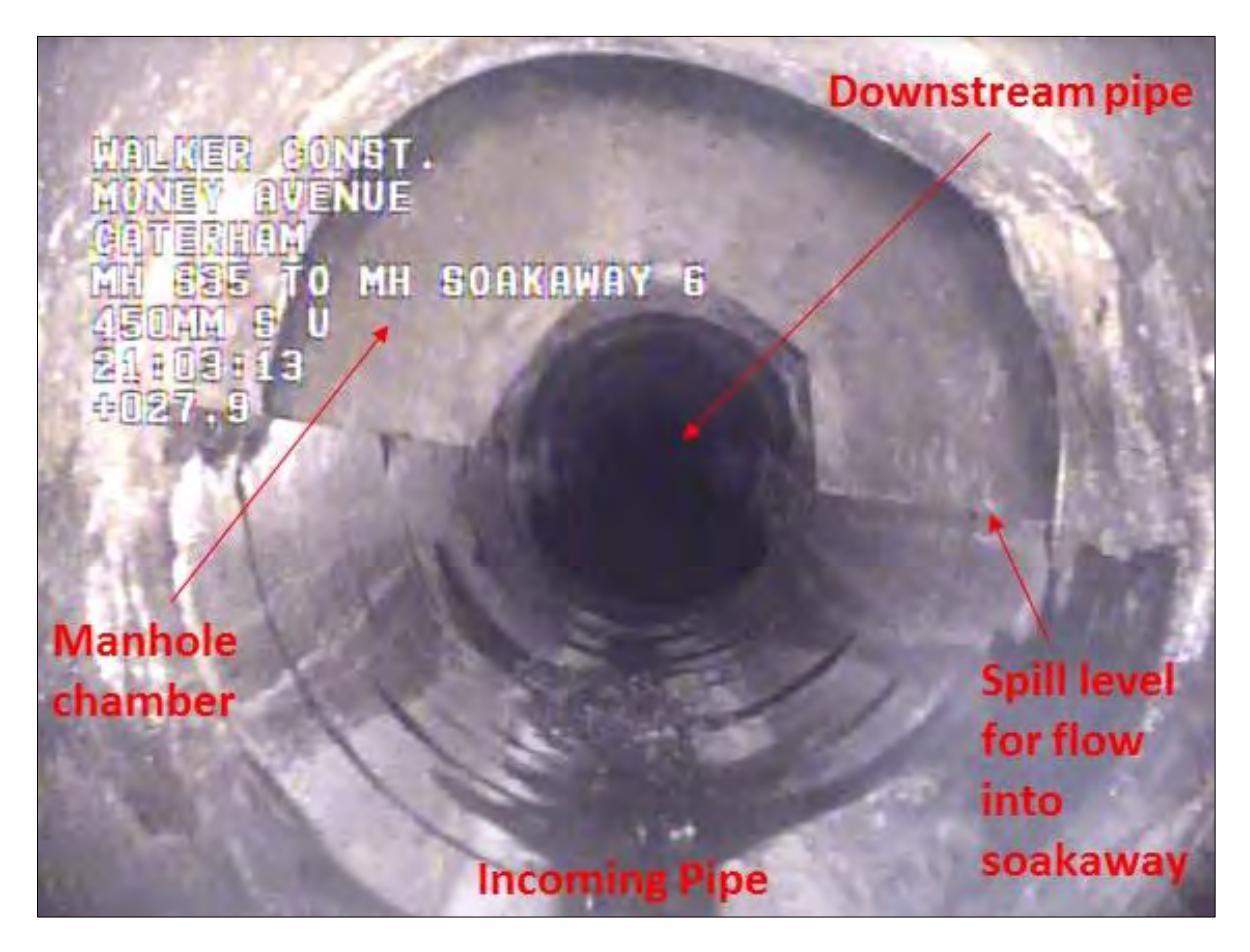
Figure B-1 CCTV photo of soakaway 2 (Money Avenue)

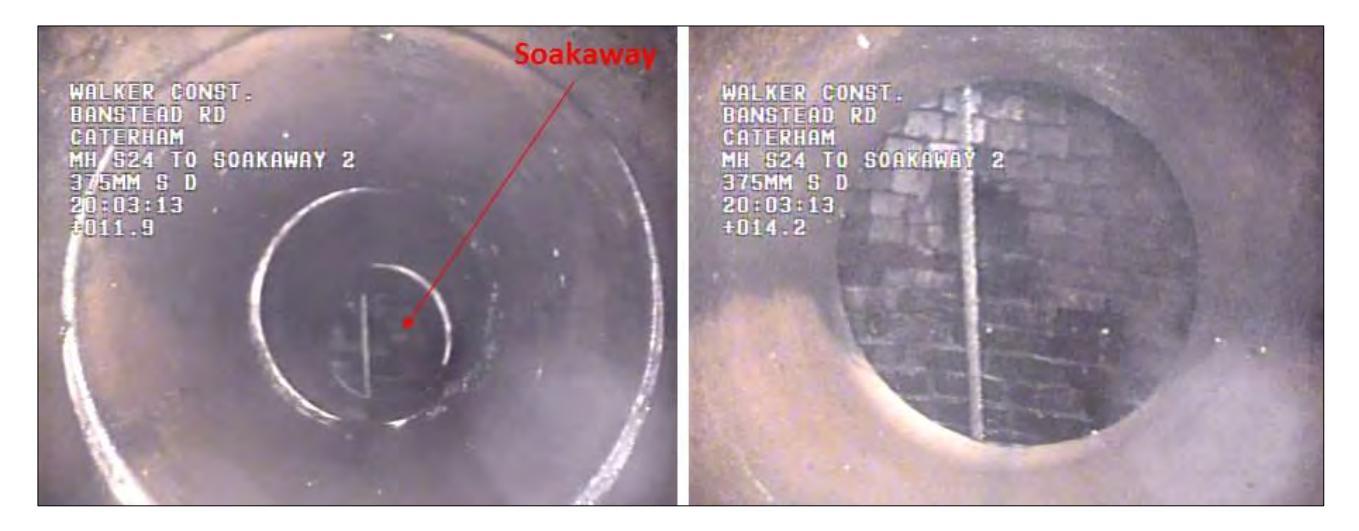
Figure B-2 CCTV photo of soakaway 3 (Junction of Campbell Road and Banstead Road)

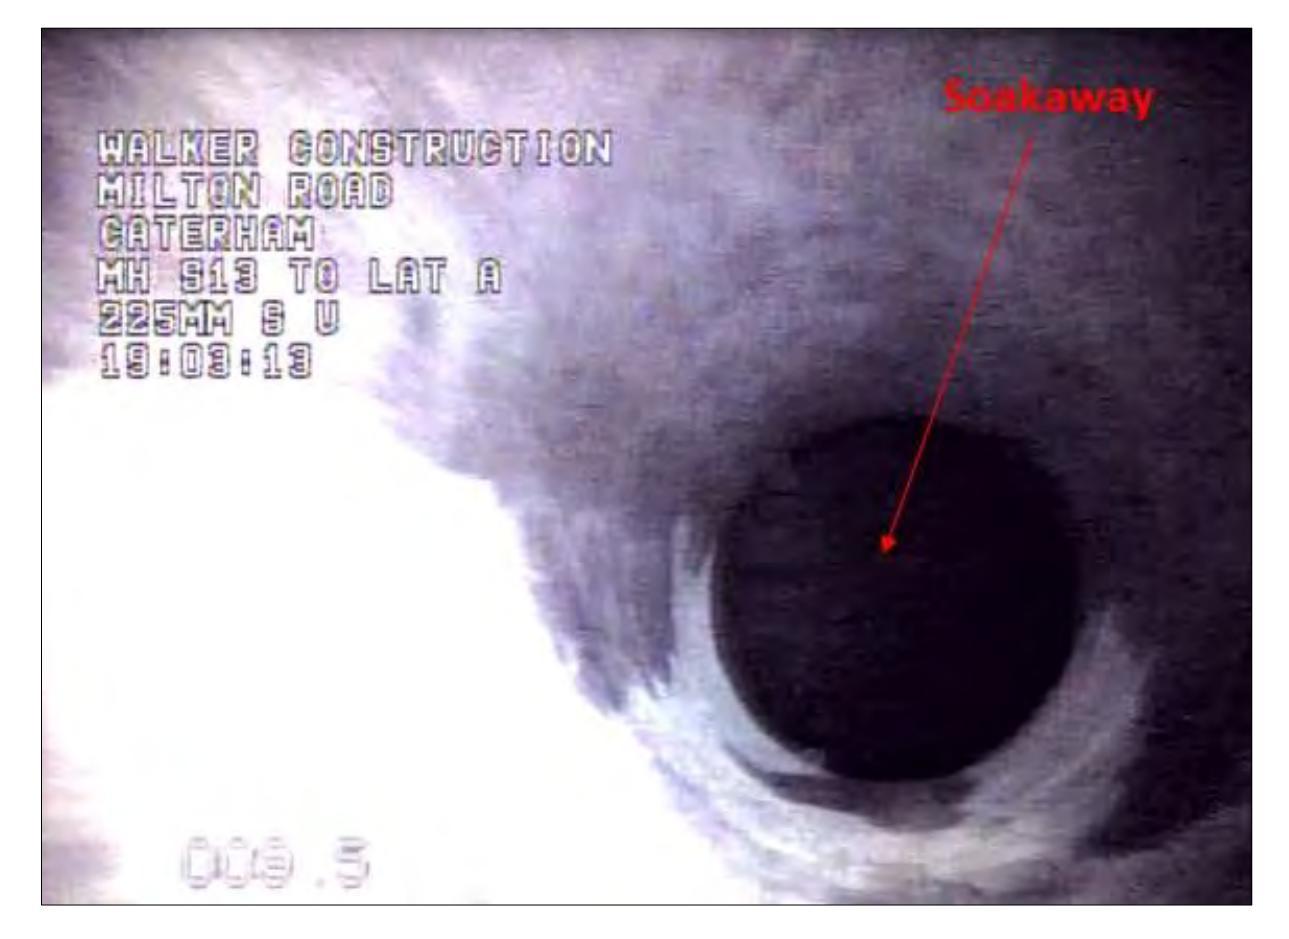
Figure B-3 CCTV photo of soakaway 4 (Junction of Milton Road and Banstead Road)
