Summary Reports of Smallfield and Burstow S19 Investigations

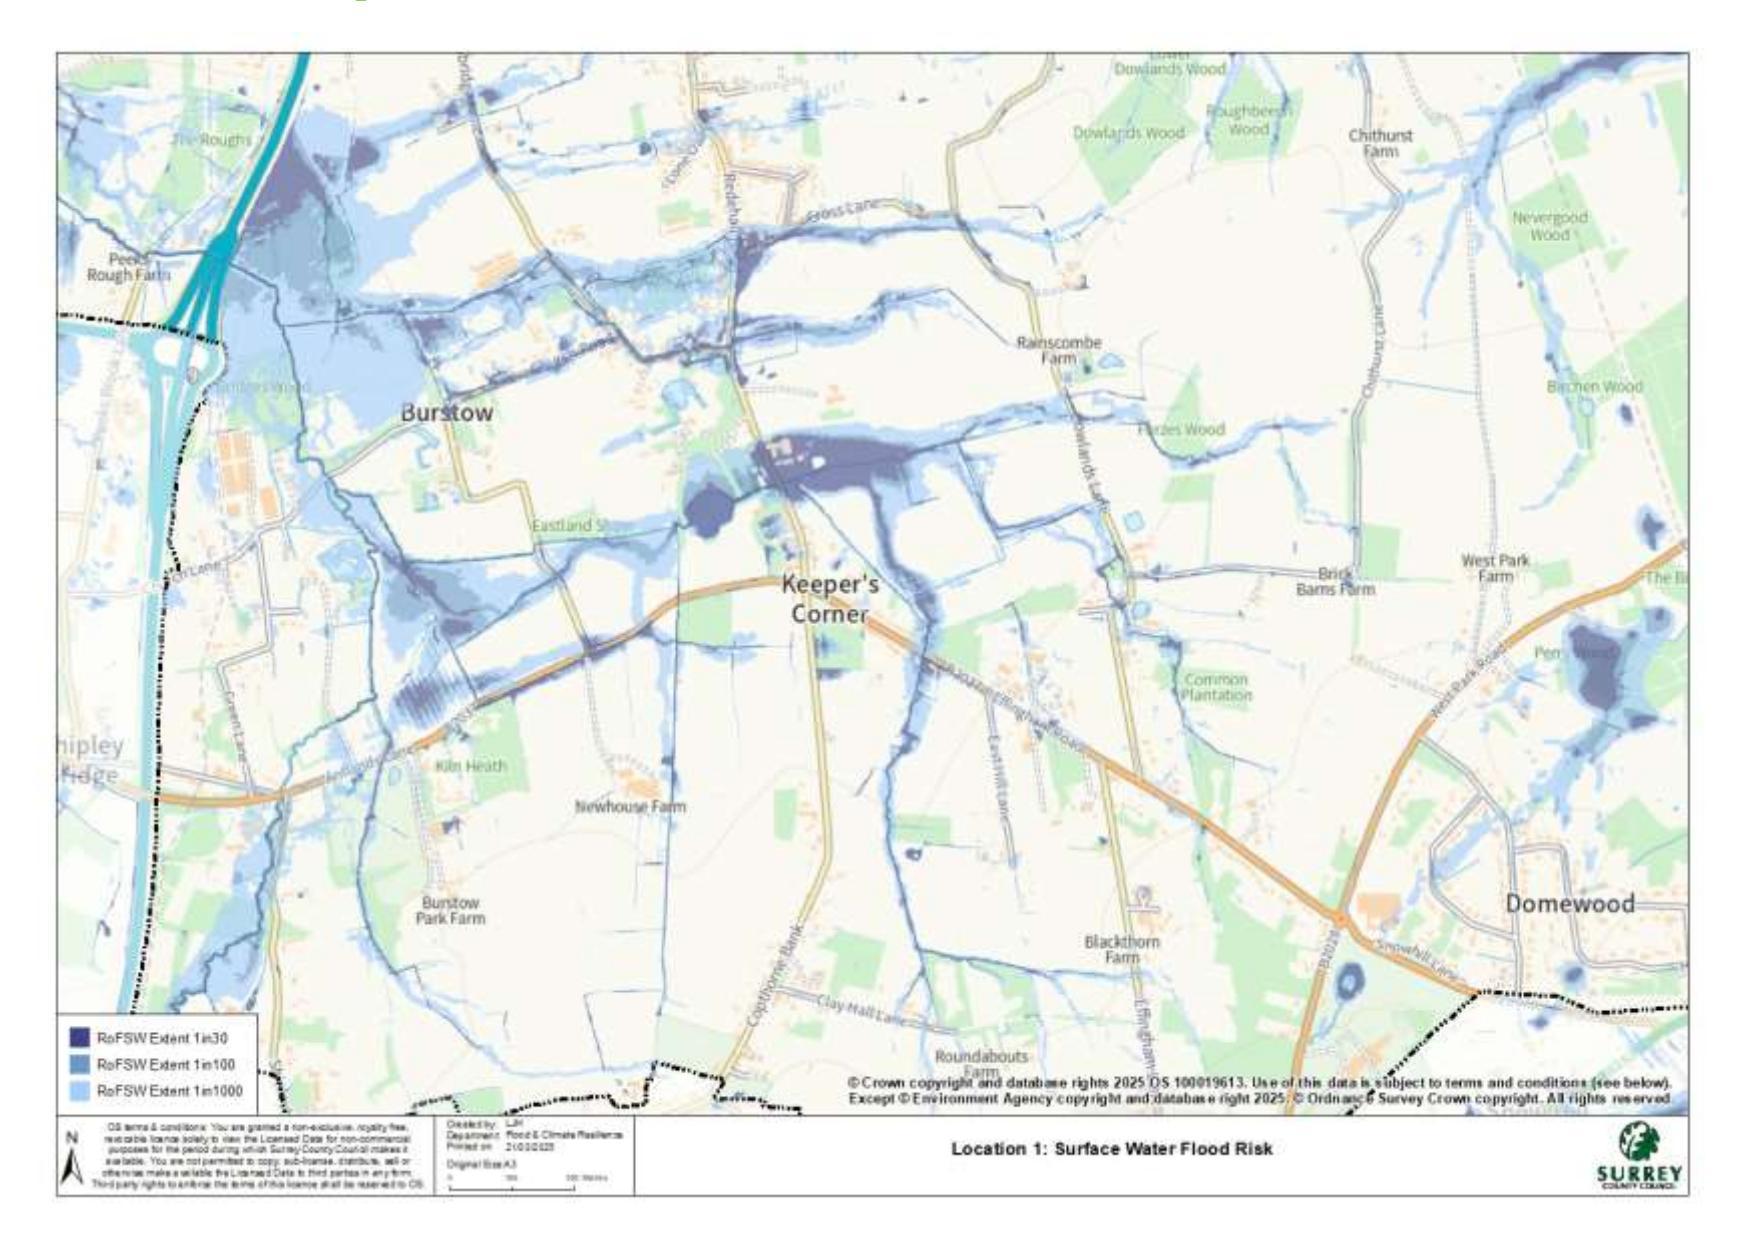
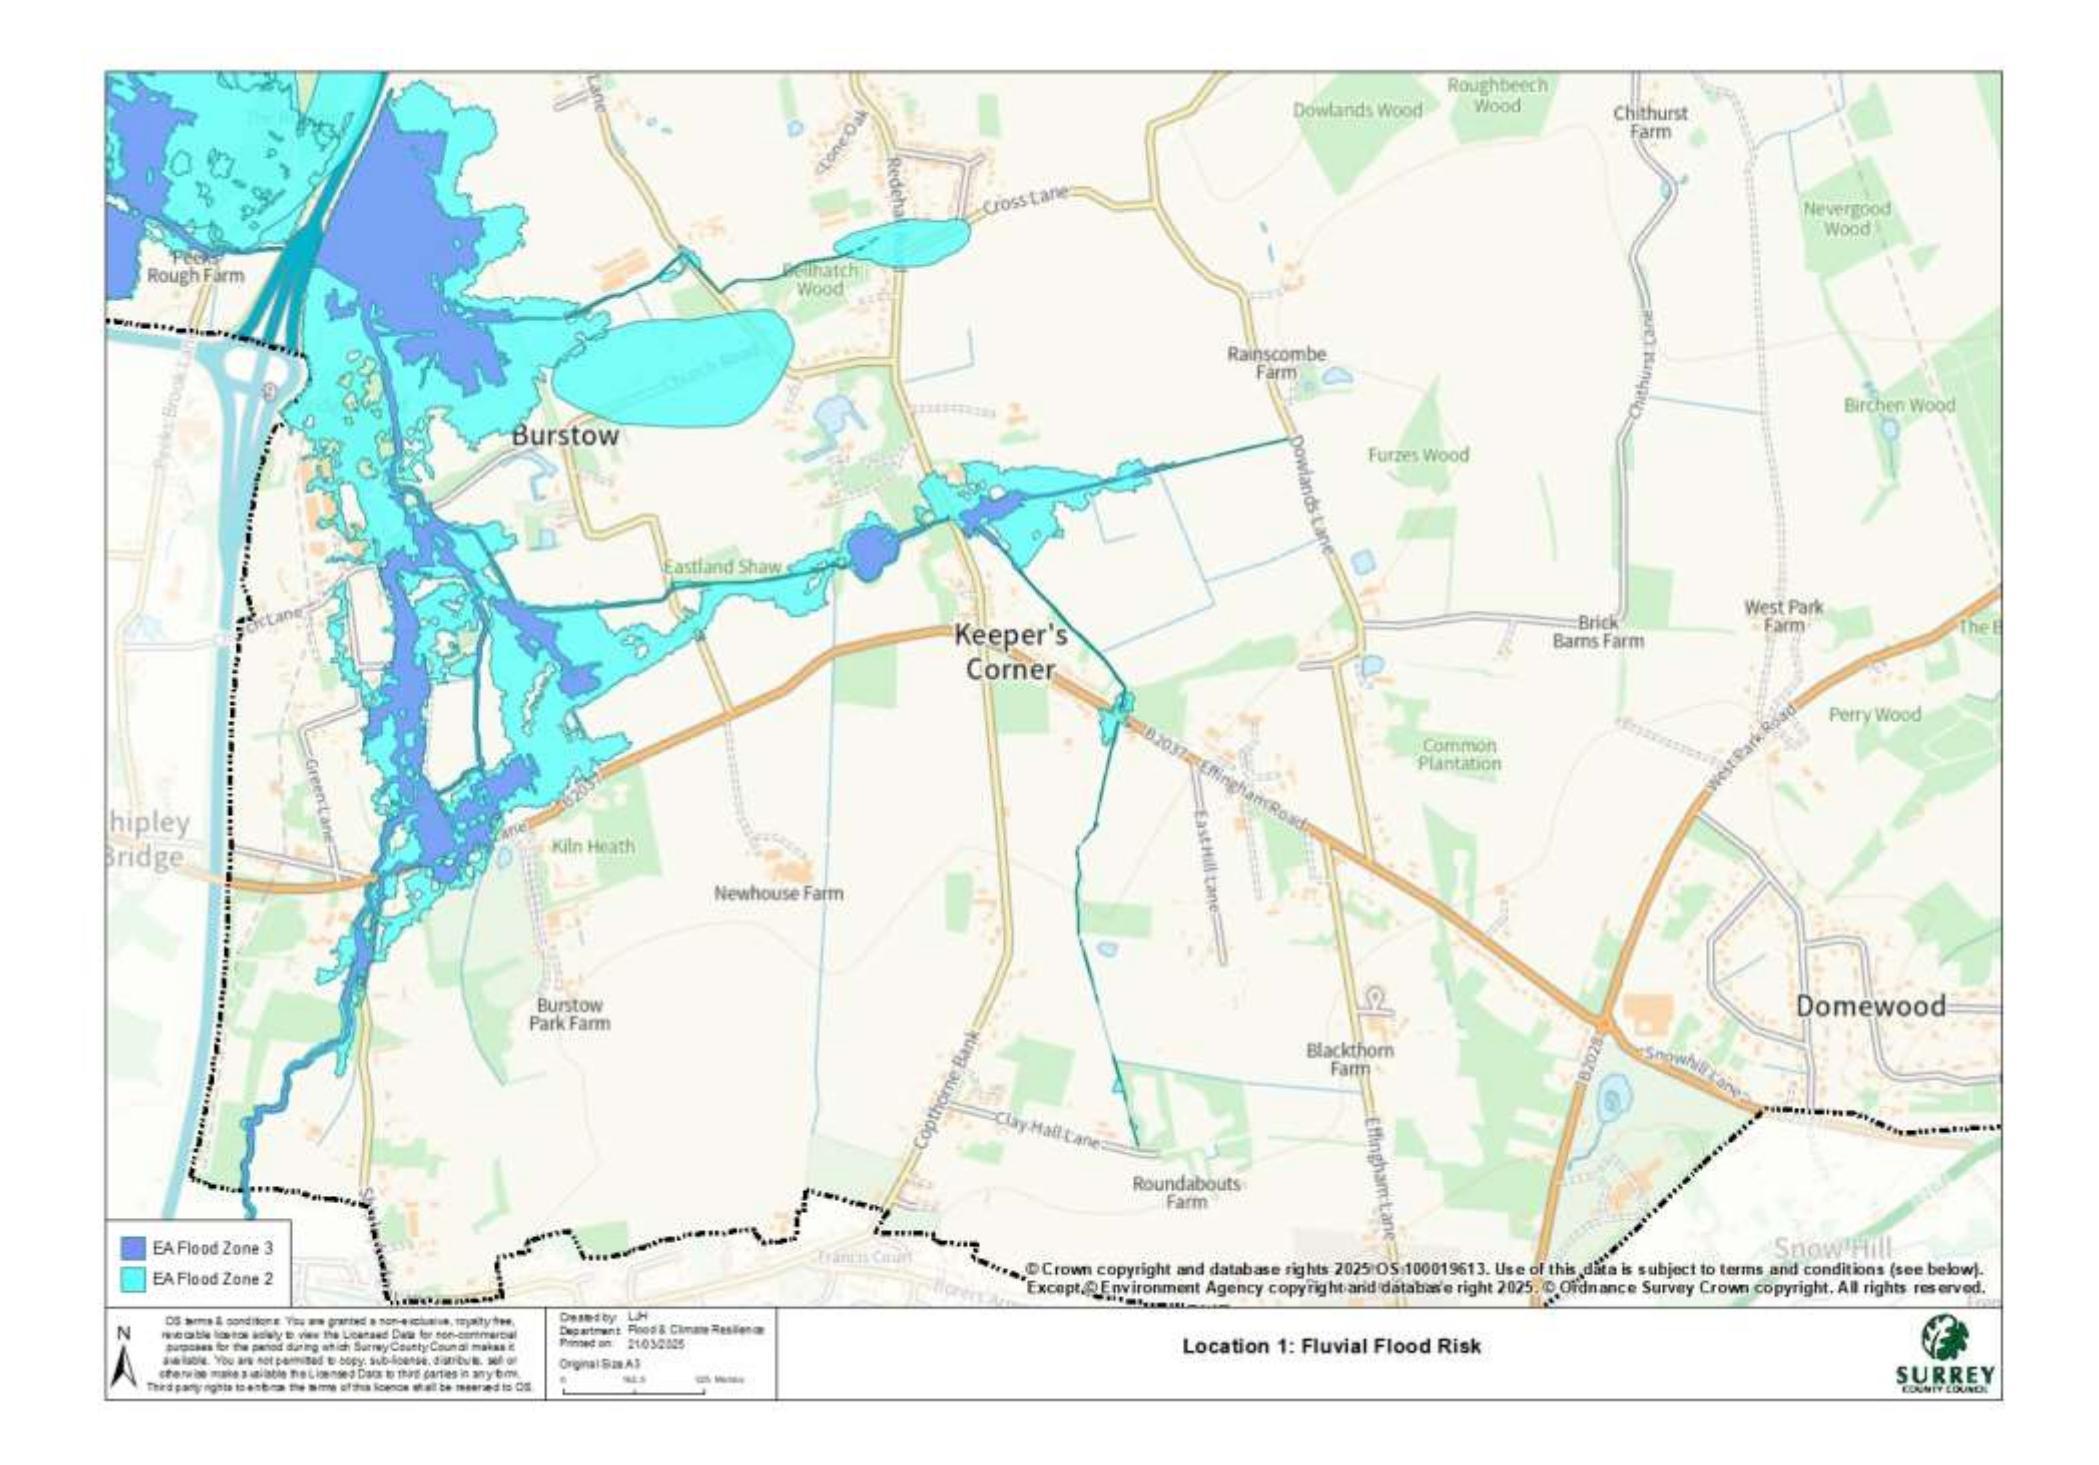
Annex A: Location 1 (Enquiry Reference: 2419524)

On November 17th, 2022, extensive flooding impacted 3 properties externally, including one commercial property and the highways following heavy rainfall.

The flooding occurred as surface water runoff accumulated on adjacent roads due to blocked ditches and multiple gully defects. Consequently, water overflowed from the ditches, bypassed gullies, and converged several surrounding roads.

The site is classified as a Wetspot, characterized by a high risk of surface water flooding, fluvial flooding, and potential groundwater flooding. The affected properties and highways have experienced a history of recurring flooding over the past four years.

- Landowners to carry out maintenance to the watercourse within the boundaries of their land to allow flow of water.
- **Landowners** to consider implementing property flood resilience to reduce risk of flooding to property, sought from a suitably qualified professional.
- **SCC Highways** to consider an inspection of gullies, should a defect be found, to fix assets.

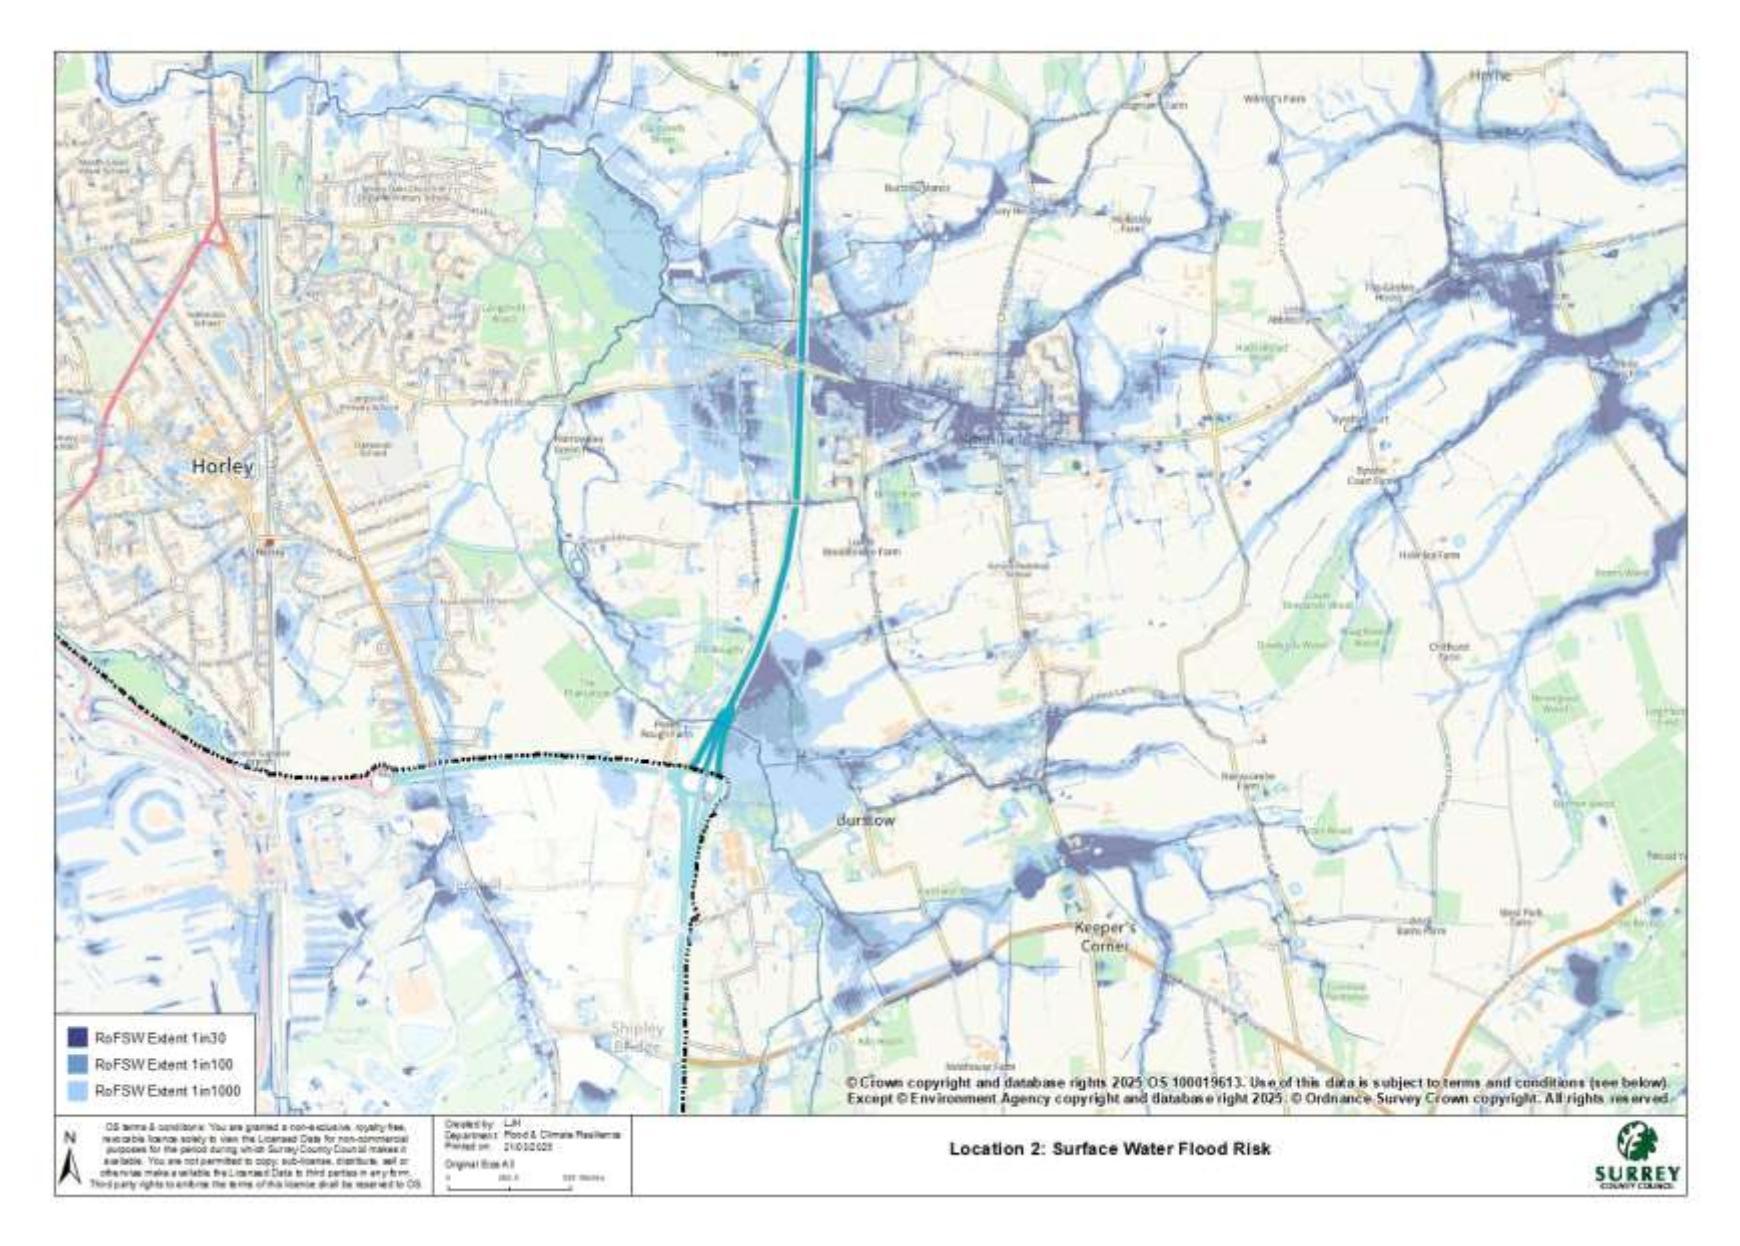
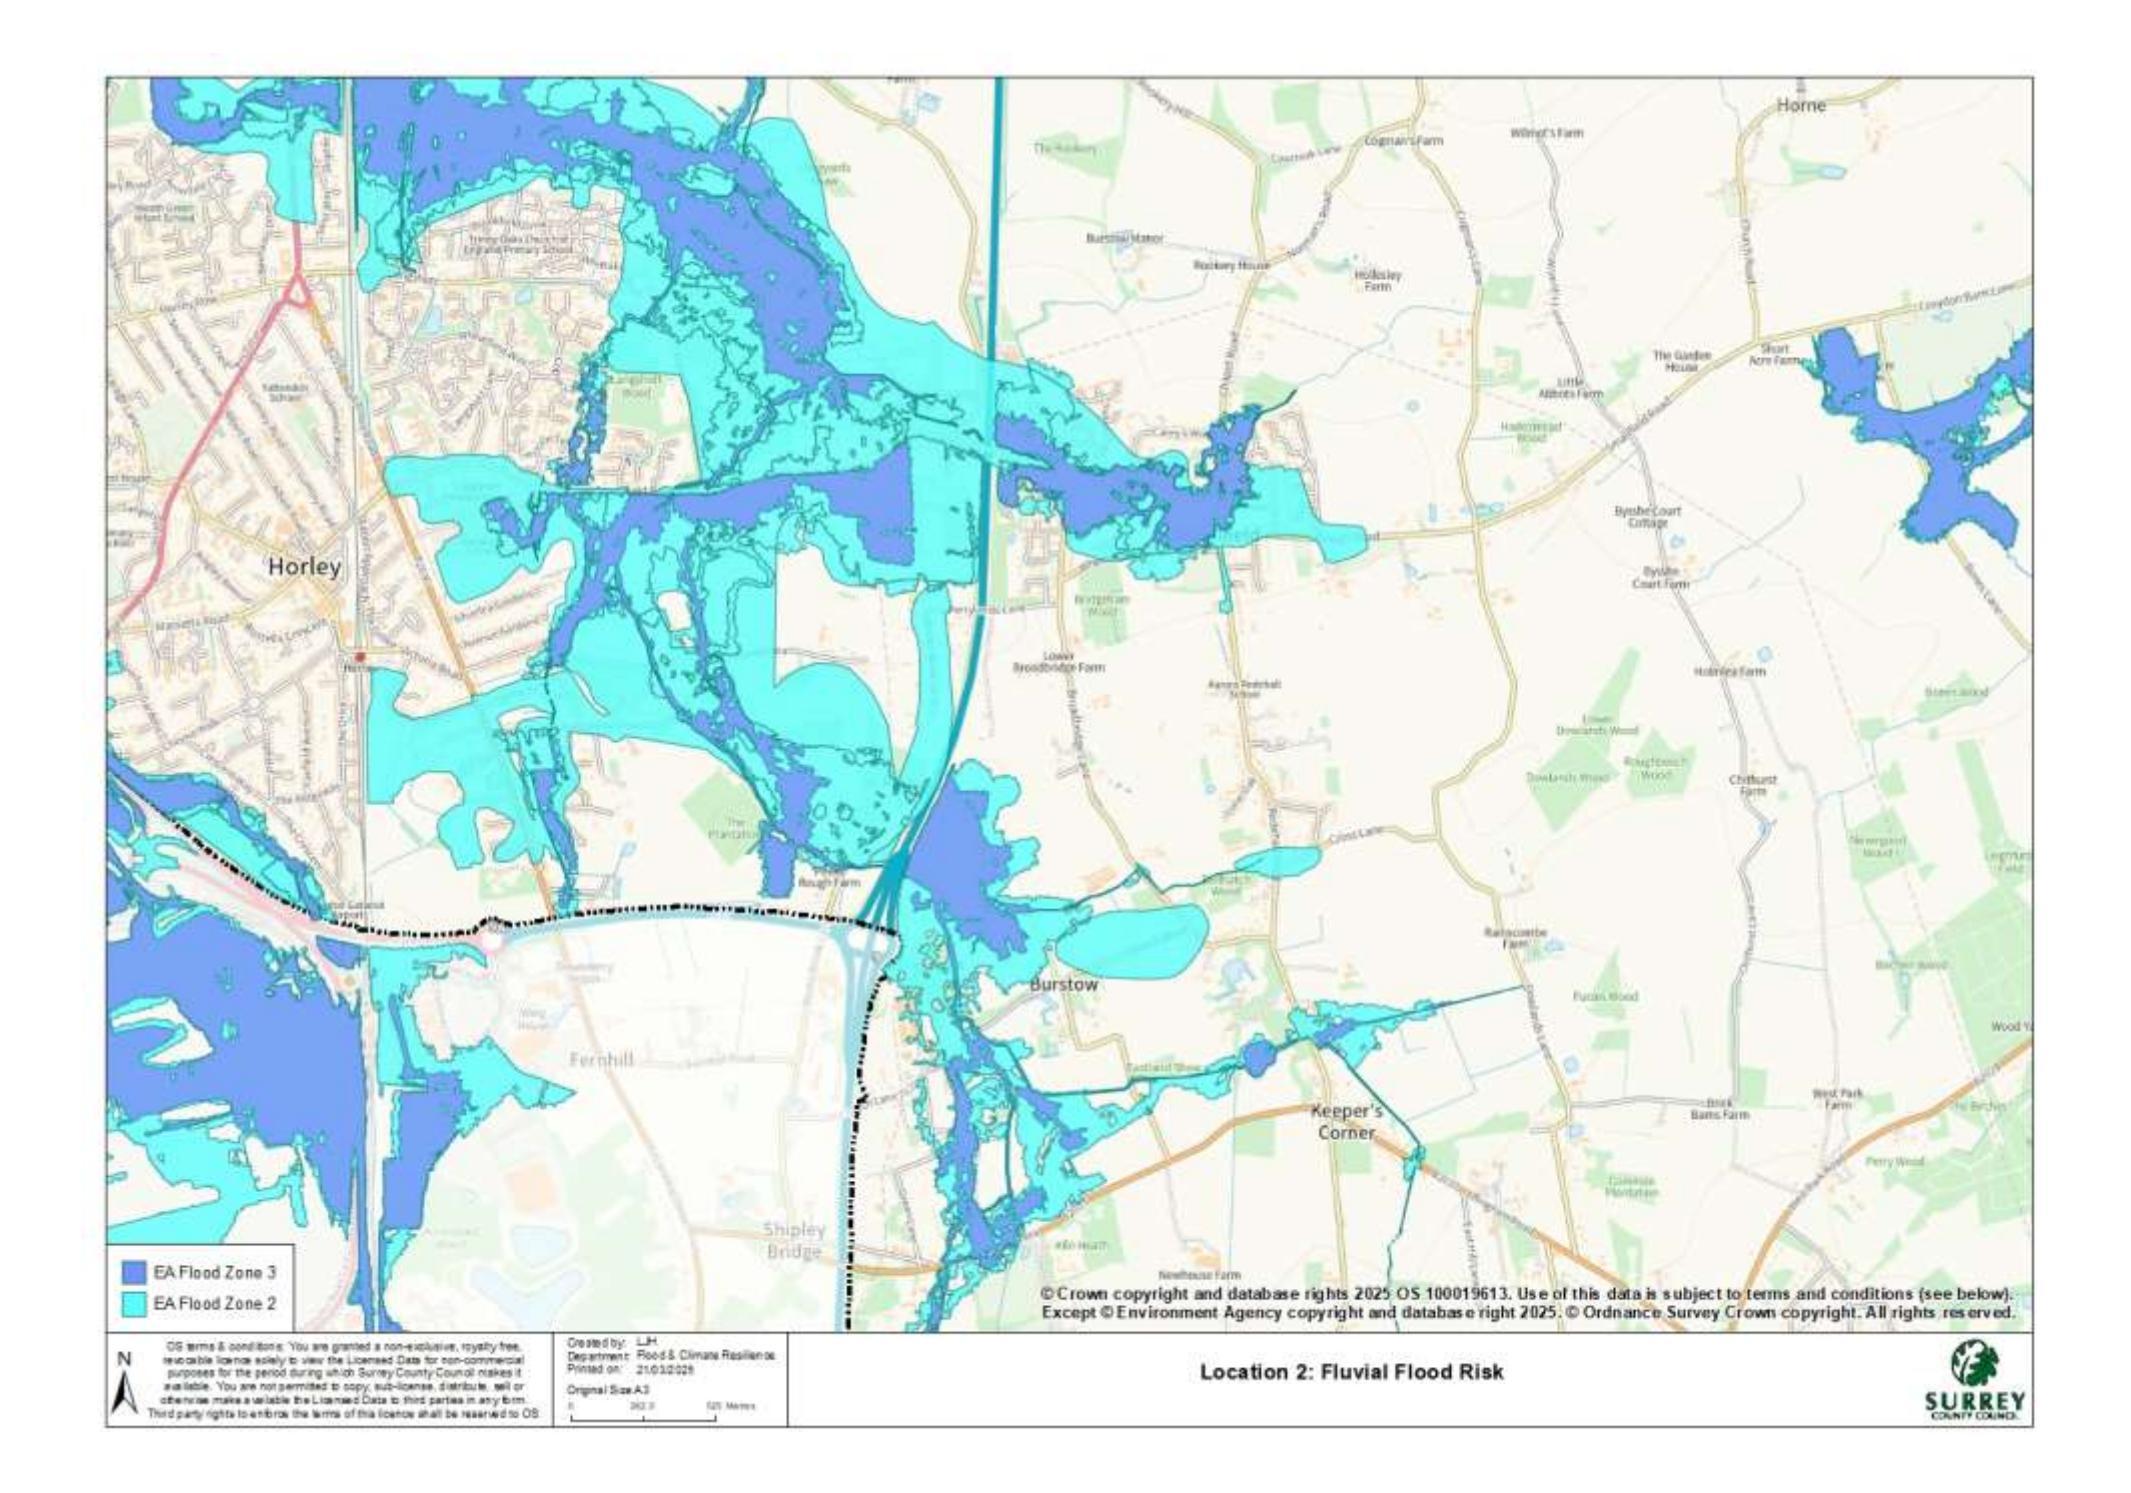
Annex B: Location 2 (Enquiry Reference: ME-50067307)

On November 17th, 2022, two properties experienced external flooding following heavy rainfall. Water accumulated at the front and rear of the properties, overtopping the ditch running alongside them. During the site visit, water was still present in the ditch.

The properties are located in an area at high risk of surface water flooding, with a history of nearby highway flooding. The underlying bedrock consists of mudstone, which reduces permeability and prevents water from draining away quickly, thereby increasing the likelihood of flash flooding during storm events.

The site visit also identified a buildup of debris in a ditch further upstream, where a submerged culvert was observed. This obstruction likely caused water to back up downstream, contributing to the flooding incident.

- Landowner to carry out maintenance to the watercourse within the boundaries of their land. Clearing build-up in channel bed to revealing outlet.
- Landowners to consider implementing property flood resilience measure to reduce the risk of flooding to property sought from a suitably qualified professional.

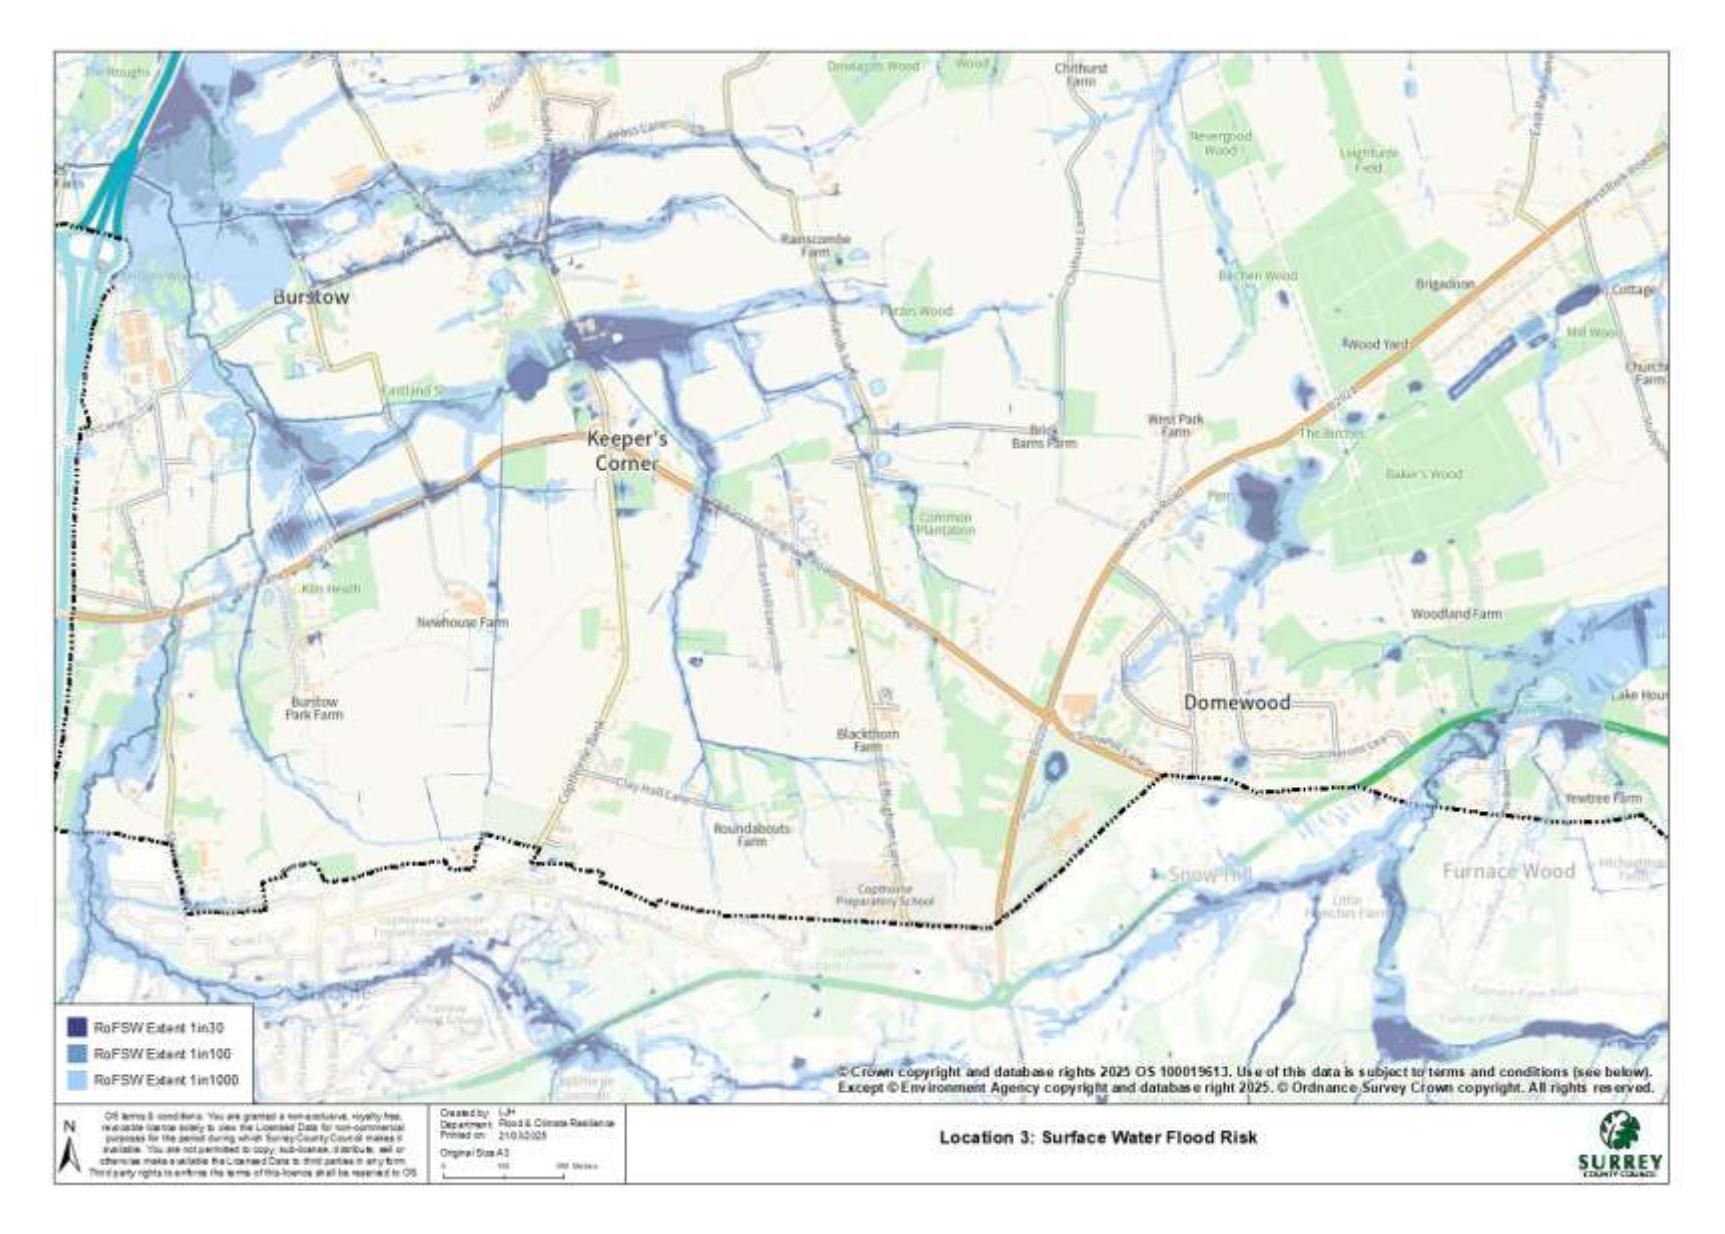
Annex C: Location 3 (Enquiry Reference: ME-50068407)

A development site and nearby residential properties experienced external flooding on three occasions—November 16th, 17th, and 23rd, 2022—following heavy rainfall. Surface water runoff originating from fields opposite the properties accumulated to a depth of 2–3 inches and entered the development through the fencing. Flooding occurred shortly after rainfall and typically took approximately 2–3 hours to drain.

An unmaintained ditch within the field was observed, but it is unlikely to either resolve the issue or be a direct cause of flooding. Key observations include:

- 1. **Flood Risk:** While the location is not classified as being at high risk of surface water, groundwater, or fluvial flooding, there is a documented history of highway and external property flooding in the vicinity.
- Resident Actions: Residents blocked an ACO drain to prevent flooding of the development, which may inadvertently impact flood risk for surrounding properties. Although the ditch opposite the property is well-maintained, surface water runoff does not follow its route.
- 3. **Drainage Capacity:** During the site visit, manholes in front of the development were filled with water, indicating that the drainage system may be operating at full capacity.

- Landowner of field to carry out maintenance to the watercourse within the boundaries of their land. Clearing build up in channel bed.
- Landowners to consider implementing additional flood protection to reduce risk of flooding to property sought from a suitably qualified professional.

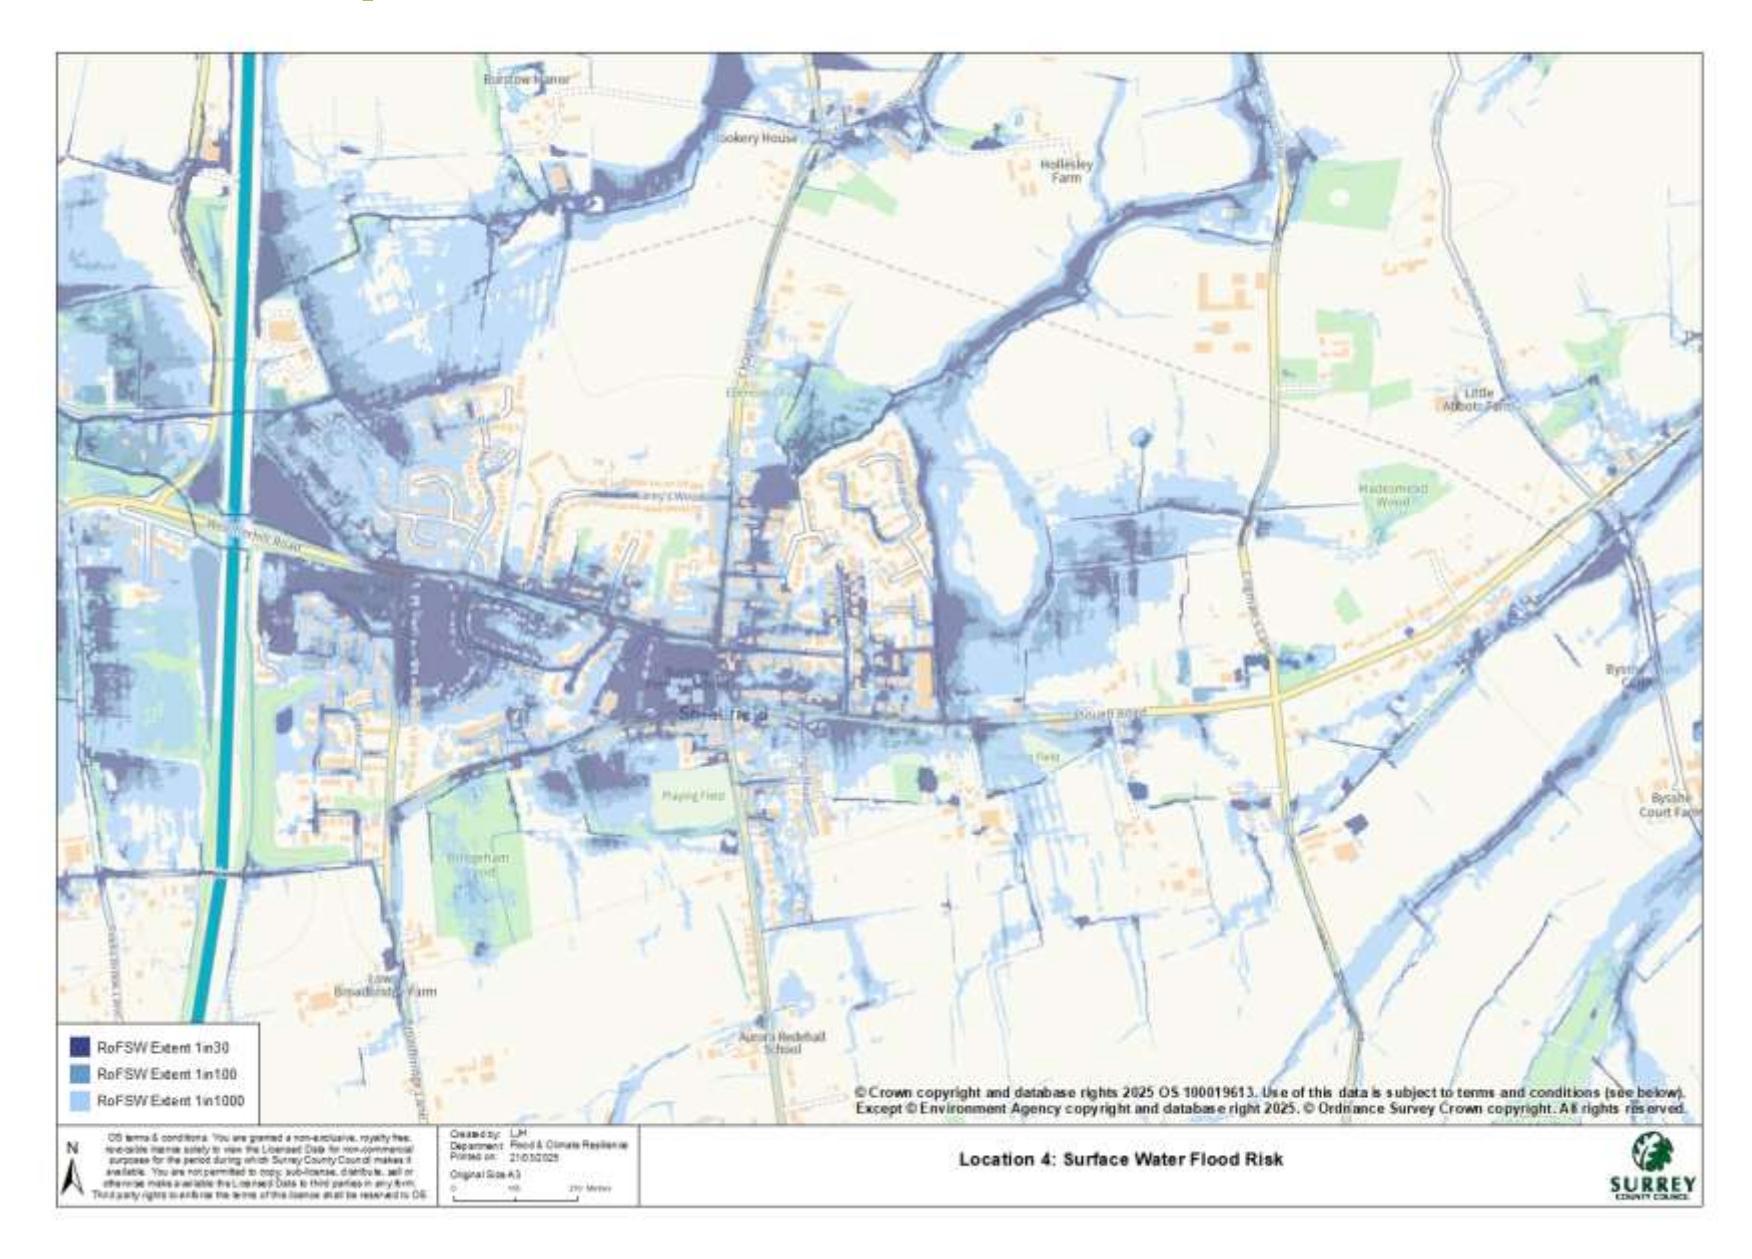
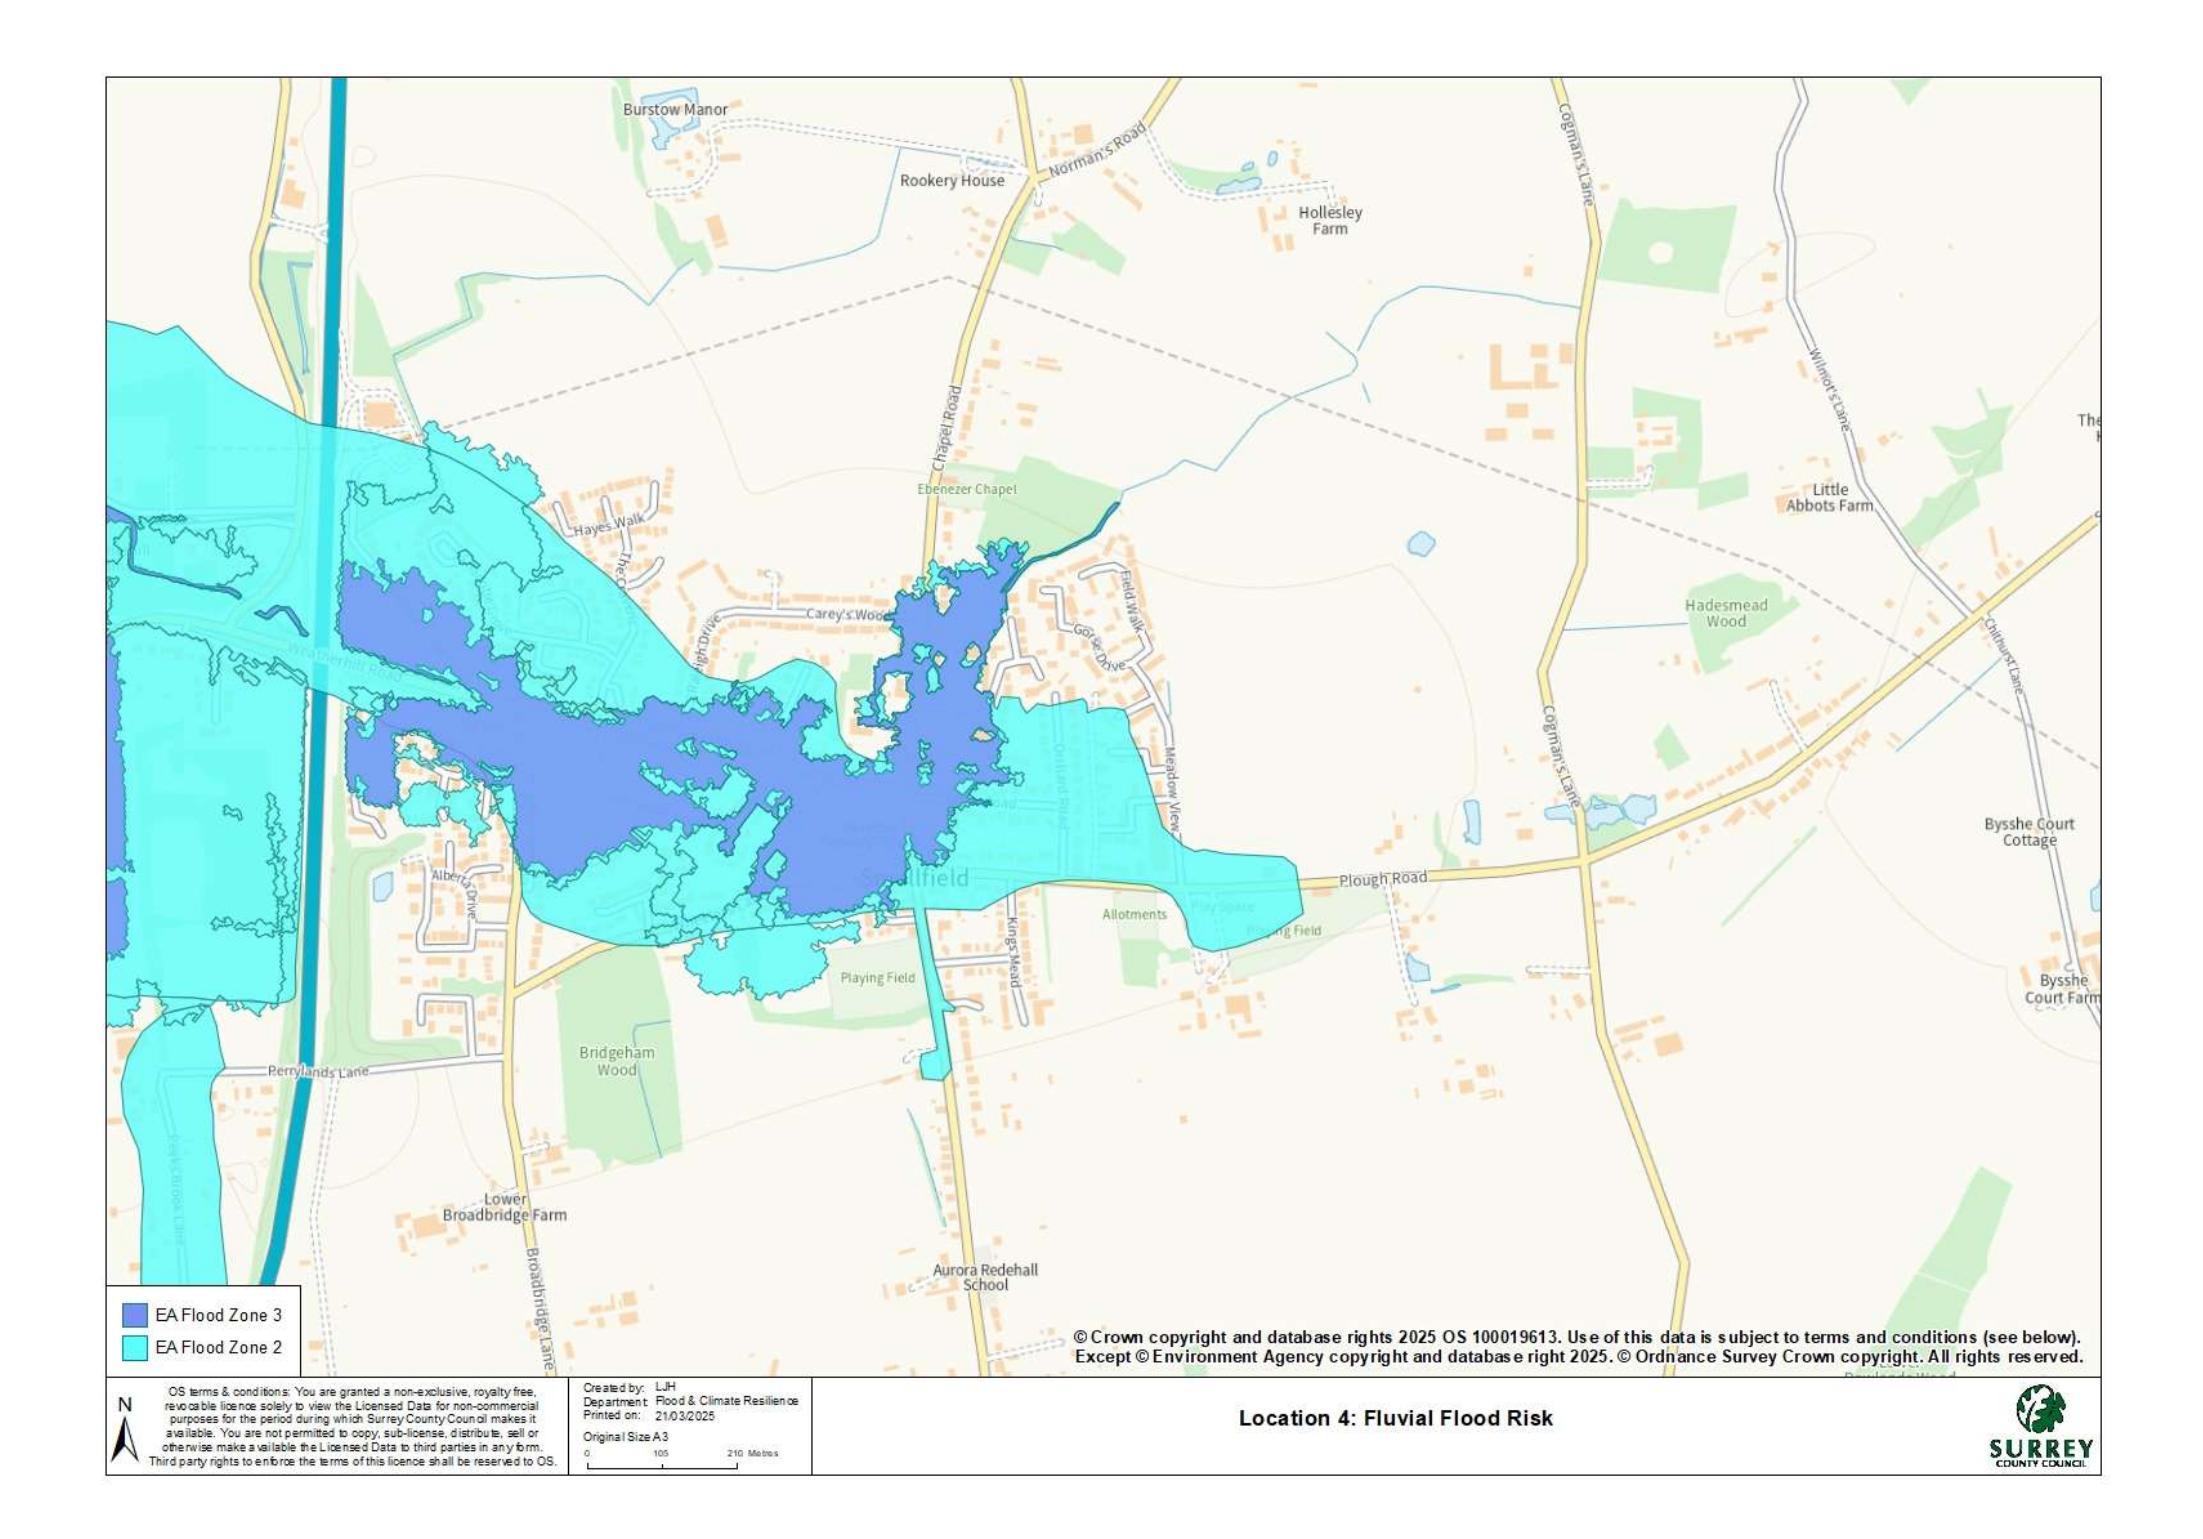
Annex D: Location 4 (Enquiry Reference: ME-50079165, ME-50101232, ME-50101280, ME-50101271)

Since 2014, this area has experienced frequent foul flooding following heavy rainfall, most notably on November 17th and November 19th, 2022. The issue arises from manholes and private sewerage drains discharging foul water during heavy rainfall. This leads to water pooling at the entrances of buildings and foul water escaping through the concrete surrounding the manholes due to pressure build-up. Although toilets have backed up, they have not yet overtopped.

A Thames Water inspection revealed significant pressure build-up in the manhole at the end of the combined foul and surface sewer, though it did not overflow. Heavy rainfall events may overwhelm Thames Water's foul sewerage system, leading to foul water discharge. The system appears to be experiencing hydro locking.

Foul flooding has been an ongoing problem in the area, with underreporting contributing to its persistence. The only previous report to the SCC Flood and Climate Resilience Team dates back to 2020.

- Thames water: To consider an inspection of foul sewerage system.
- SCC Flood and Climate resilience team: To commence talks with Thames Water to discuss a localised strategy.
