Summary Reports of Smallfield and Burstow S19 Investigations

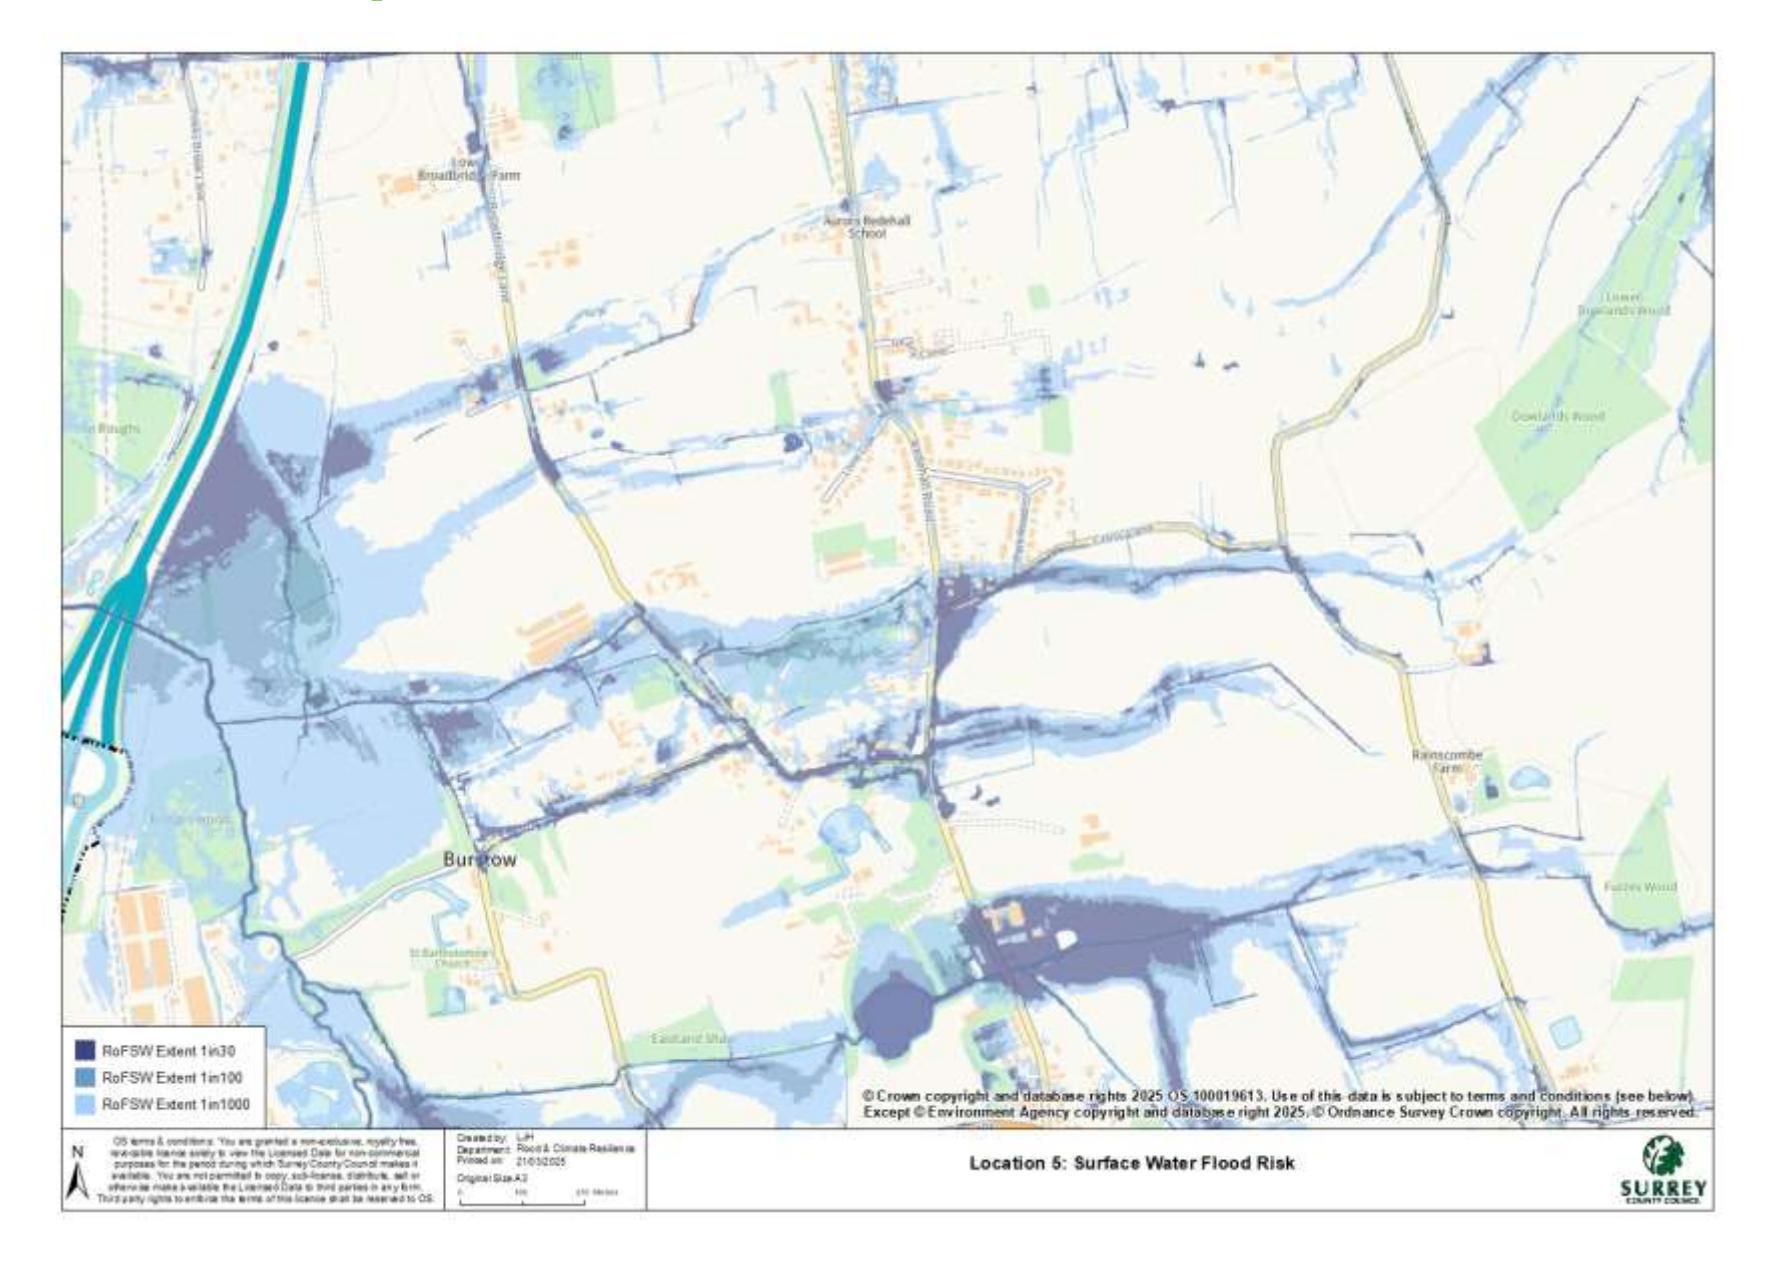
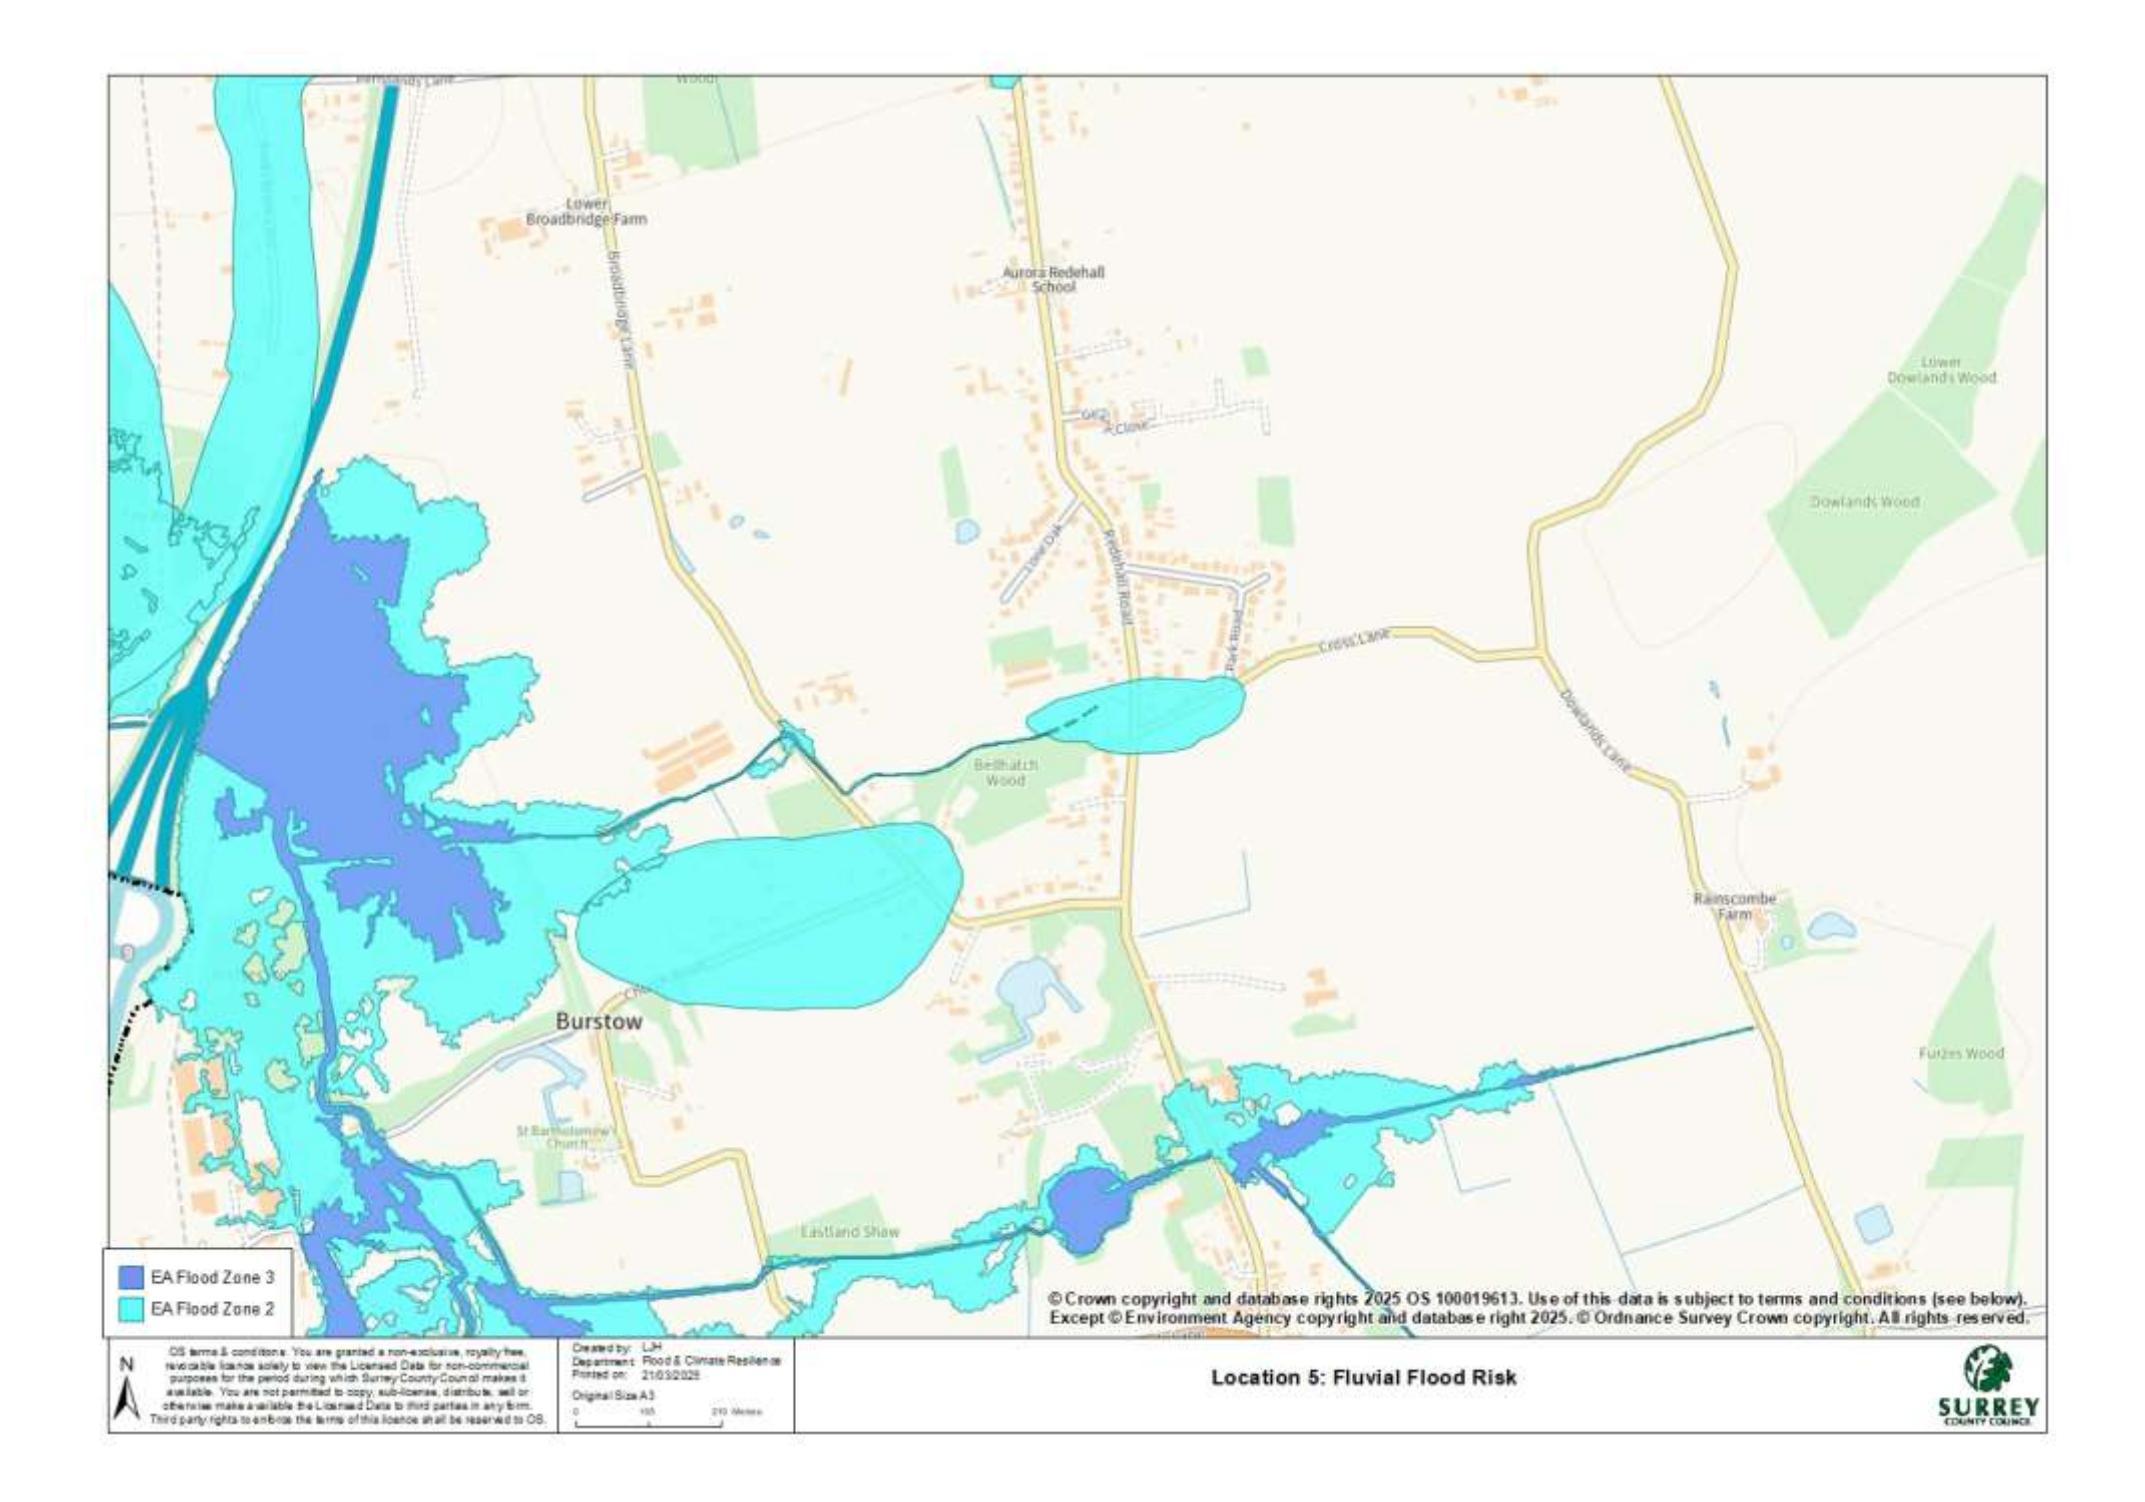
Annex E: Location 5 (Enquiry Reference: ME-50079229)

The area experienced flooding three times in November 2022 and on January 8th, 2023, following heavy rainfall. Surface water runoff flows down the road and toward properties, pooling along boundaries. While flooding has been an issue for seven years, its frequency has increased in the last two years.

Erosion of the drop kerb has reduced its level, allowing more water to flow toward properties. Although gullies are not blocked, surface water cannot reach them and instead follows the natural flow path. The eroded drop kerb likely contributes to the increased water volume.

- **Landowners**: to consider implementing property flood resilience to reduce risk of flooding to property, sought from a suitably qualified professional.
- SCC Highways: to consider maintenance of drop kerb.

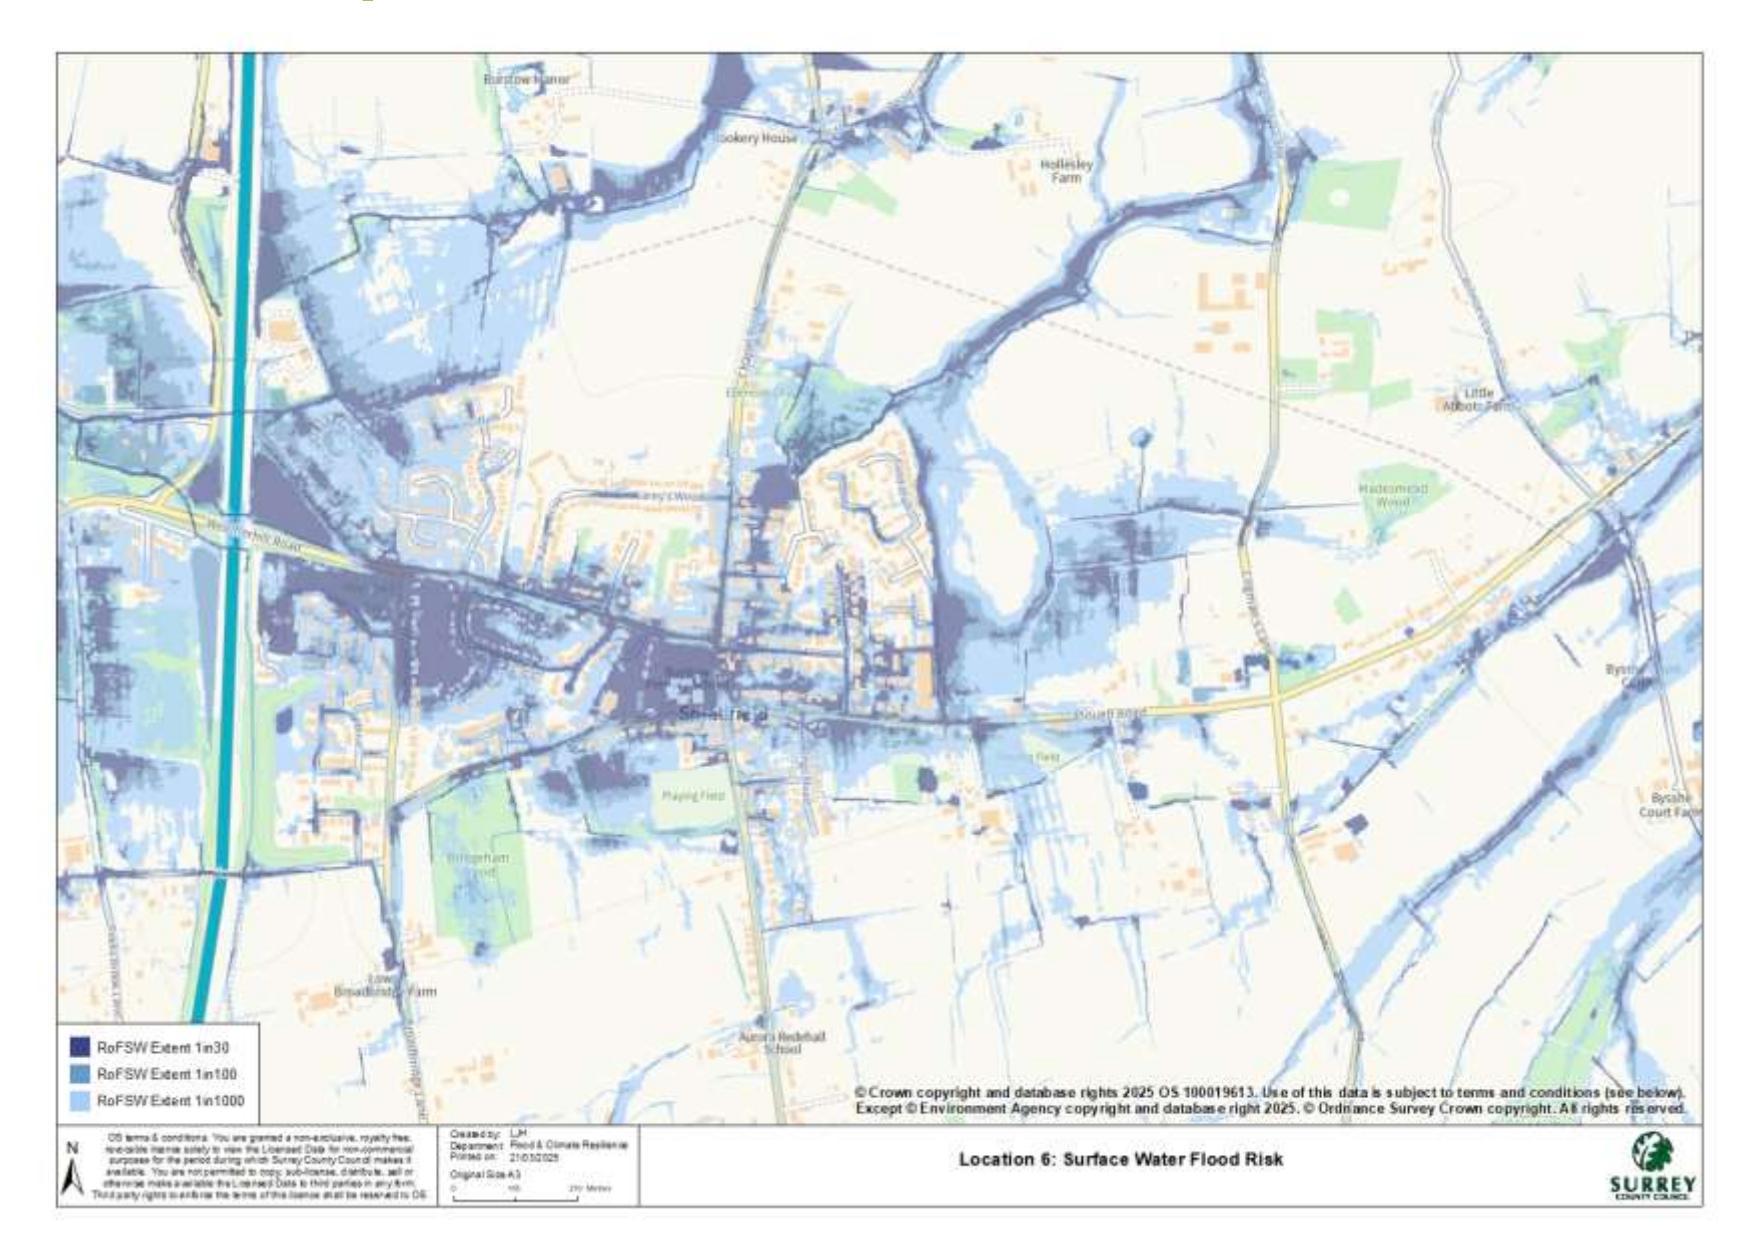
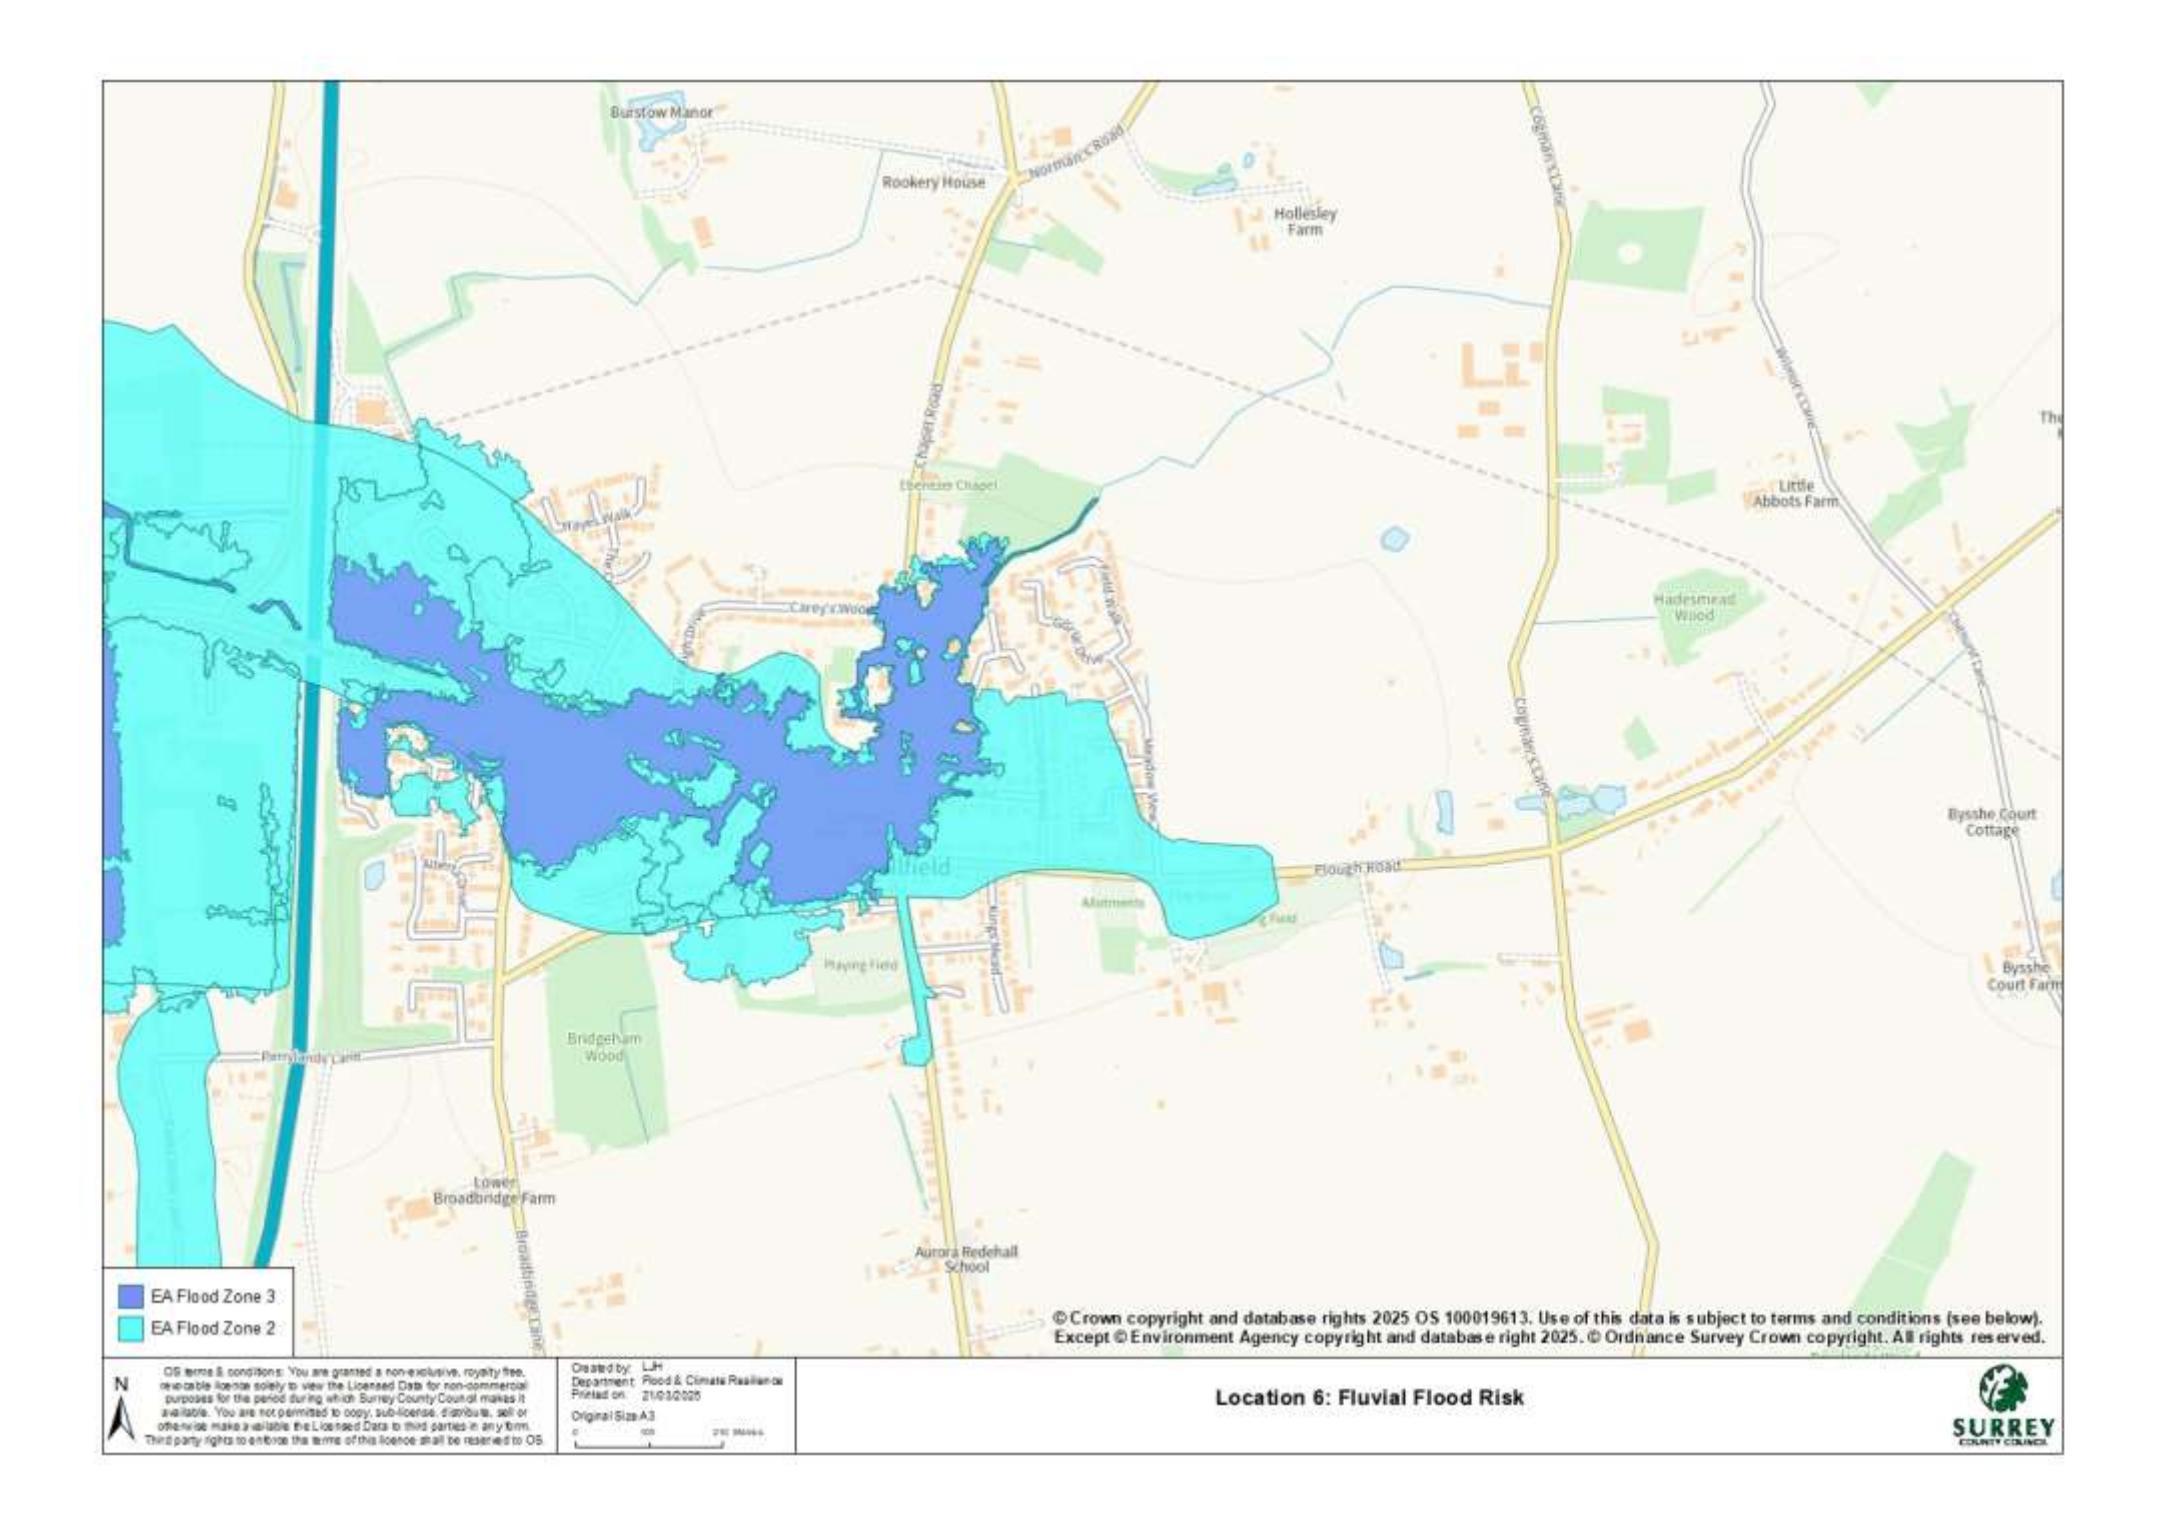
Annex F: Location 6 (Enquiry Reference: ME-50095882)

External property flooding occurred on November 21st due to water overtopping from ditches adjacent to rear gardens. The fluctuating levels of the ditch bed caused water to be held back, preventing adequate drainage. Back gardens remained waterlogged from November 21st until the week of January 16th, and again from March 9th to the time of this report.

Several obstructions to the watercourse, including debris, obstructed culverts, and unconsented culverting of ditches, contributed to flooding and waterlogging of surrounding land. The location faces high risks of fluvial, surface water, and potential groundwater flooding, making future flooding likely during heavy rainfall or storm conditions.

- Landowners: to maintain the watercourse within the boundaries of their land. Clearing build up in channel bed to reveal outlet and level out the bed of the ditch.
- Landowners: to maintain pipes/ drainage system to allow flow of water.
- Landowner: to reinstate the ditch within the boundary of their land.
- SCC Flood and Climate Resilience Team: may wish to consider re-levelling of the ditch to the rear of affected properties to allow water to sufficiently drain away.

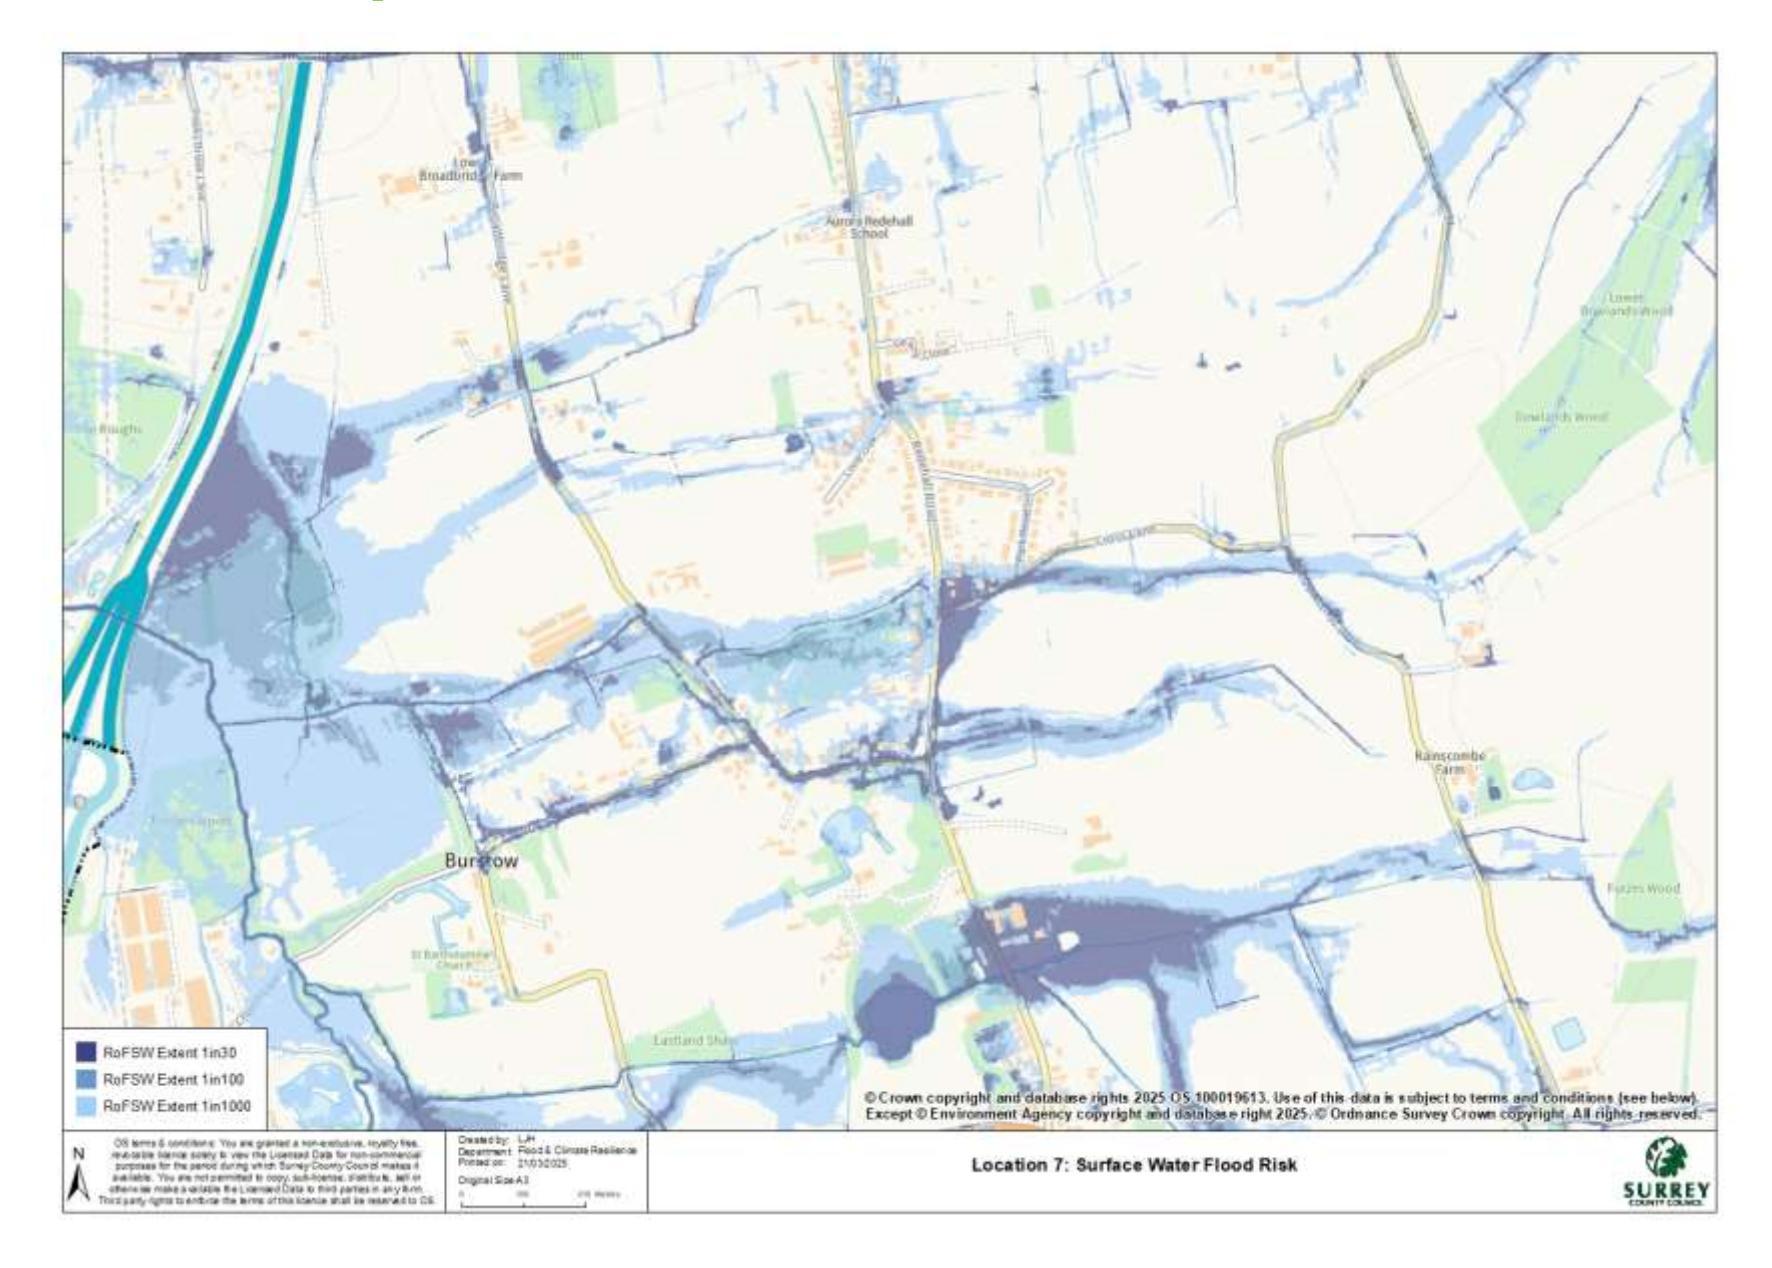
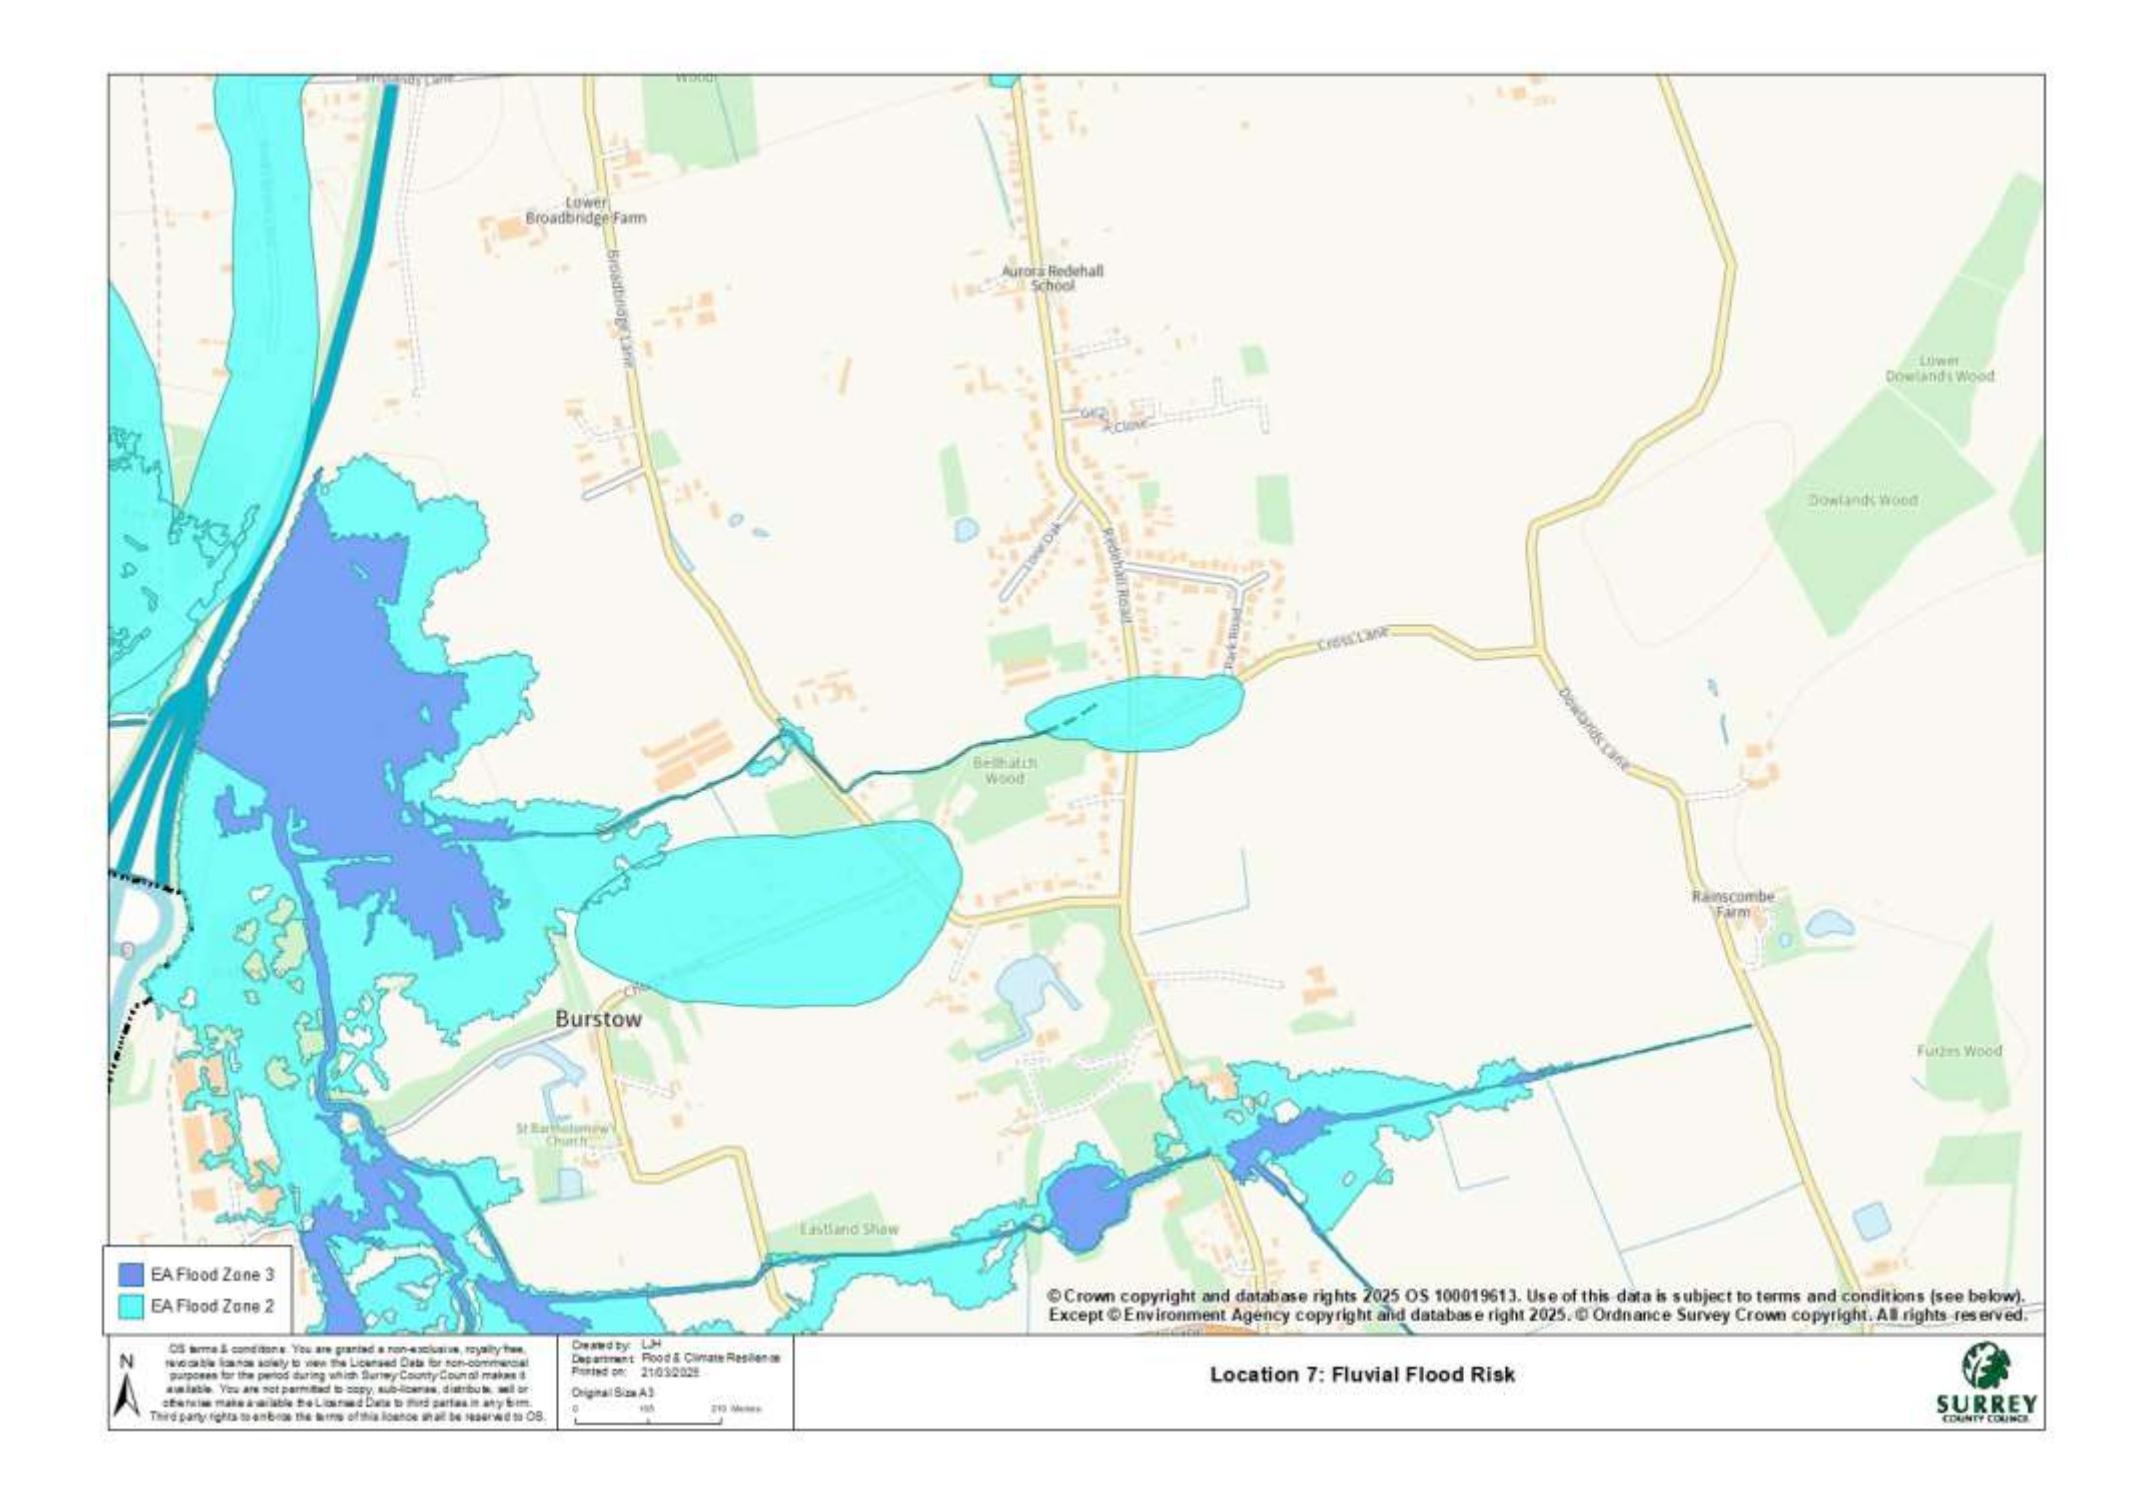
Annex G: Location 7 (Enquiry Reference: ME-50101234 & ME-50101226 & ME-50101257)

External and internal property flooding from foul and surface water occurred on November 11th, 2022, November 16th, 2022, and December 31st, 2022, following heavy rainfall. Drainage plans indicate that surface and foul water from a nearby development are connected to Thames Water's combined sewers via the highway; however, two non-return valves have been installed, and the development is not currently considered to have increased flood risk.

Both highway manholes surcharged with foul water during the flooding events, and a private foul pipe and manholes burst, causing external foul flooding. Properties also experienced flooding from surface water running down the highway, possibly linked to a ditch overtopping. Historically, water has entered driveways from the highway in the same manner. Water pooling on the western side of the road, potentially due to blocked gullies, and the highway drainage system being at capacity may have exacerbated the flooding.

Plans to culvert a ditch were noted on-site, but at the time of this report, ordinary watercourse consent has not been applied for or granted.

- Landowners: may wish to consider implementing property flood resilience measures to protect their property from risk of flooding, sought from a suitably qualified professional.
- Landowners: Should works be carried out to culvert a watercourse without ordinary water course consent, for landowner to reinstate the watercourse.
- **Thames Water:** may wish to consider an inspection of their assets, should a defect be found, to fix asset.
- **SCC highways:** may wish to consider an inspection of their assets, should a defect be found, to fix asset.
- SCC Wetspots: may wish to consider adding location of the wetspots programme.
