Summary Reports of Smallfield and Burstow S19 Investigations

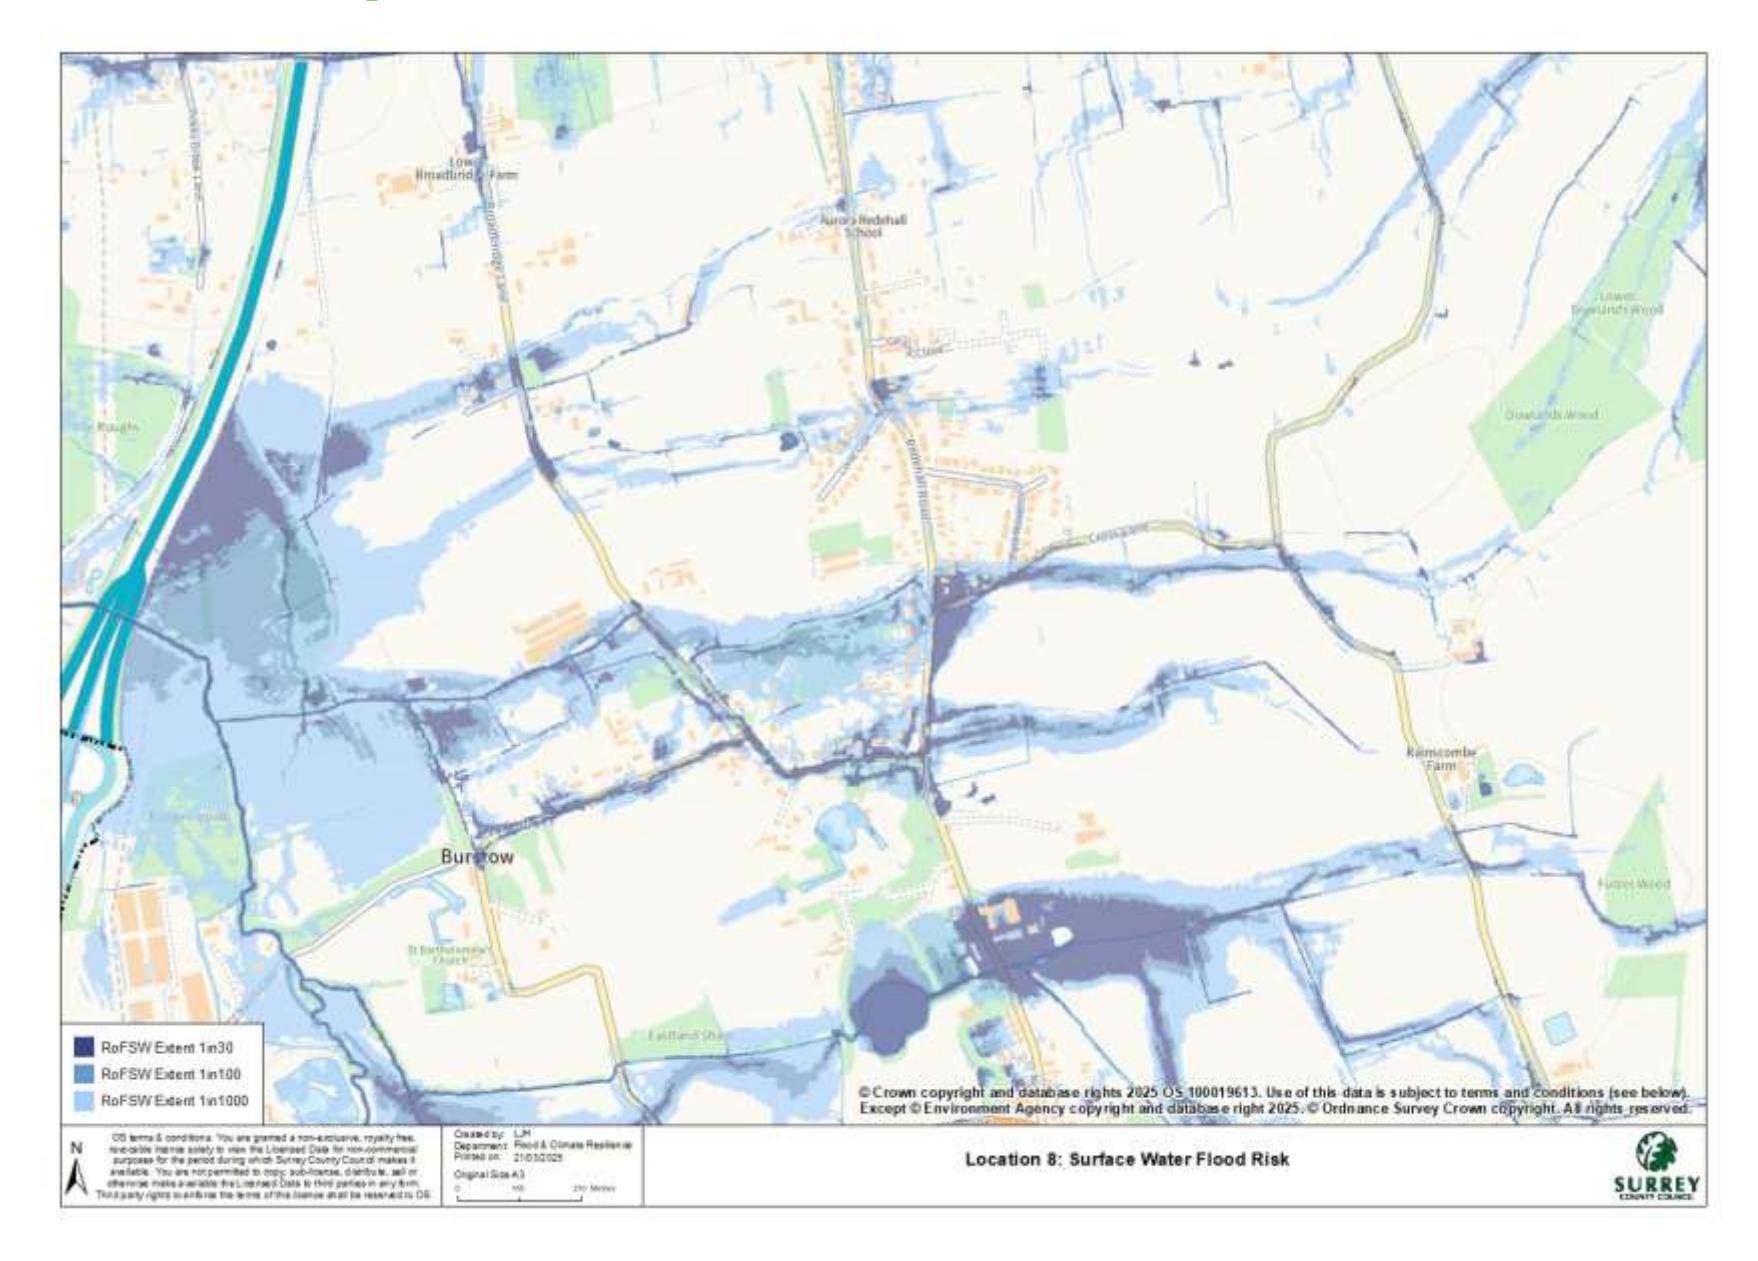
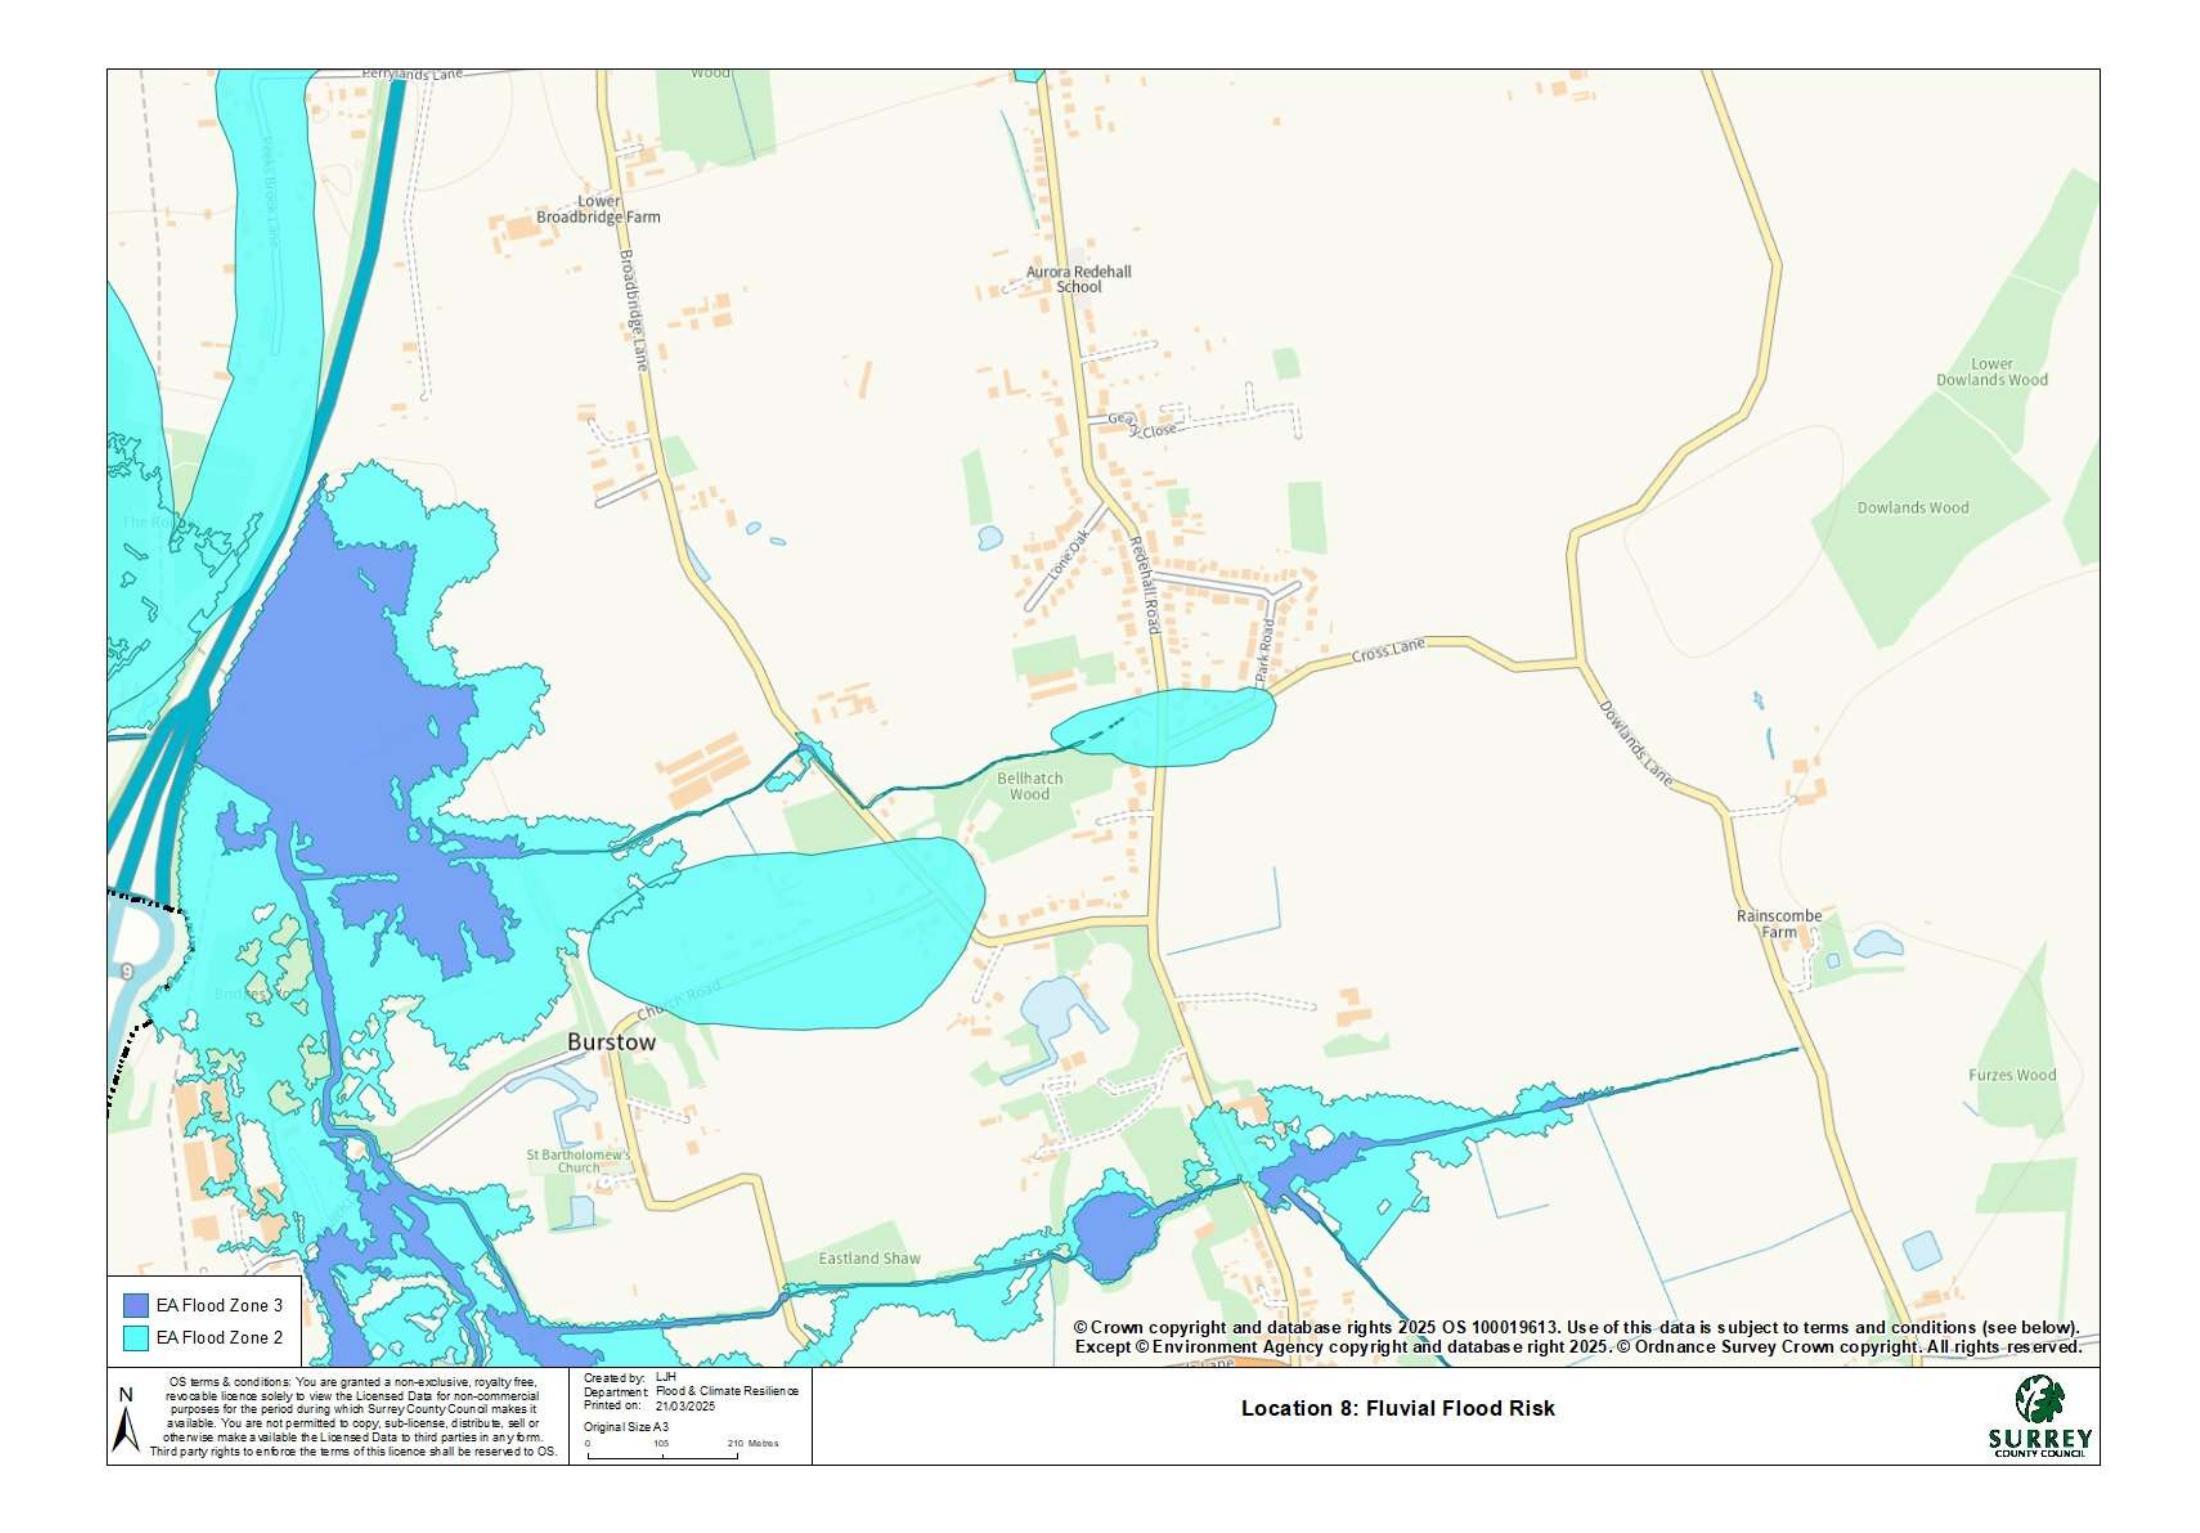
Annex H: Location 8 (Enquiry Reference: ME-50101298)

External property flooding affected front and back gardens at the beginning of January 2023, with additional incidents occurring once in 2022 and twice in 2021. Northern ditches on both sides of the junction overtopped, flooding the highway and causing surface water to flow toward properties.

Pooling was observed in the northern ditch upstream, caused by a blocked 300mm pipe, along with several blockages in the southern ditch. Properties in the area are at high risk of surface water and fluvial flooding. Flooding is likely attributed to debris build-up and/or a blocked pipe running beneath the properties.

- Landowners: to carry out maintenance to the watercourse within the boundaries of/ adjacent to their land. Clearing build up in channel bed to reveal outlet.
- Landowners: to carry out maintenance of pipes within the boundary of their land.
- SCC Land and Property: to carry out maintenance of watercourses within the boundary of their land.

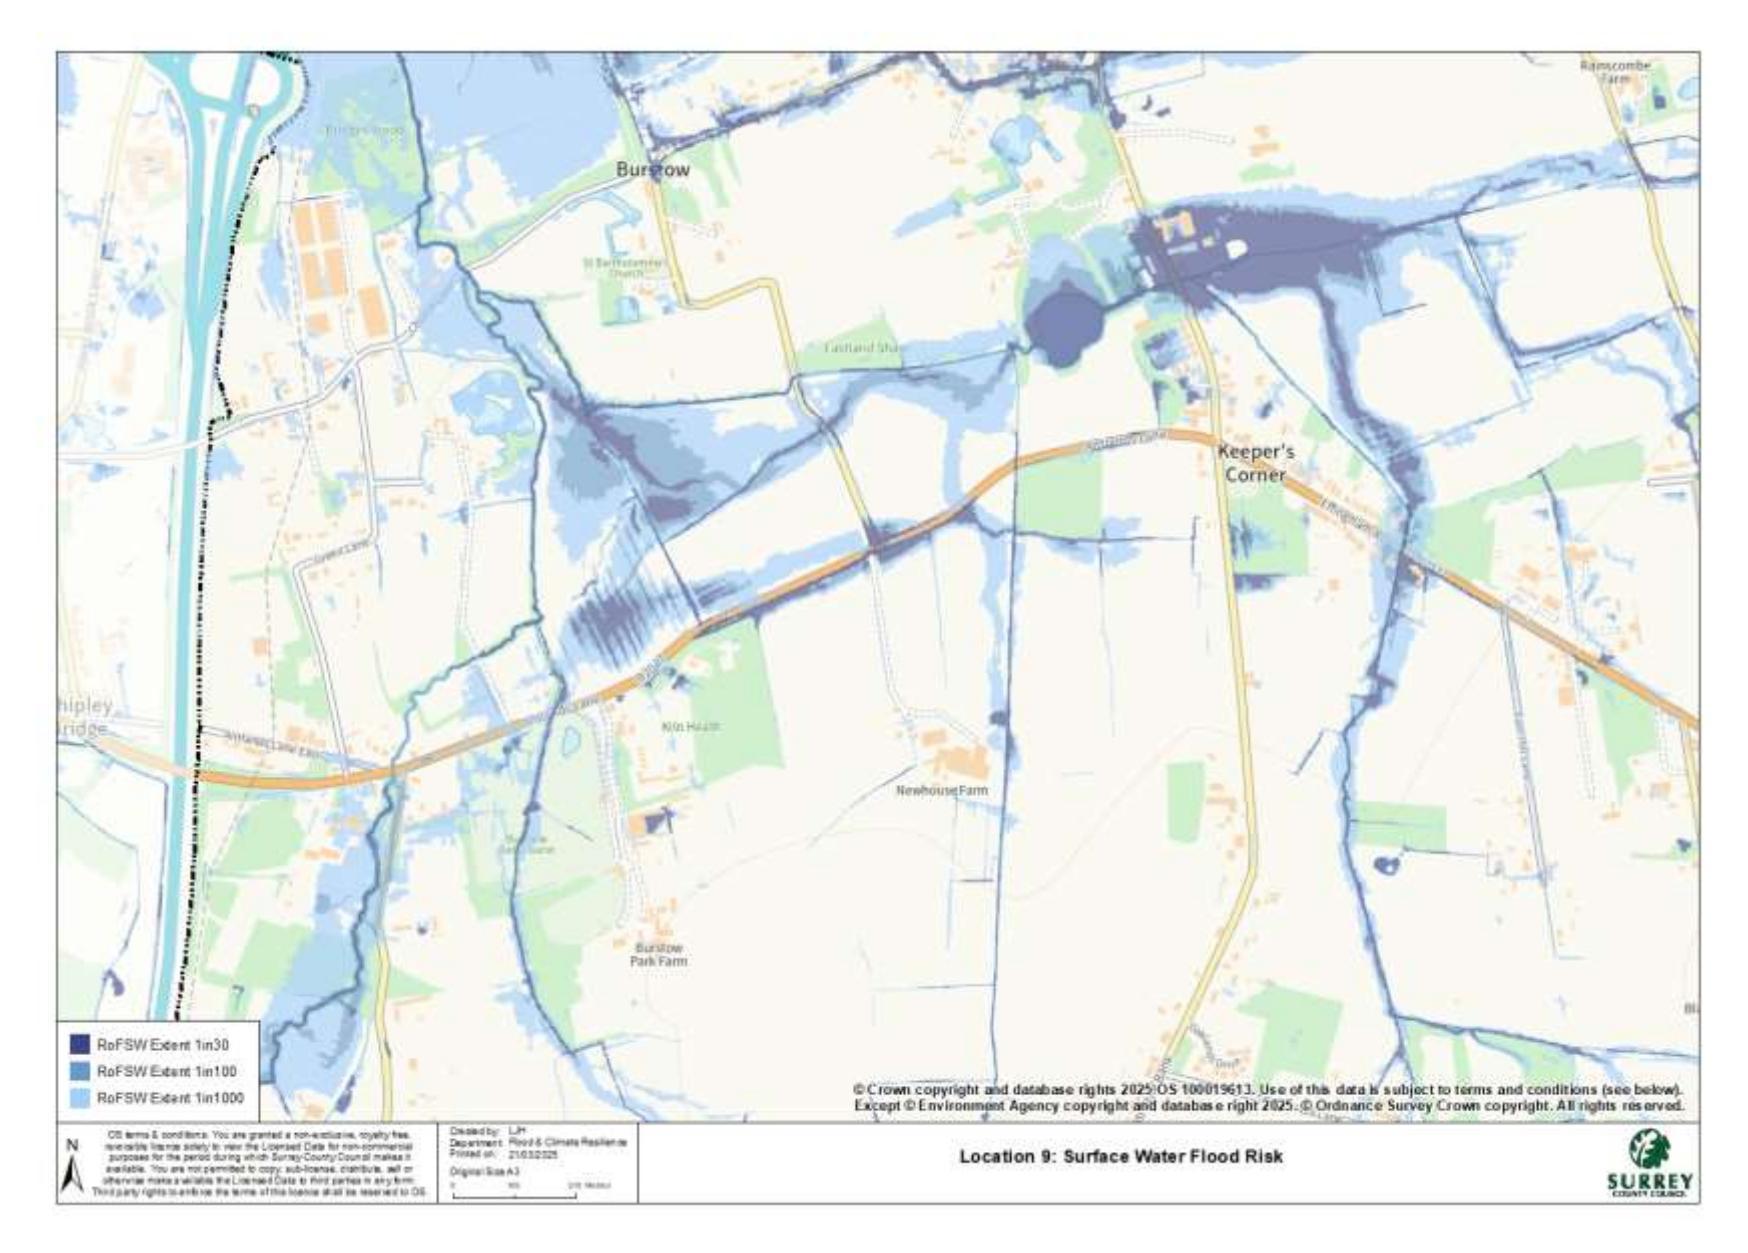
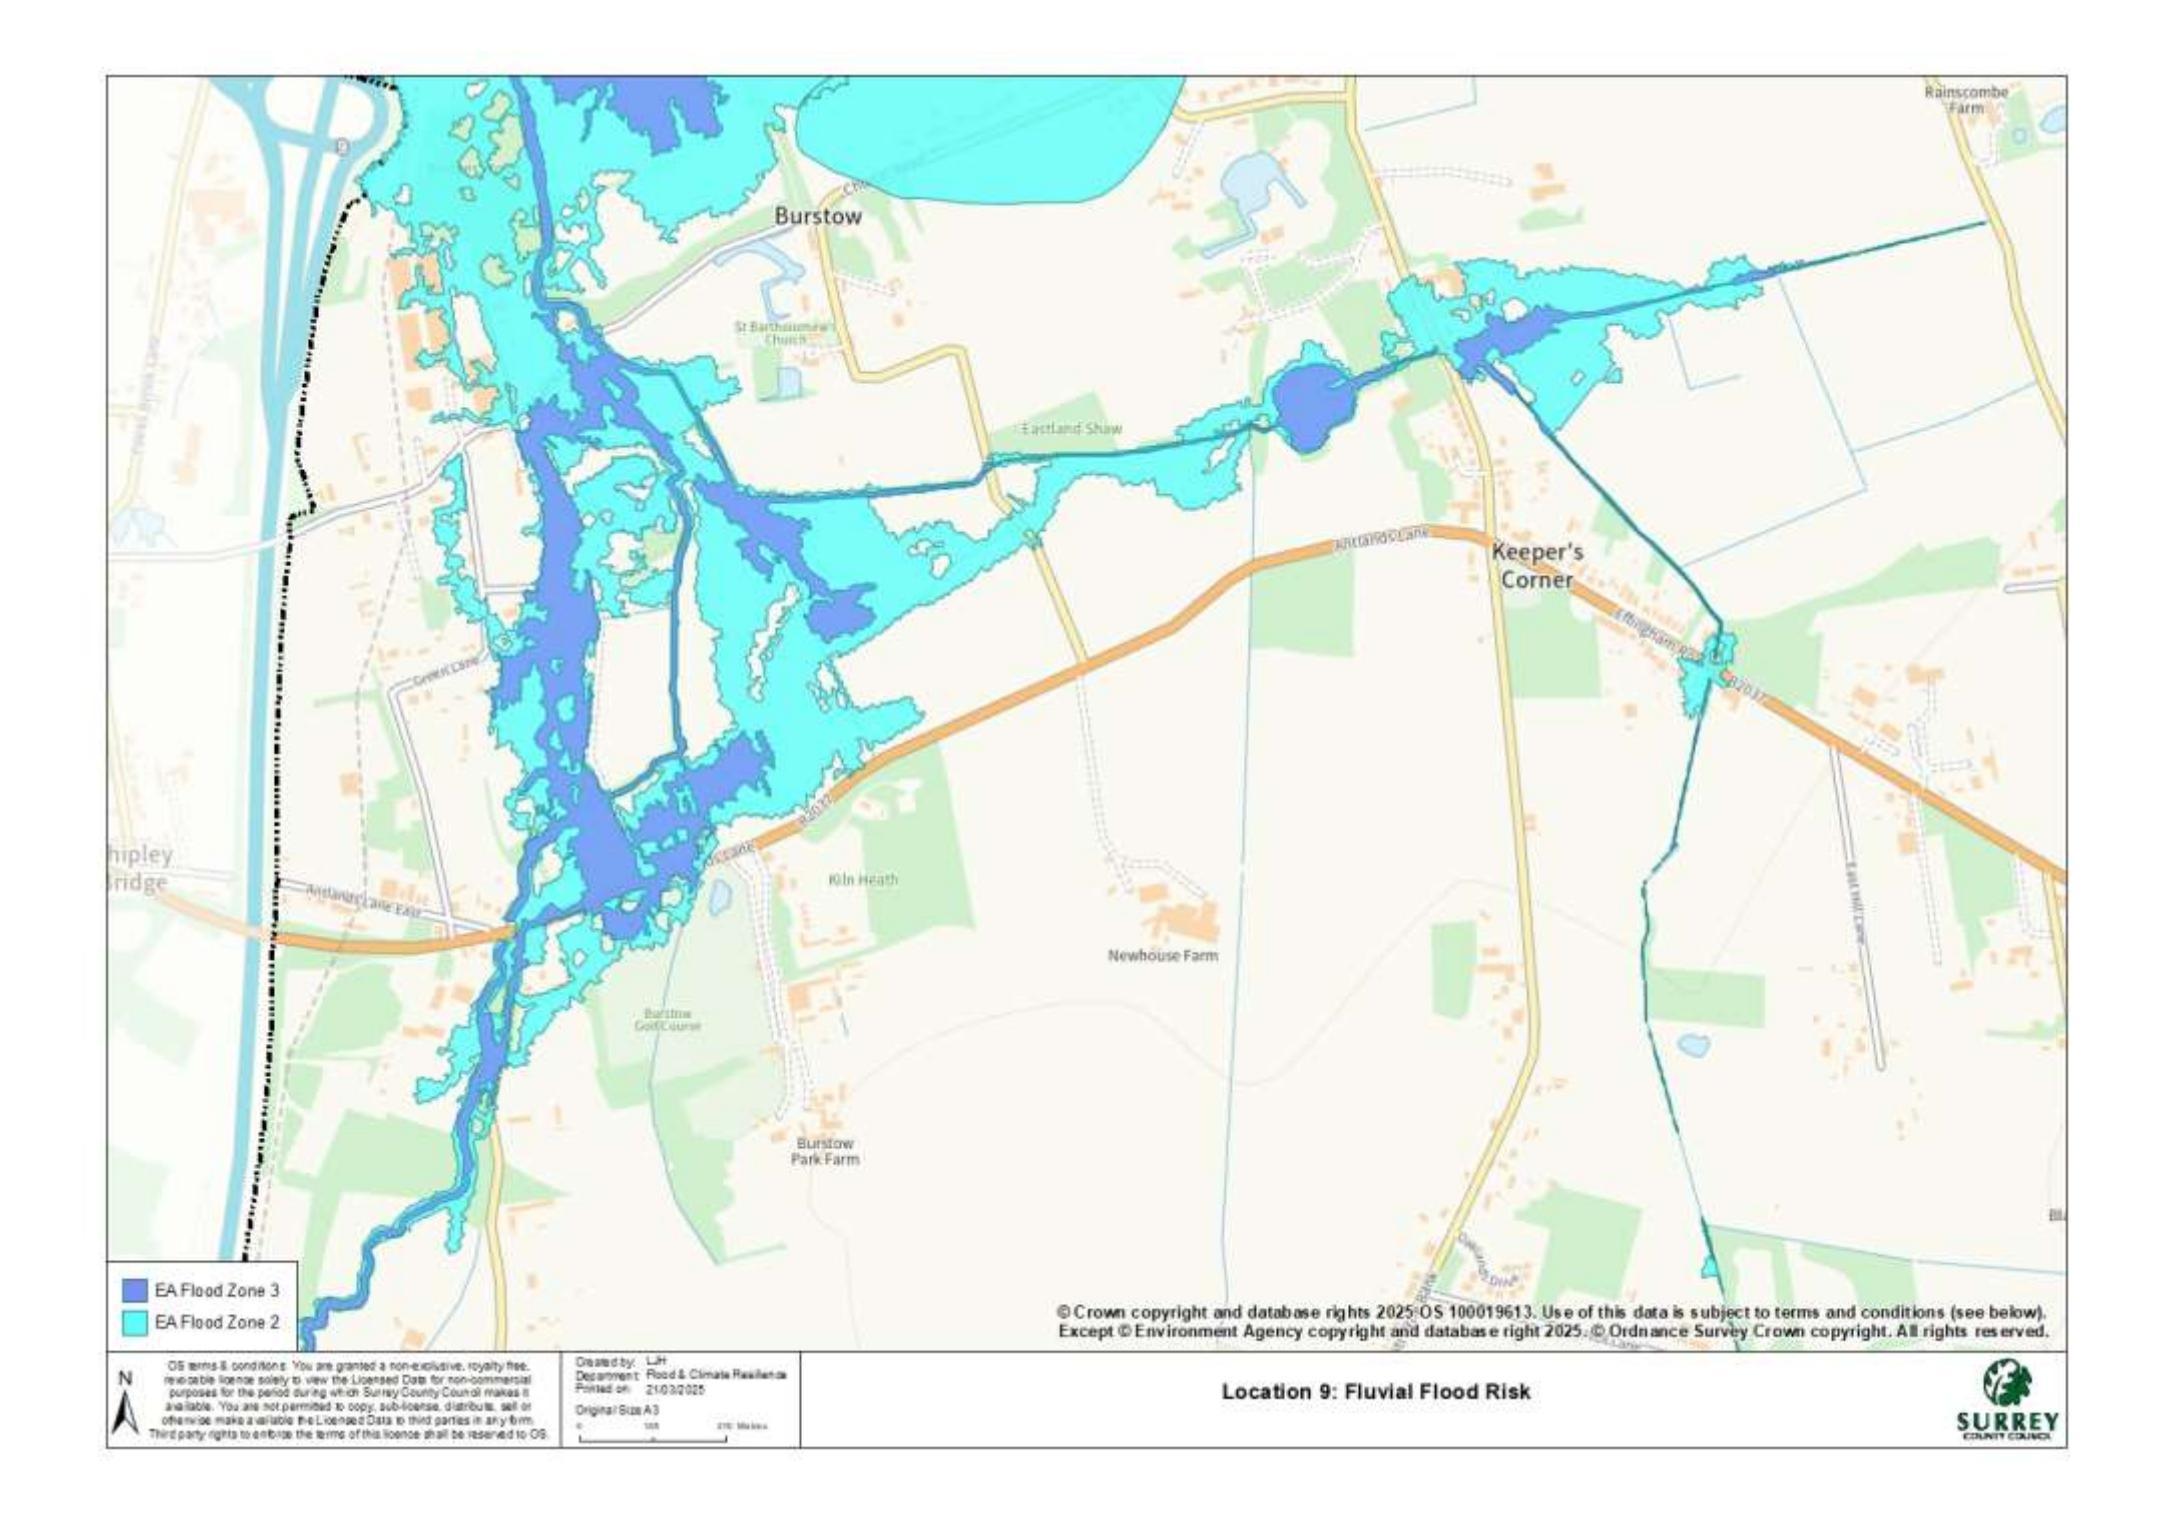
Annex I: Location 9 (Enquiry Reference: ME-50101329)

Obstruction to the Burstow stream further upstream, causing water levels to raise and overtop.

• Environment Agency (EA): may wish to investigate flooding of the Burstow stream to identify potential blockages.

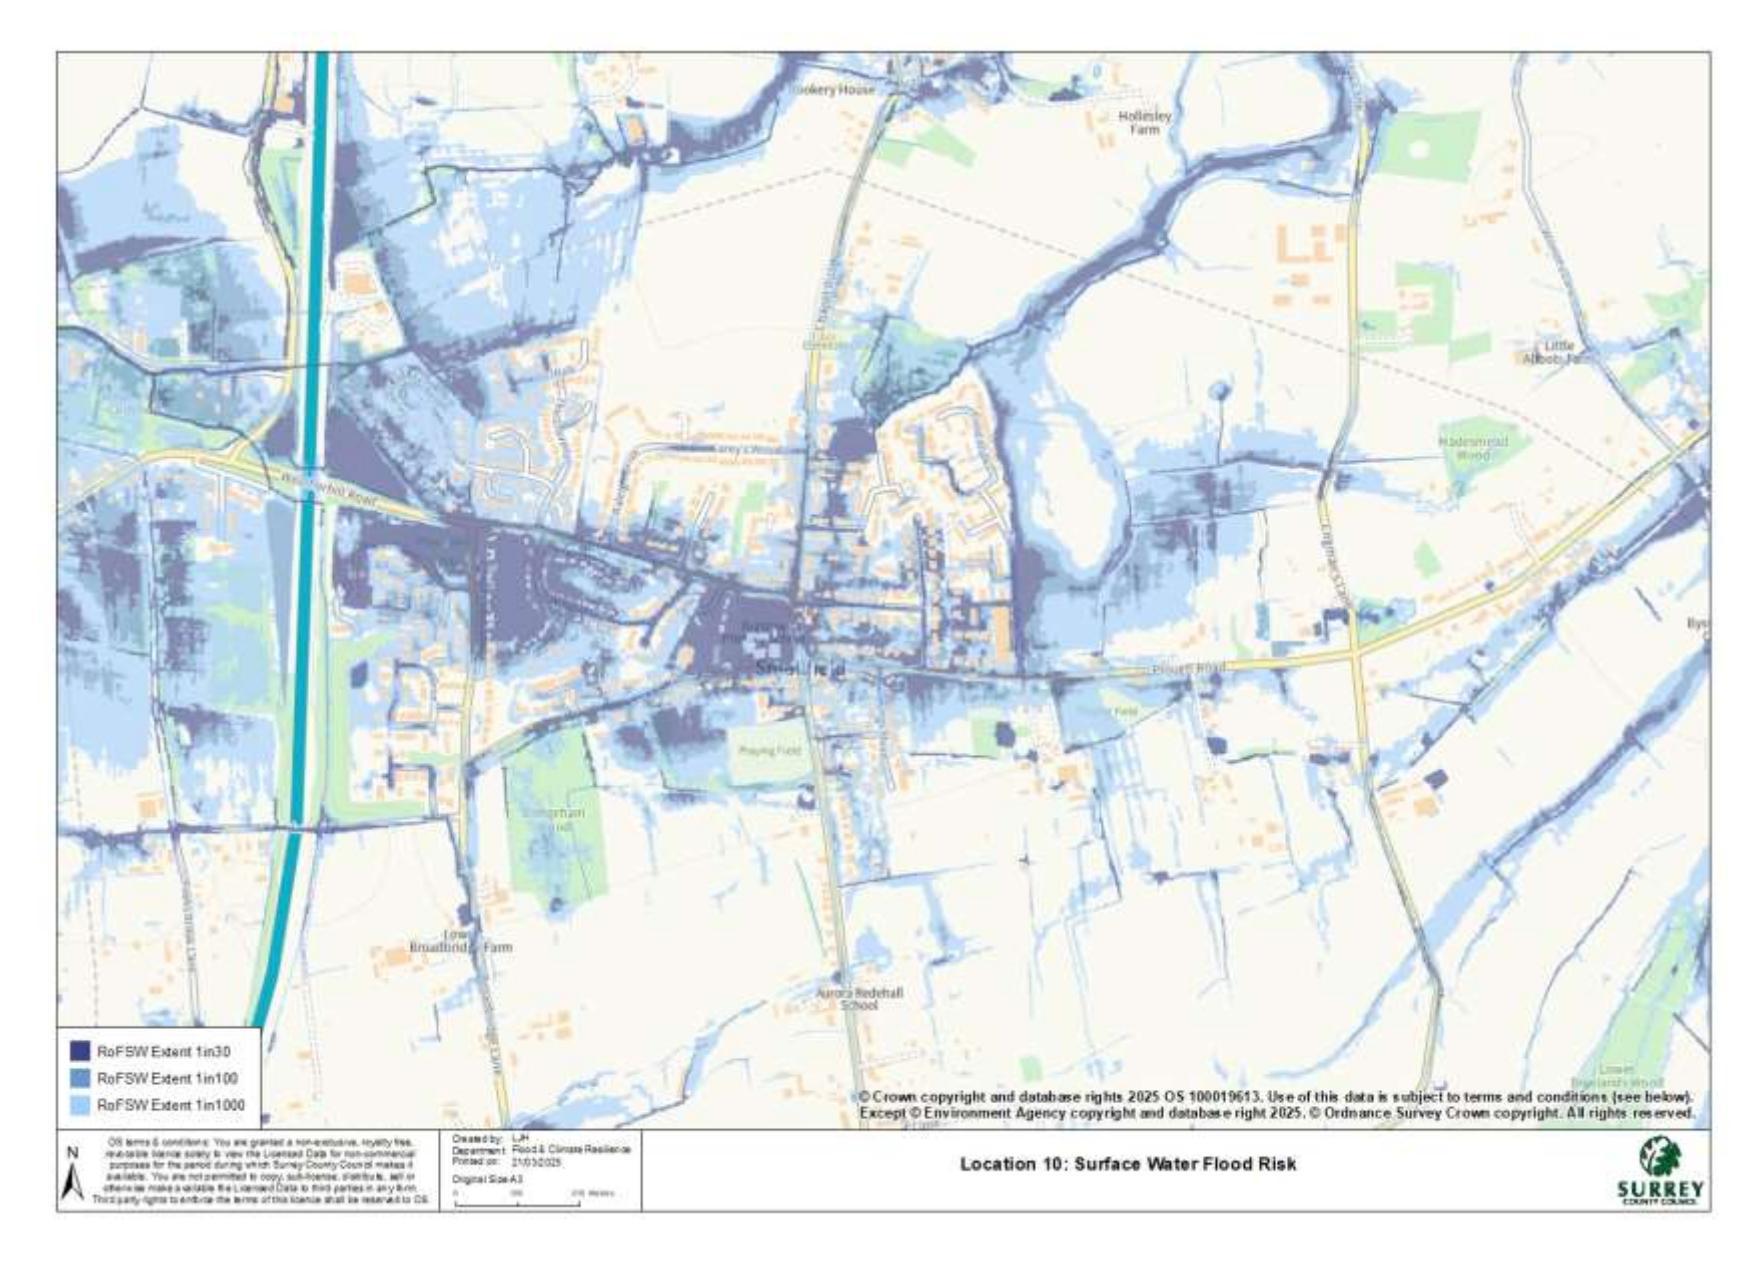
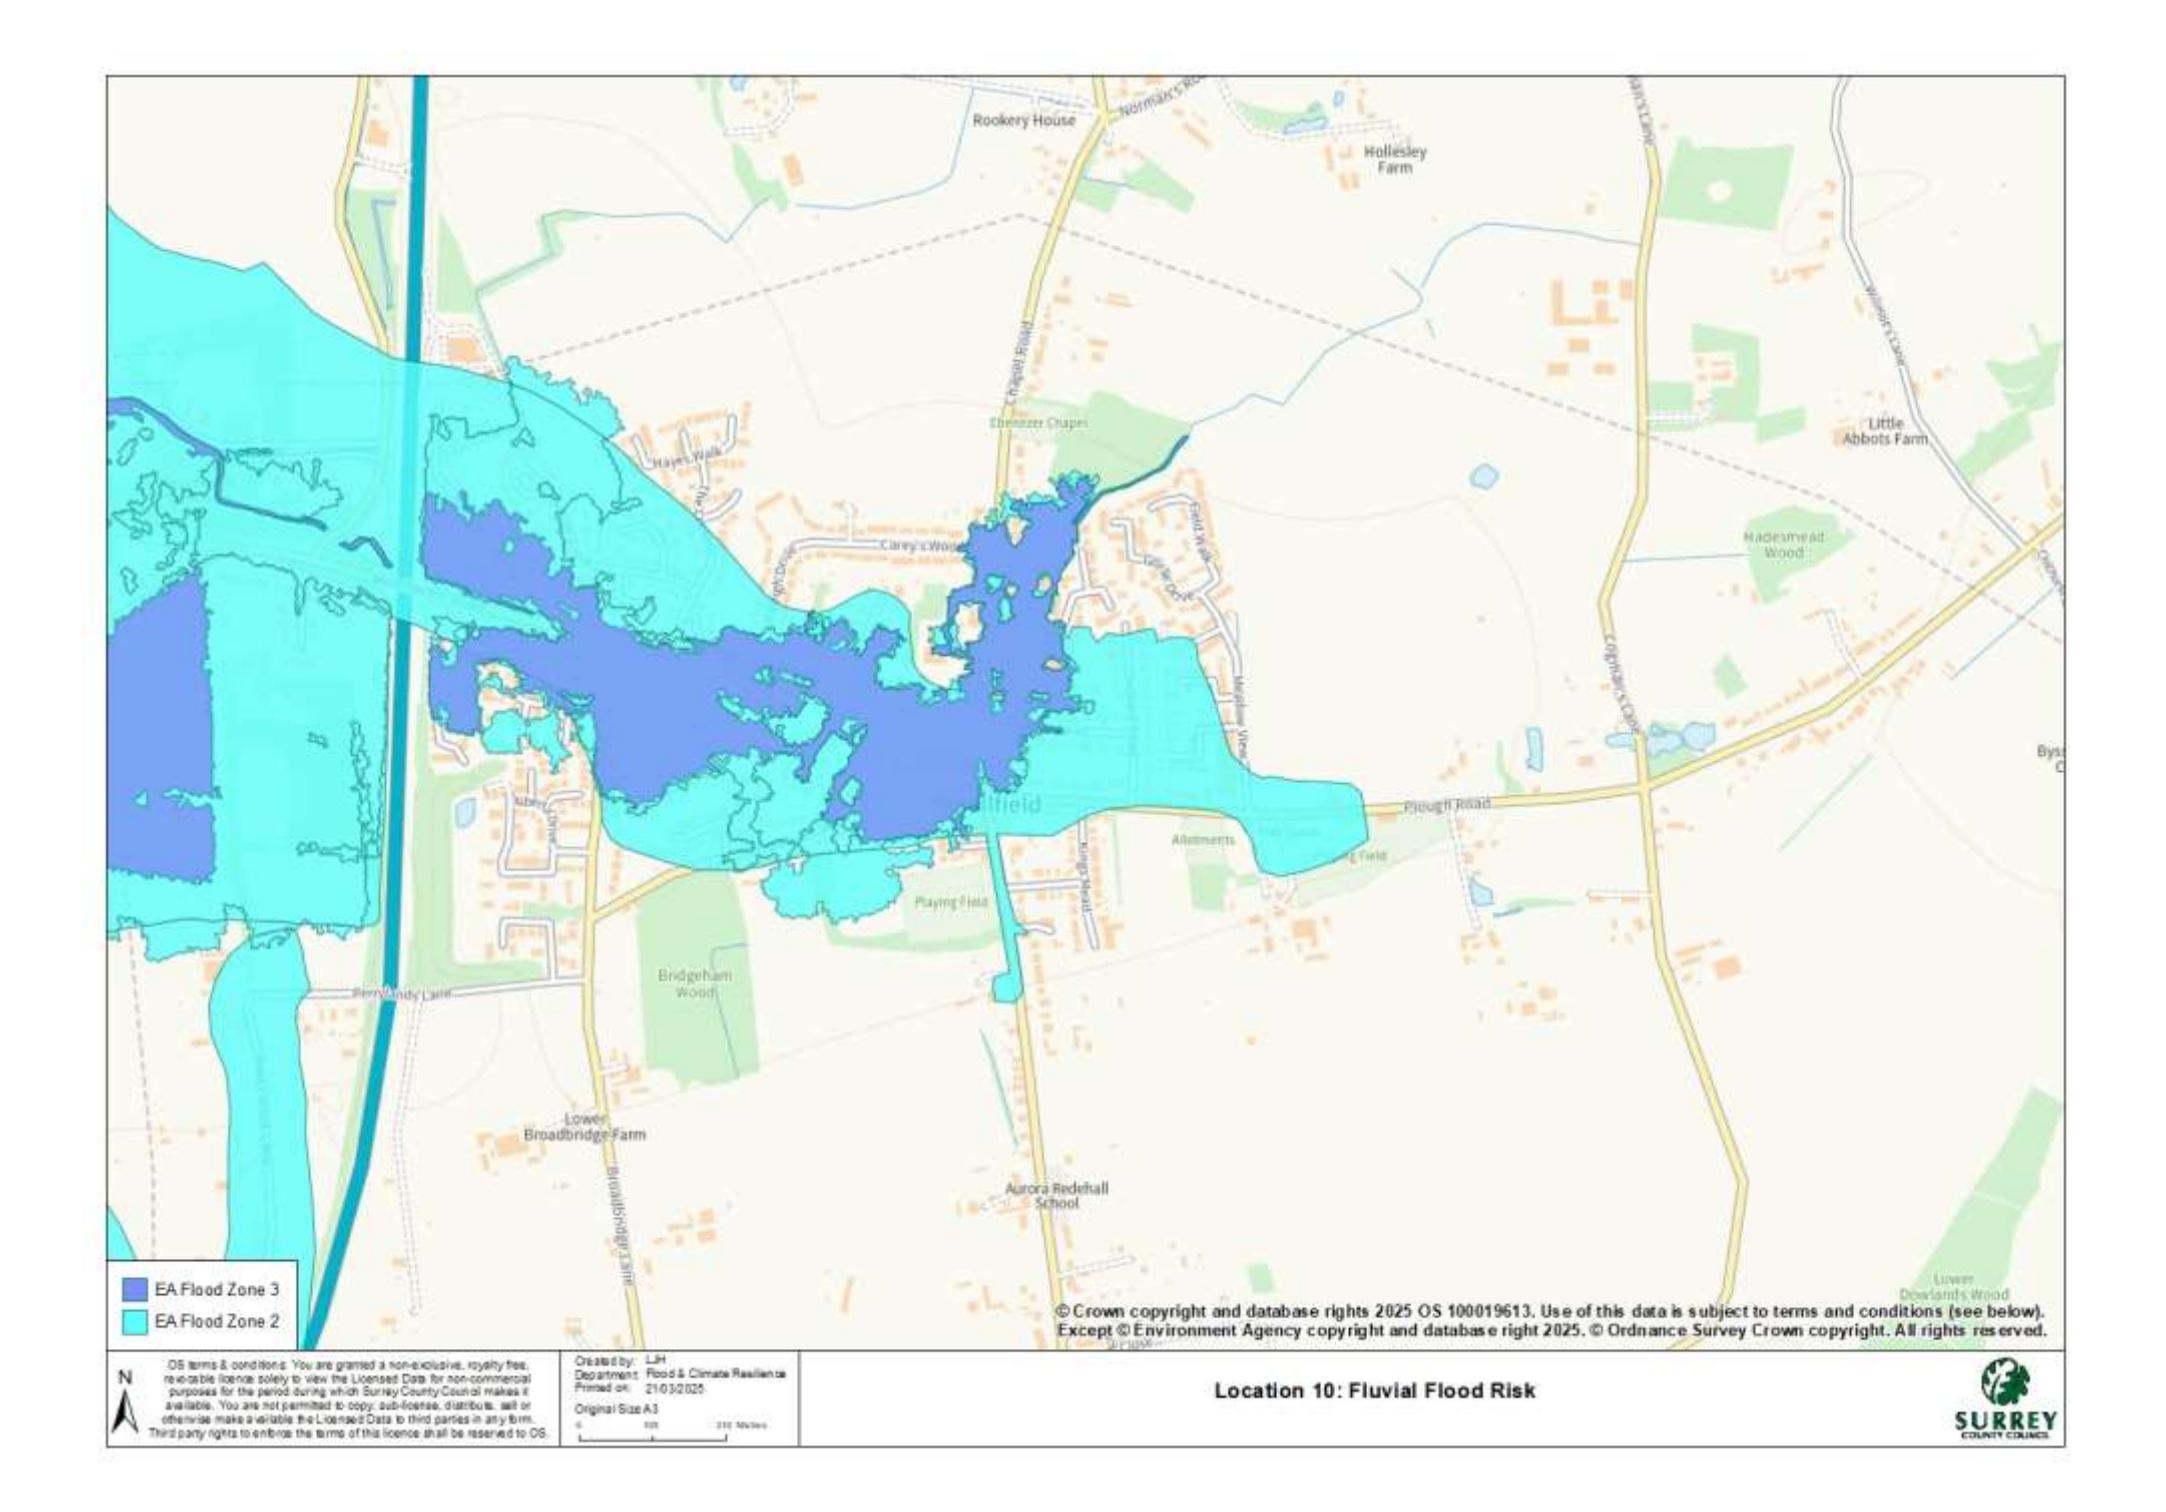
Annex J: Location 10 (Enquiry Reference: ME-50101303)

Flooding occurs following heavy rainfall, this is likely due to the garden being the lowest point.

Broken guttering and blocked drains to the rear of property is likely contributing to the volume of water

- Landowners: may wish to consider maintenance of broken guttering to the rear of the garages.
- SCC Flood and Climate Resilience Team: Further investigation may be carried out by SCC Flood and Climate Resilience Team to look into historic watercourse location.

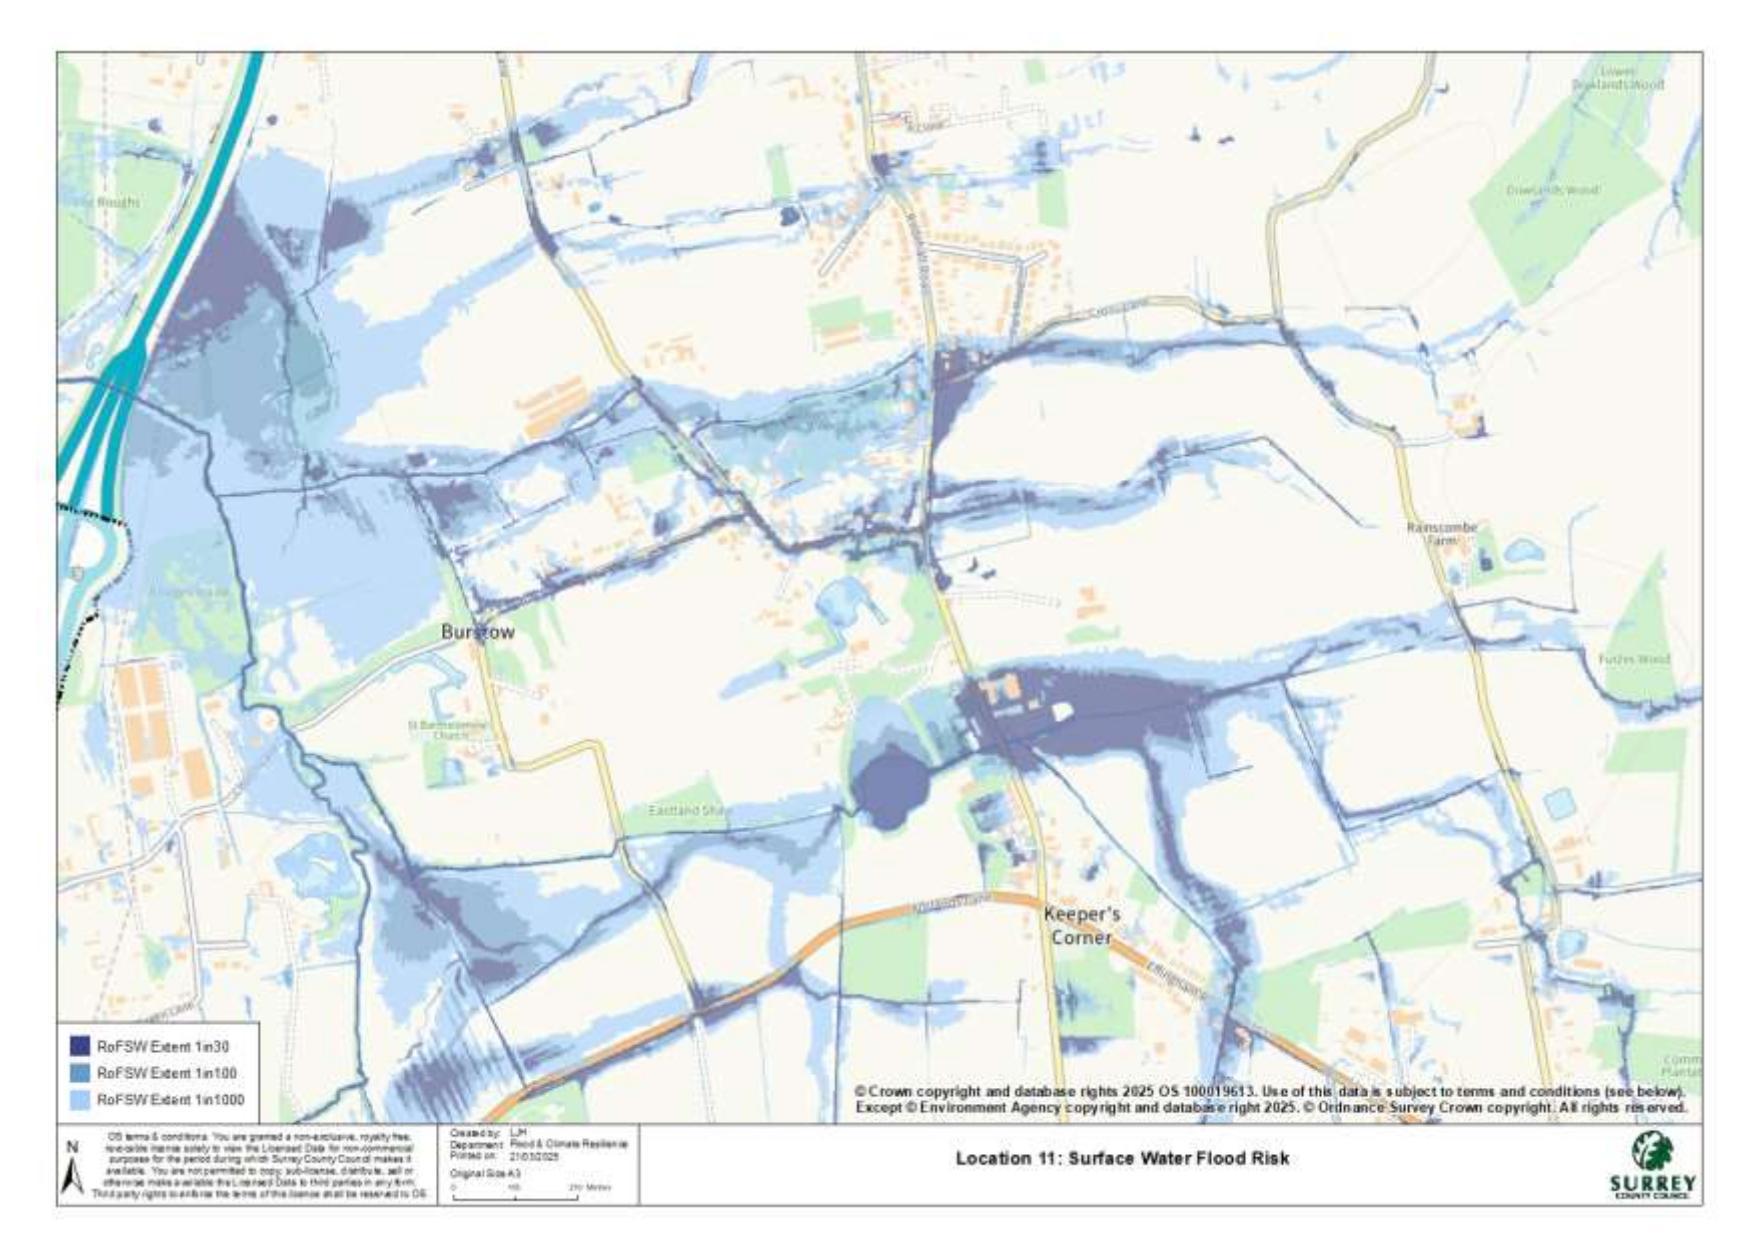
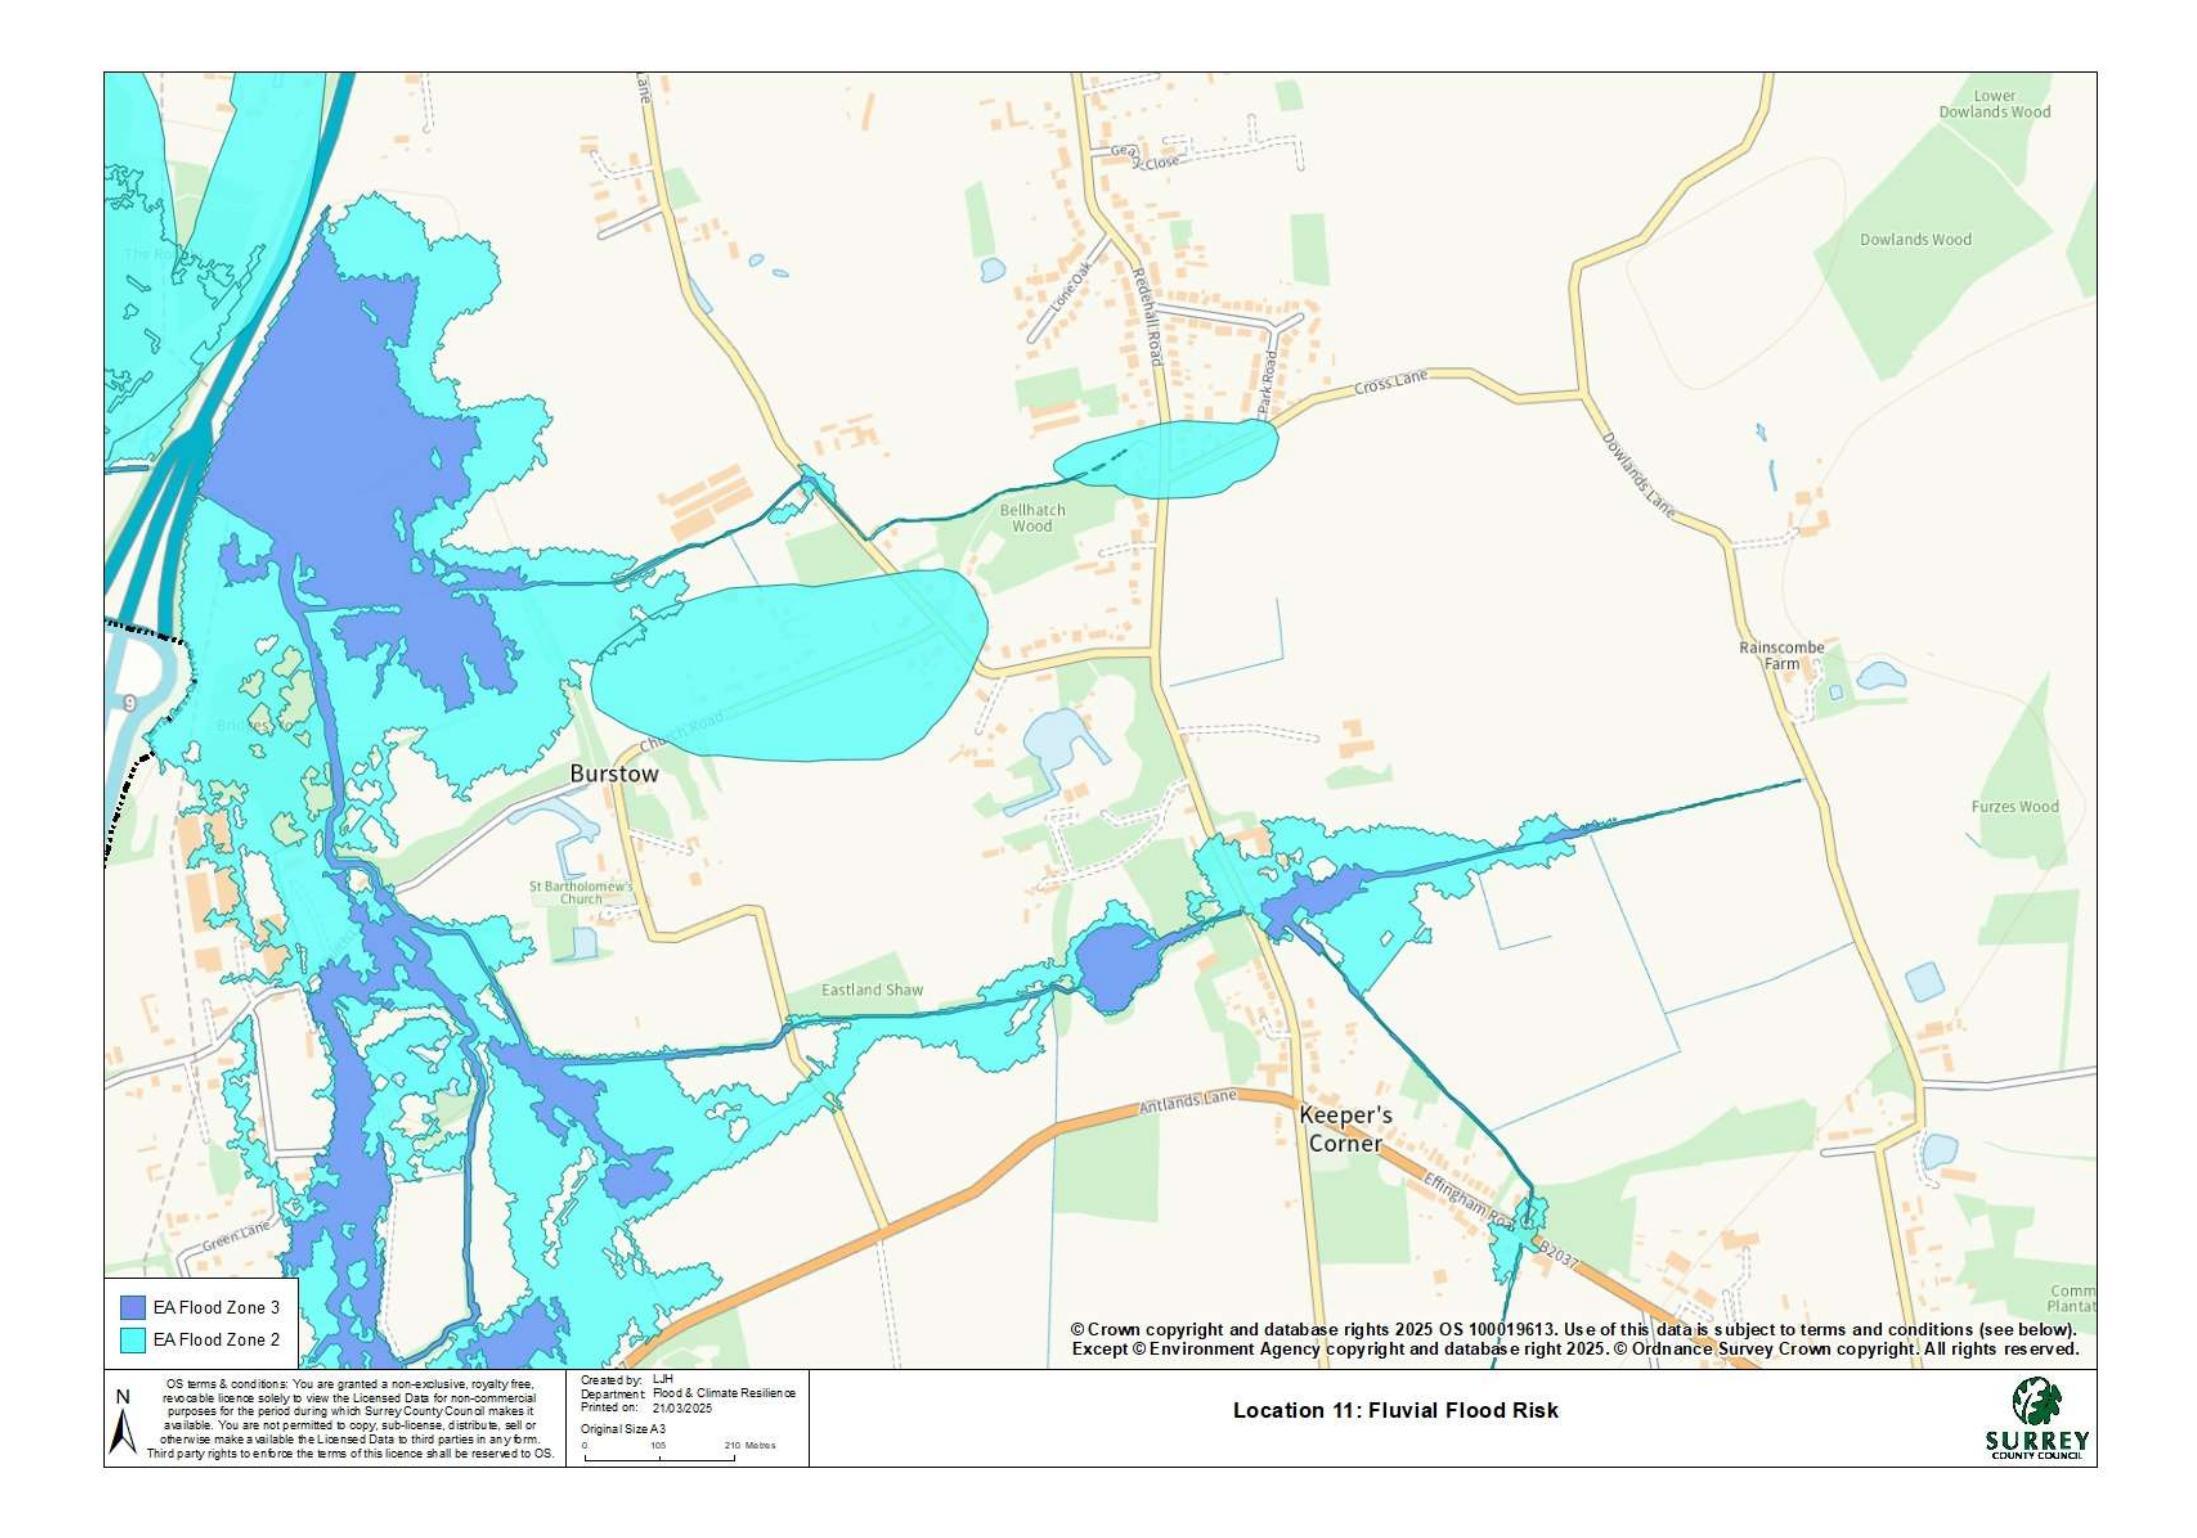
Annex K: Location 11 (Enquiry Reference: ME-50104011)

External property flooding occurred on November 17th and December 23rd, 2022, following heavy rainfall. Surface and foul water from the highway overwhelmed private drainage systems, leading to discharges from drains and a manhole on the highway.

Local residents reportedly used a manhole further up the highway to drain surface water, which likely contributed to the combined sewer becoming overwhelmed and backing up. Additionally, debris build-up in several ditches caused water to flow down the highway.

Potential mismanagement of drainage systems in the area may be exacerbating water accumulation and preventing proper drainage. Further investigation is required.

- **Thames Water:** may wish to consider an inspection of their assets, should a defect be found, to fix asset.
- **The SCC wetspots team:** may wish to consider an inspection of their asset, should a defect be found, to review plans.
- Landowners: to manage the flow of water through the use and monitoring of the sluice gate.
- Landowners: to maintain the watercourse within the boundaries of/ adjacent to their land. Clearing build-up in channel bed to reveal outlet.
- SCC Flood and Climate Resilience Team: To monitor the location following clearance of ditches.
