Worcester Park Section 19 Report

Worcester Park, Epsom and Ewell, Surrey

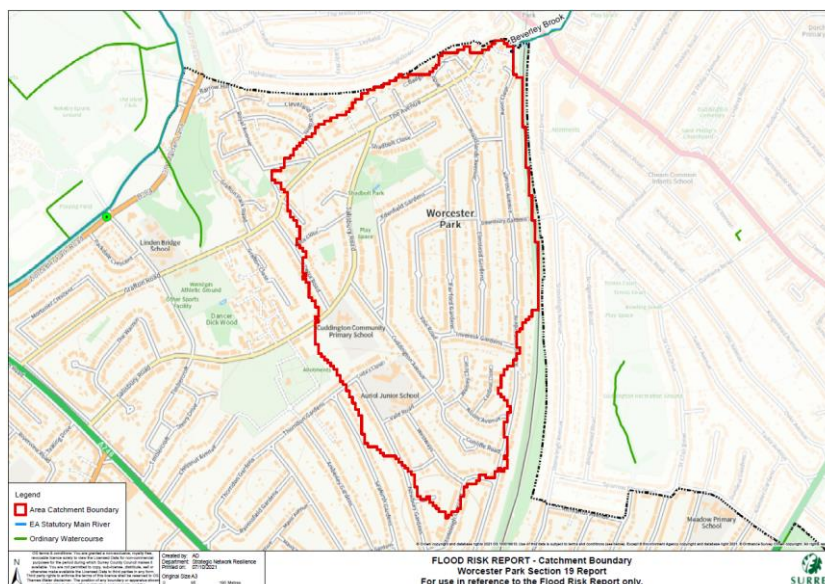
Figure 1: Site Location

Worcester Park is situated within the northern most section of the district of Epsom and Ewell, Surrey and acts as a sub-catchment for the Beverley Brook (Figure 1). The area borders the boundary of The Royal Borough of Kingston Upon Thames and The London Borough of Sutton. The area is comprised of residential housing with a recreational park in the west named Shadbolt Park. A railway line runs north to south along the eastern boundary. The open channel of the Beverley Brook is designated a main river is situated north-east of the Epsom and Ewell boundary.

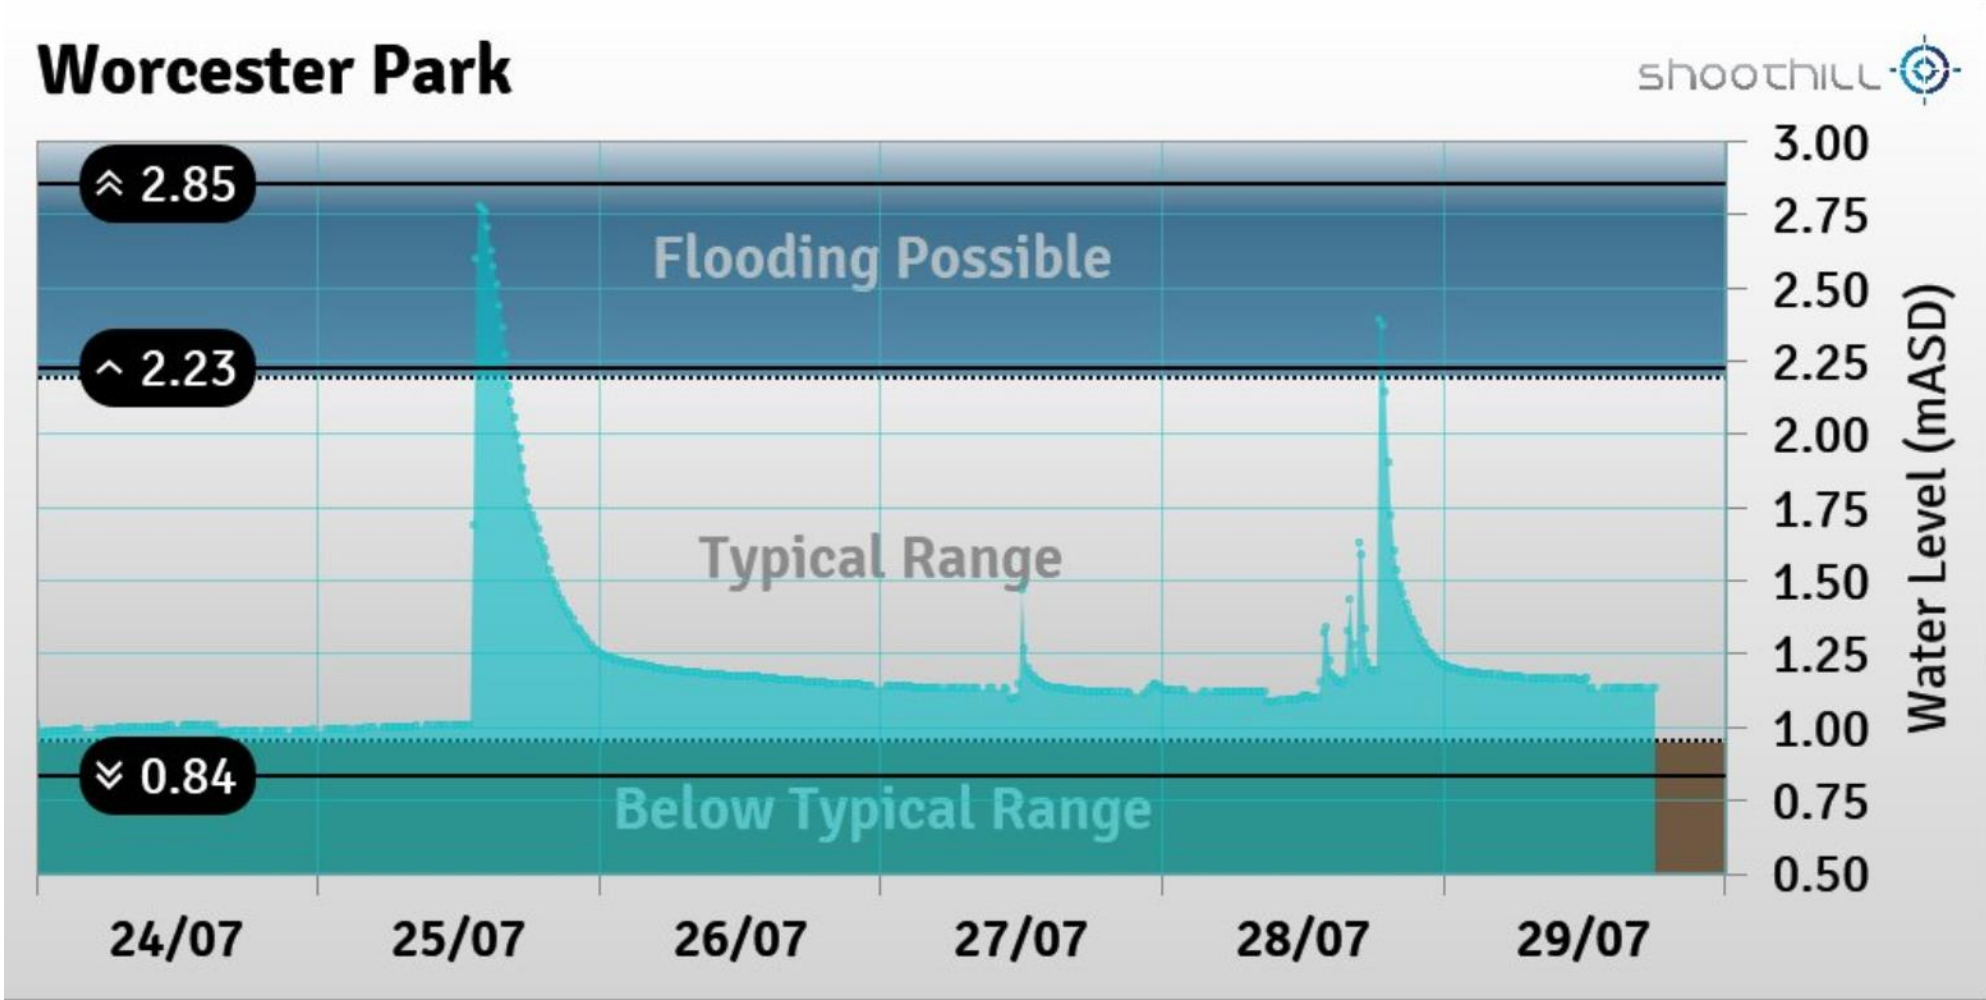
Appendix E - Shoothill Gauge Map Beverley Brook Telemetry System

A telemetry system comprises a series of monitoring devices that record the height of the water level along a watercourse. The Environment Agency has a series of monitoring stations situated along the Beverley Brook. The nearest monitoring device on the Beverley Brook is situated on Green Lane immediately downstream of the outlets for the Thames Water drainage system. This monitoring station monitors the level of the Beverley Brook and plots the level on a graph in real time. The records from the flooding that occurred on the 25th July can be seen in Appendix E - Shoothill Gauge Map Beverley Brook Telemetry System³.

A review of this data shows the highest level recorded was in July of 2007 with a river level height of 2.85m above stage datum (mASD). The recent flooding on the 25th July resulted in rivers levels of 2.76mASD, which is less than 100mm from the highest recorded river levels.

The graph shows a very short lag time with a sharp rise in the height of the water. This is likely the result of multiple surface water drainage systems conveying water into the Beverley Brook, with little or no attenuation. The identified drainage systems appear to drain surface water from the Worcester Park area, in addition to other local residential areas from The Royal Borough of Kingston Upon Thames and The London Borough of Sutton. This results in water levels rising rapidly in the Beverley Brook, submerging the outlets to the drainage system and causing a hydraulic lock.

Additional flooding was also reported to have occurred on the 28th July and the residents reported that this was foul sewer flooding. This is likely linked to high river levels noted in the Beverley Brook on the 28th July 2021 as shown on the Shoothill Gauge Map for 28th July 2021.
