Caterham-on-the-Hill Surface Water Management Study Surrey County Council

April 2016

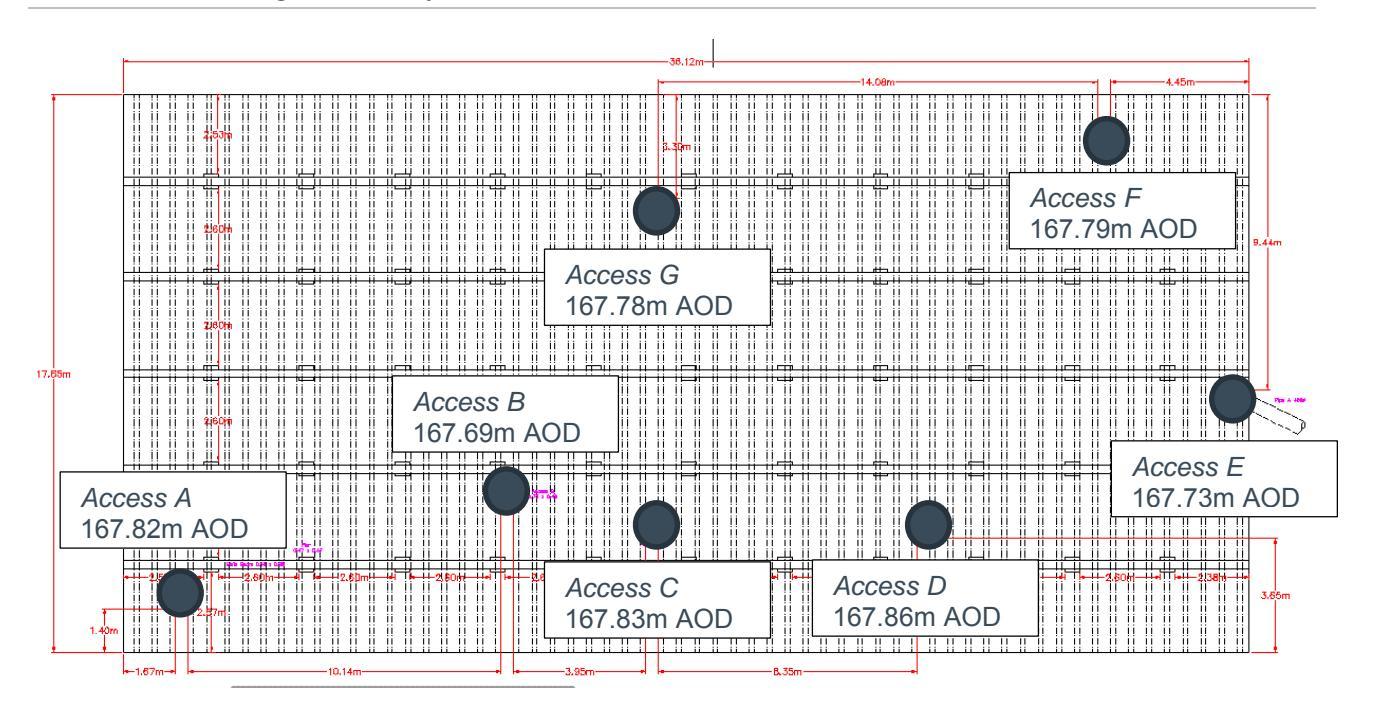
Figure 2-1 Plan view of the Money Pit showing access locations and levels

There are seven inspection covers at random intervals in the slab. There are no means of entering (such as ladders or step-irons) to allow persons to enter the chamber from these access covers. Figure 2-1 illustrates the location of the inspection covers and the surveyed cover level.

Access covers were found to be rusted, although not to a dangerous state. At the time of the survey, approximately 80% of the slab over the Money Pit was covered with vegetation, including brambles and small shrubs and trees. Soil and roots had to be cleared to access the covers. The vegetation growth meant that the survey team was unable to assess the condition of the slab surface. There was evidence of root ingress into the chamber from the stab above, as illustrated in Figure 2-2. The chamber wall and brick piers all seemed structurally sound with no evidence of cracking or displaced brickwork. The mortar joints seemed in good condition.

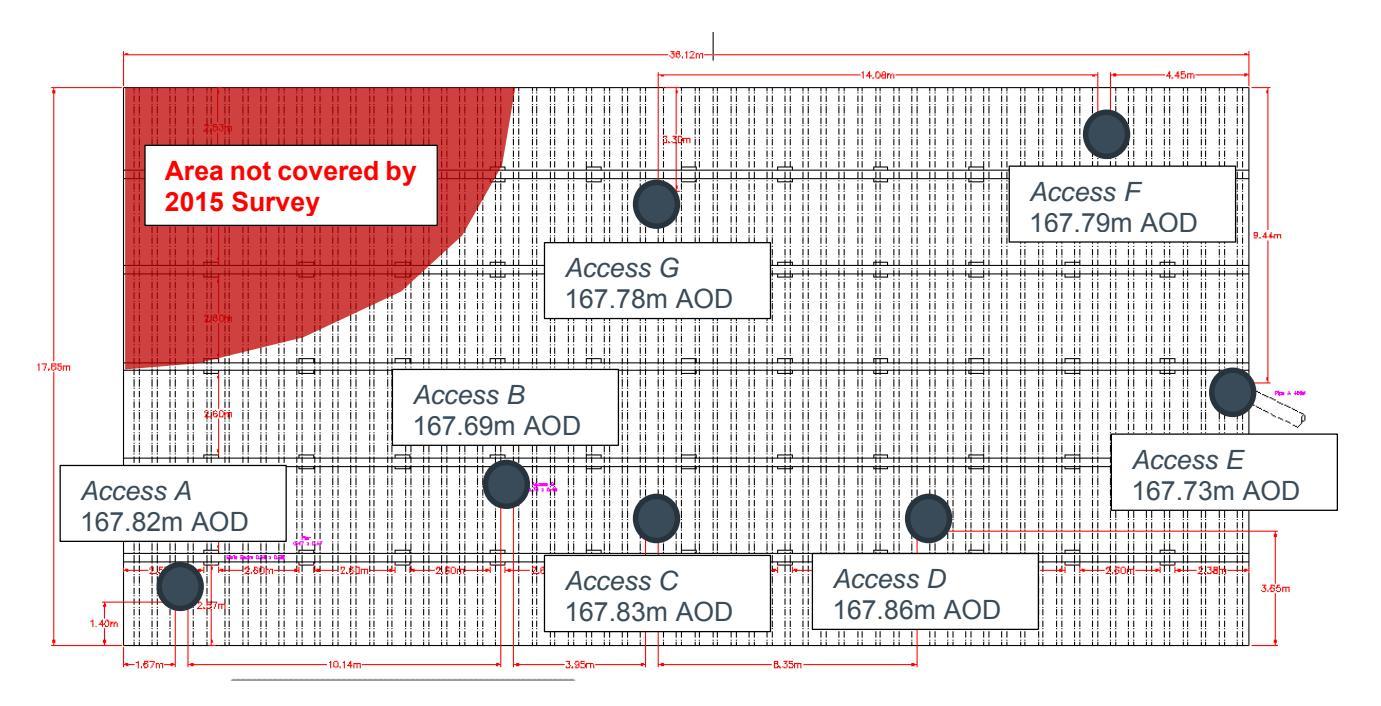
Figure 2-7 Coverage of the 2015 Money Pit survey

No outgoing connections were found. Since the surveyors were only able to survey the area immediately surrounding the base of the access chambers, there is a possibility that an outgoing connection is present in the northern corner of the asset which was not covered in the survey, as shown in Figure 2-7. It is also noted that any low-level incoming or outgoing pipes could not have been observed because they would have been buried beneath the 400mm of silt.

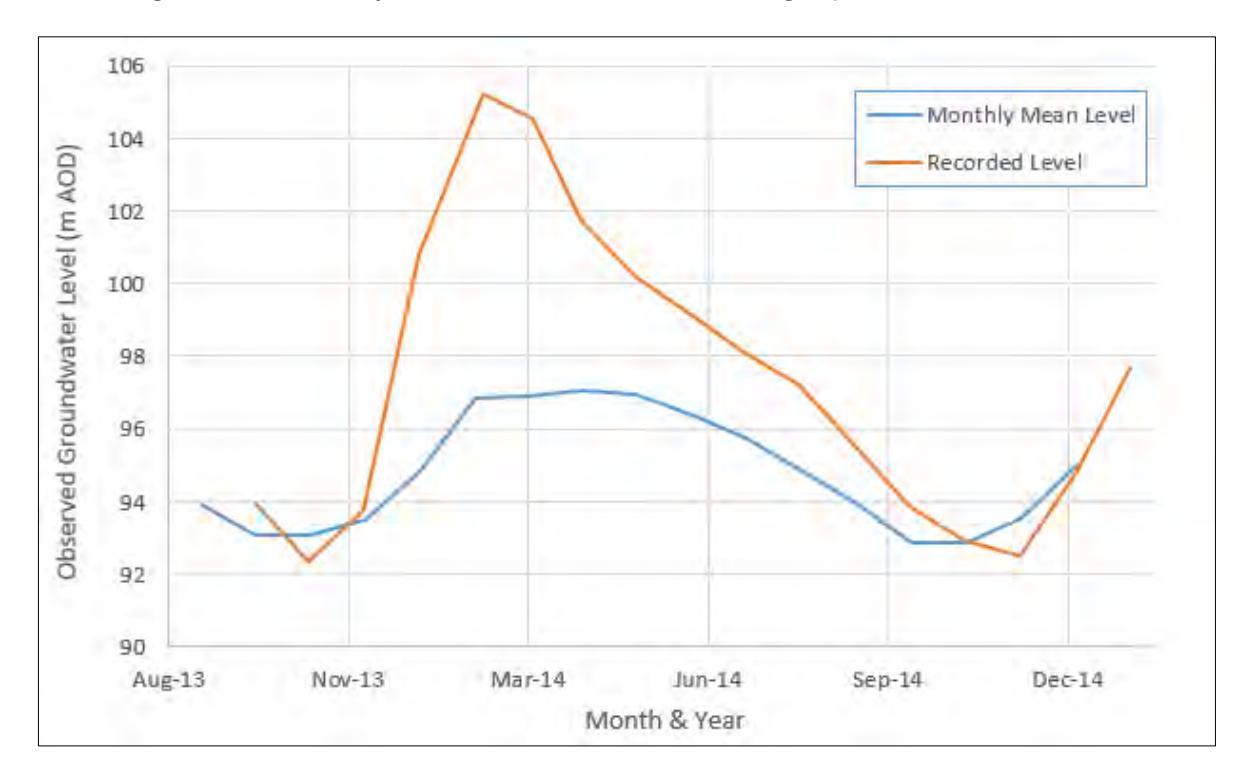
Figure 3-1 Recorded Groundwater Levels at Well House Inn

The National Hydrological Monitoring programme provides monthly hydrological summaries which can be downloaded from the CEH website. These summaries include data from the groundwater level index wells, the closest of which is Well House Inn gauge, located on Chipstead Lane (Kingswood), approximately 6km to the west of Coulsdon Common. The gauged record provides a measure of groundwater level in the North Downs chalk, which includes the Lewes Nodular Chalk Formation; the bedrock geology underlying Caterham-on-the-Hill. Table 3-3 lists the monthly average groundwater level and a single recorded groundwater level at the well for the last 18 months. This data is illustrated on a graph in Figure 3-1.

in the chalk bedrock, these are still over 40m below the ground surface at Caterham-on-the-Hill (152m AOD at the Coulsdon Common soakaway and 167m AOD at the money pit), suggesting that groundwater infiltration into the drainage assets is unlikely to have contributed to the flooding experienced over winter 2013/14.

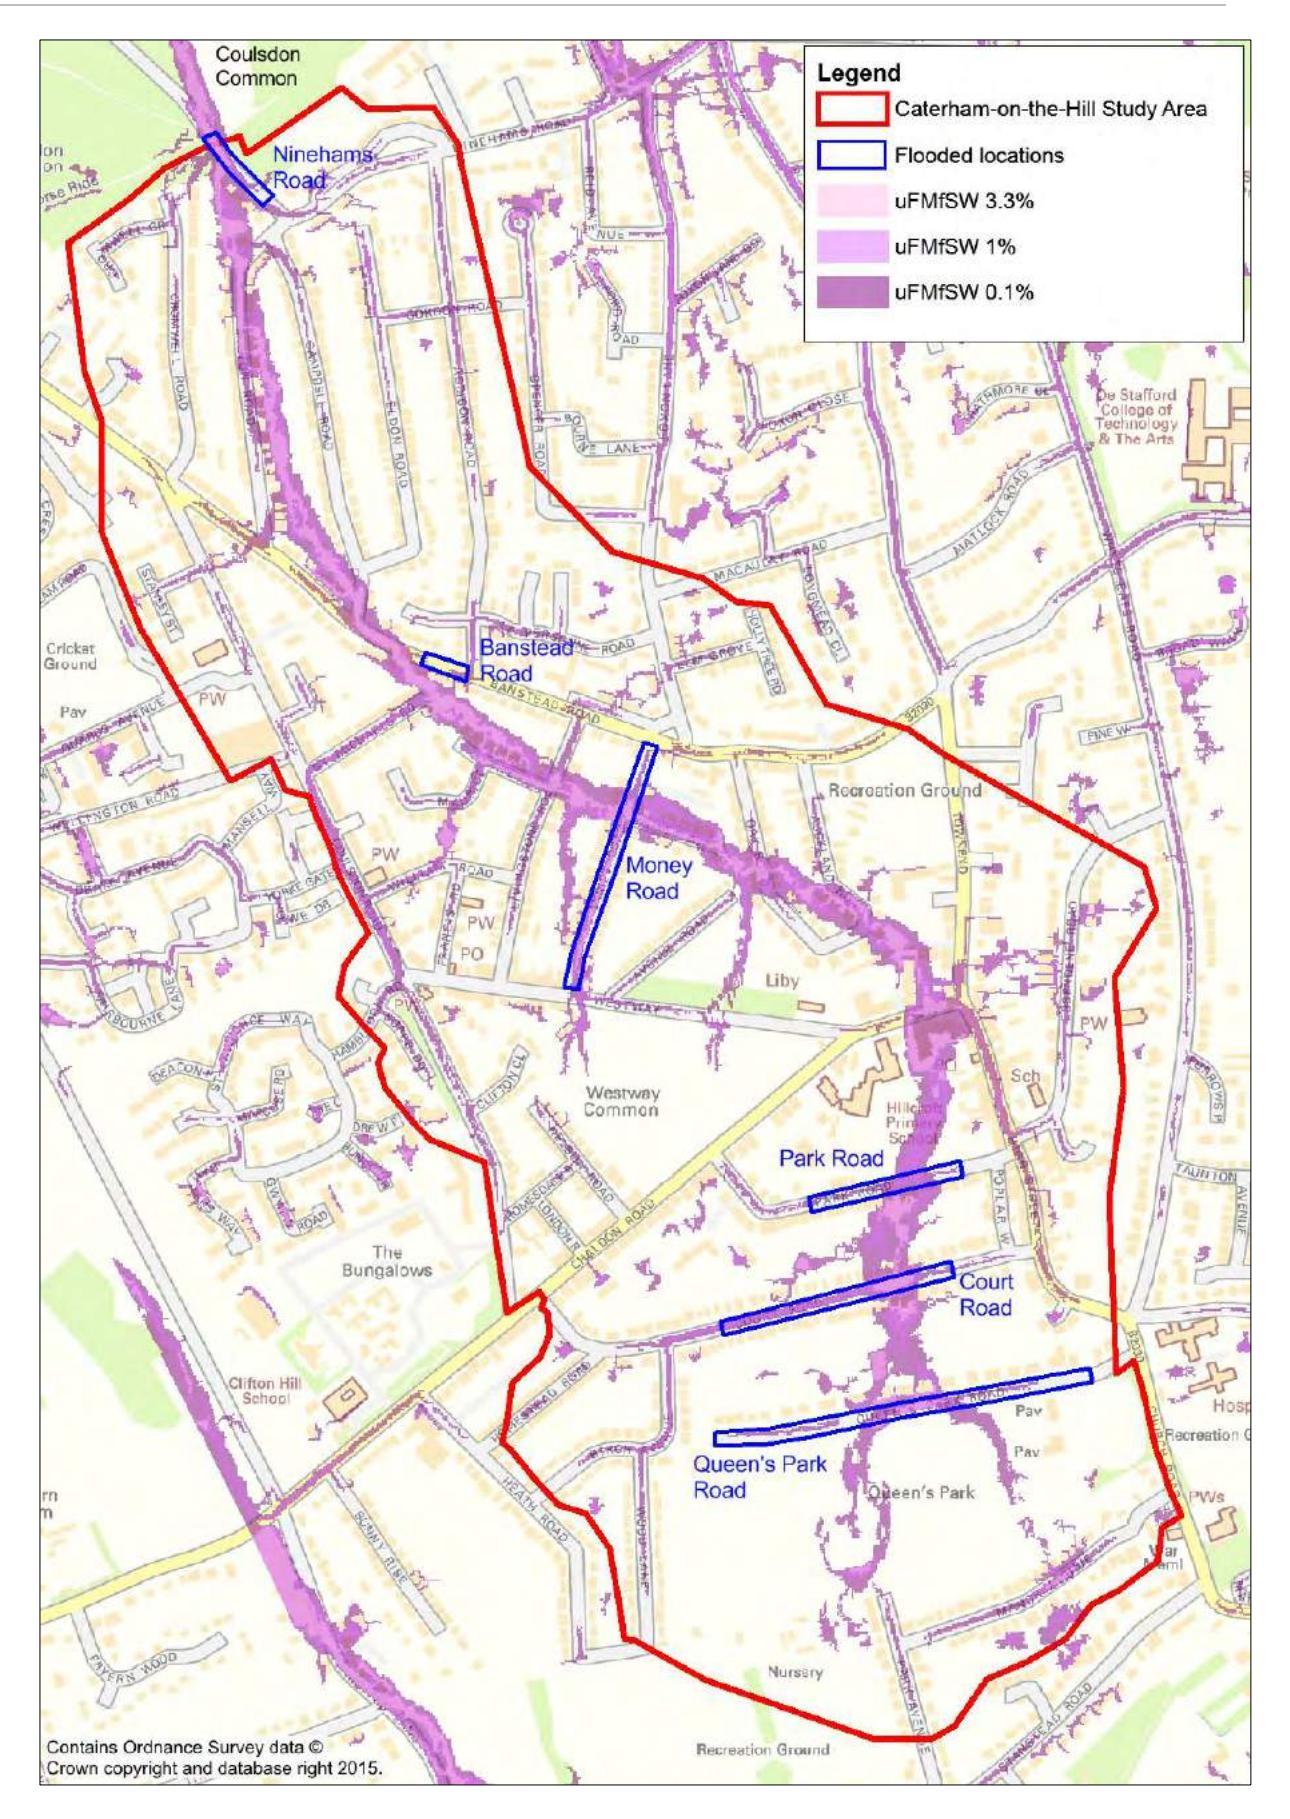
Figure 3-2 Modelled and historic surface water flood risk

The Environment Agency Updated Flood Maps for Surface Water (uFMfSW) provided in Figure 3-2 clearly illustrate the main surface water flow path through Caterham-on-the-Hill, suggesting that roads and properties are at risk of flooding with an annual probability of 3.3%. This is likely to be caused by urban runoff, with contributions from rural surfaces depending on the severity of the event and antecedent catchment conditions.

Comparing the modelled flood risk with the historical and anecdotal flood records reveals that all of the reported flooding in Caterham-on-the-Hill is located within the area susceptible to surface water flooding as defined by the Environment Agency maps. It is therefore considered that the Environment Agency uFMfSW is sufficient in providing a baseline overview of the risk of flooding from surface water in Caterham-on-the-Hill.

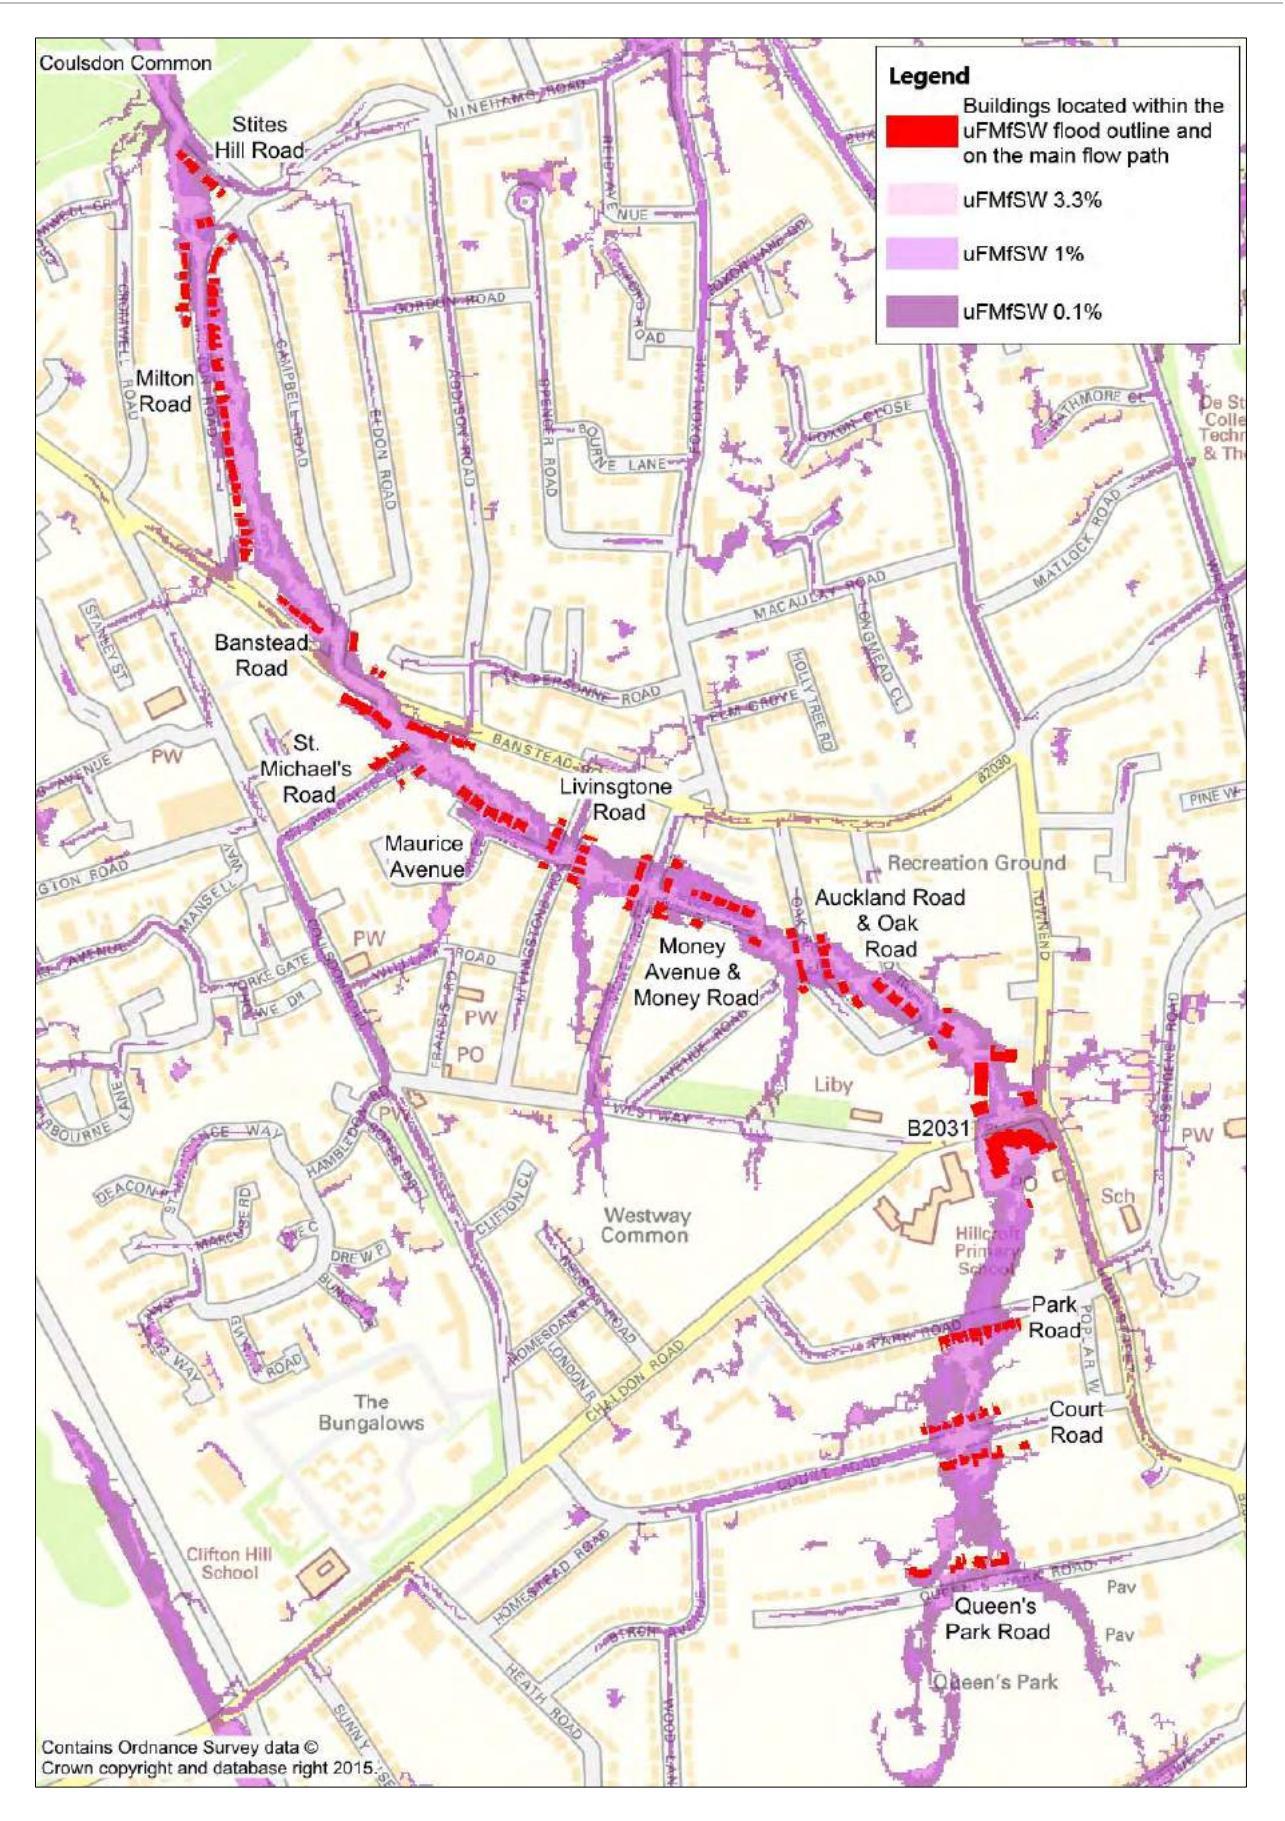
Figure 3-3 Properties at risk of surface water flooding on the route of the main flow path

Buildings located within the Environment Agency 1 in 30 Annual Probability (AP), 1 in 100 AP and 1 in 1,000 flood outline were identified and counted. The resulting property counts, broken down by road, are documented in Table 3-4 and are illustrated on Figure 3-3. There are an estimated 94 properties at risk in the 1 in 30 AP event, all but one of which is residential. There are an additional 65 properties at risk in the 1 in 100 AP event. The uFMfSW is un-calibrated and the number of properties at risk presented here should therefore be used with an appropriate level of caution to reflect the level of uncertainty in the dataset.

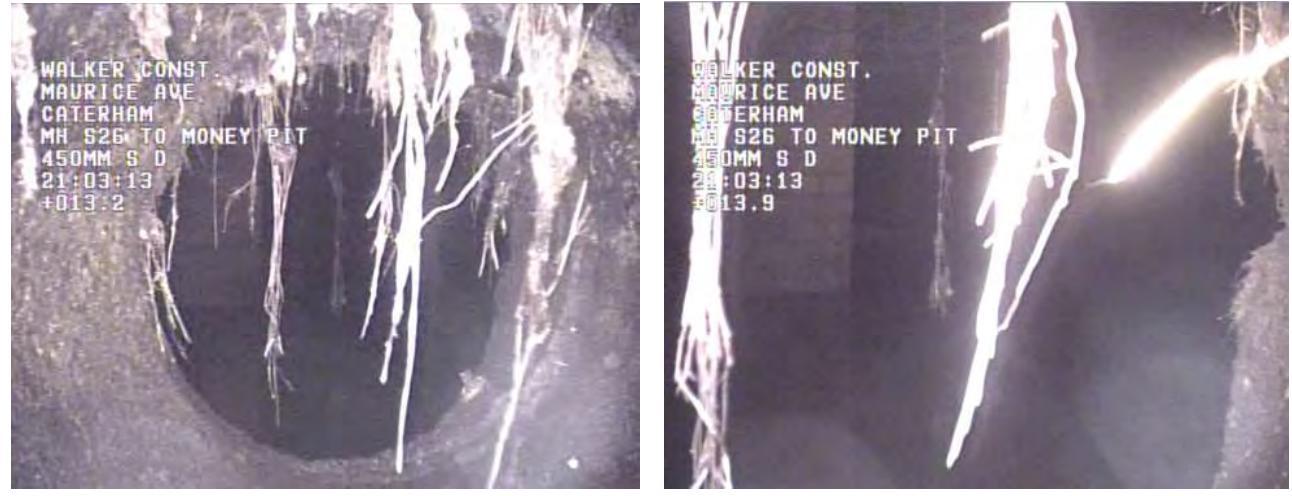
CCTV survey (2013) - image from the surface water pipe looking downstream into the Money Pit.

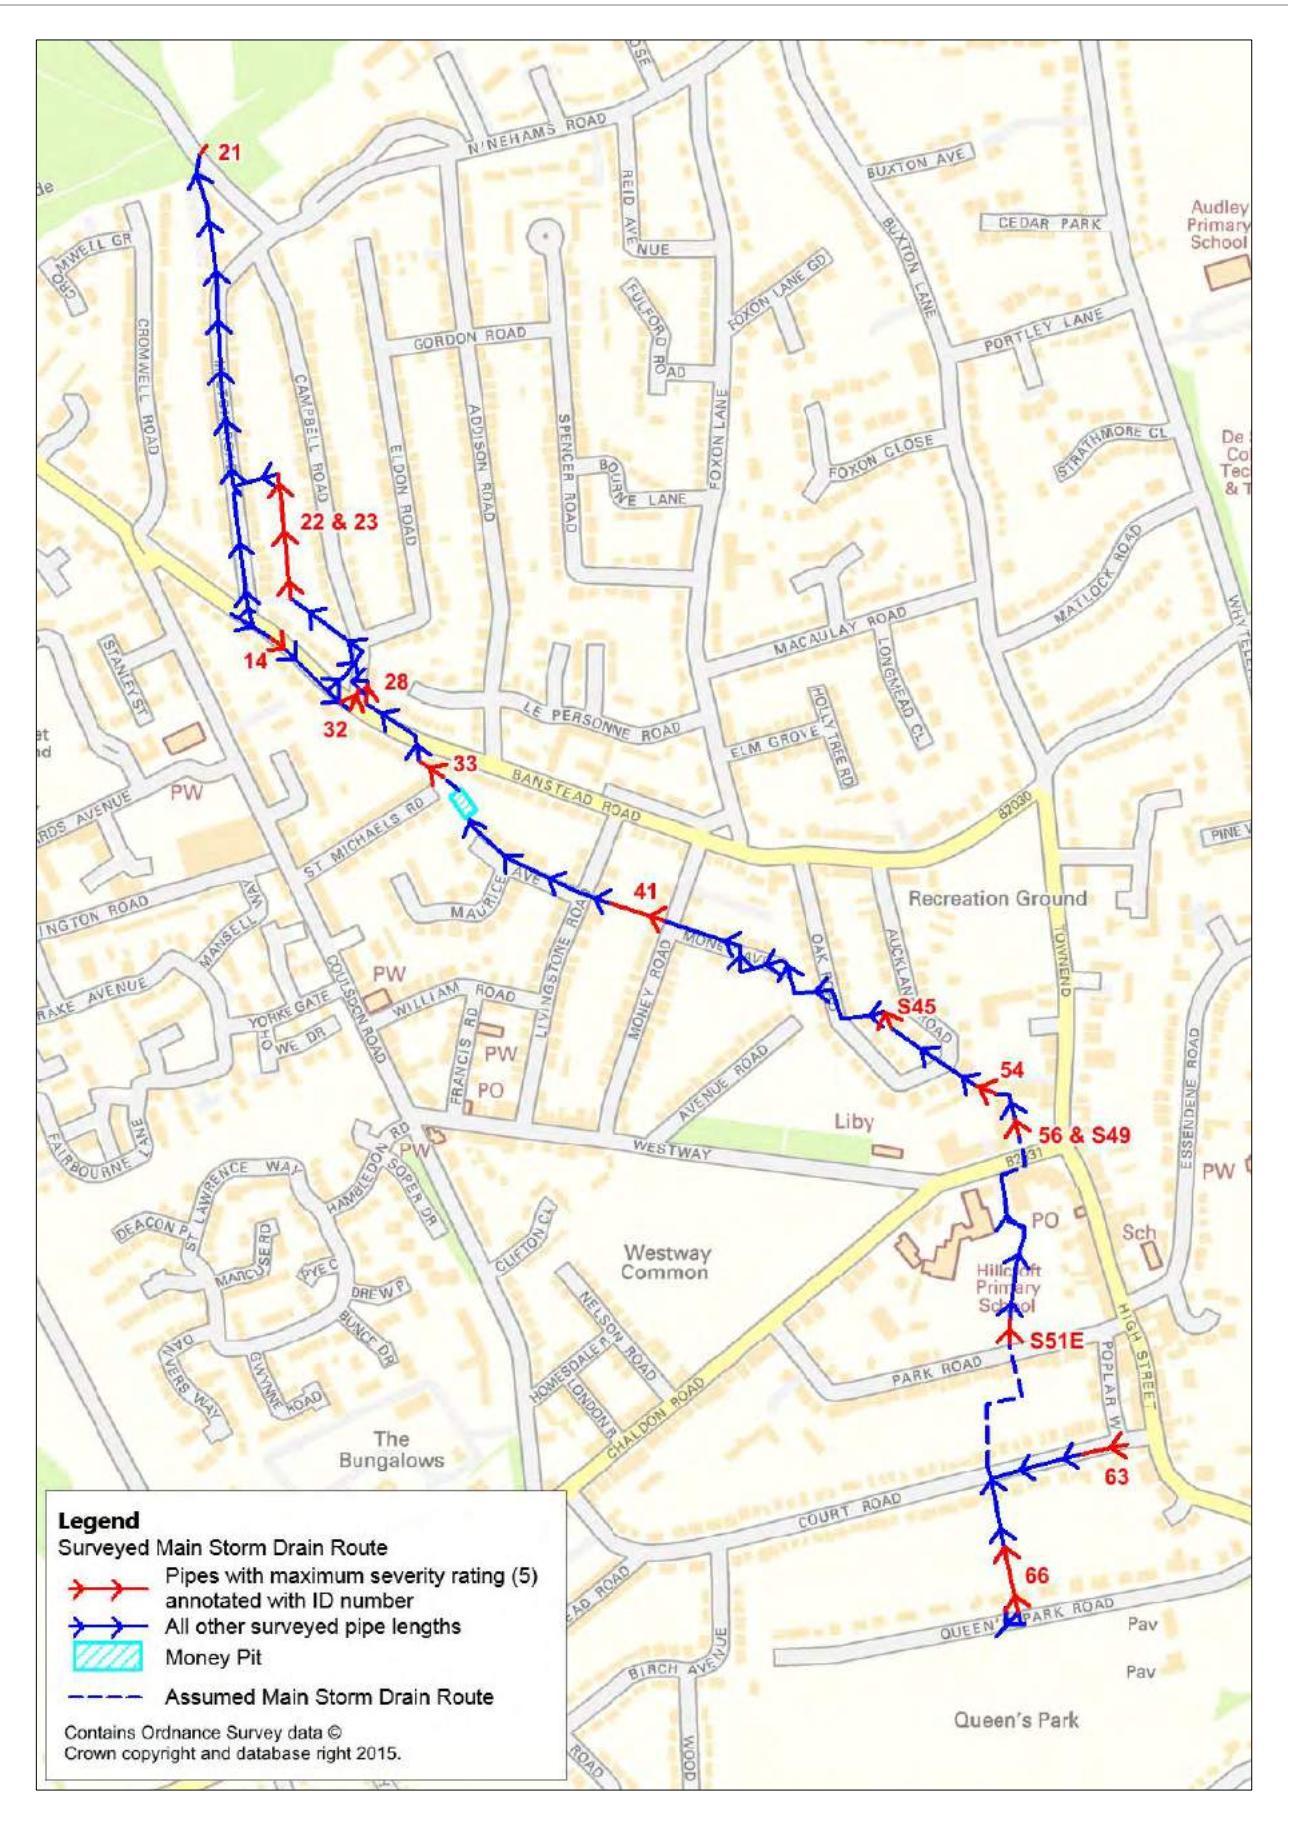
Figure B-4 Map of CCTV-surveyed pipe lengths

A summary table containing information about all 68 surveyed pipe lengths is available in Appendix B. The ID column within this table relates to the pipe locations as illustrated on the map in Appendix B. A summary of the pipe lengths that were allocated the maximum severity score are shown in Table 2-2. Of significant interest are pipe lengths 63 and 66, both of which are located in between Queens Park Road and Court Road, an area that is known to flood (see Section 3). These pipes are in a poor condition, with cracks and roots, and two collapsed sections. There are reported blockages of up to 50% in what are relatively small pipes (150mm in

Also of interest is the pipe just downstream of Money Avenue (no. 41). Money Avenue is also an area highlighted by SCC as an area that has experienced flooding, verified by the SCC Wetspots and the Environment Agency uFMfSW. Pipe 41 has also been allocated the highest severity ranking, which in this location relates to cracks and siltation.
