Nork and Tattenhams Section 19 Report – Addendum: 2024 Update.

This report will act as an update to the previously published Section 19 Report of July 2021 which investigated flooding of the Nork and Tattenhams area. For ease, each location that has been reported to be impacted by flooding will be broken down into catchment areas as detailed in the 2021 Section 19 report.

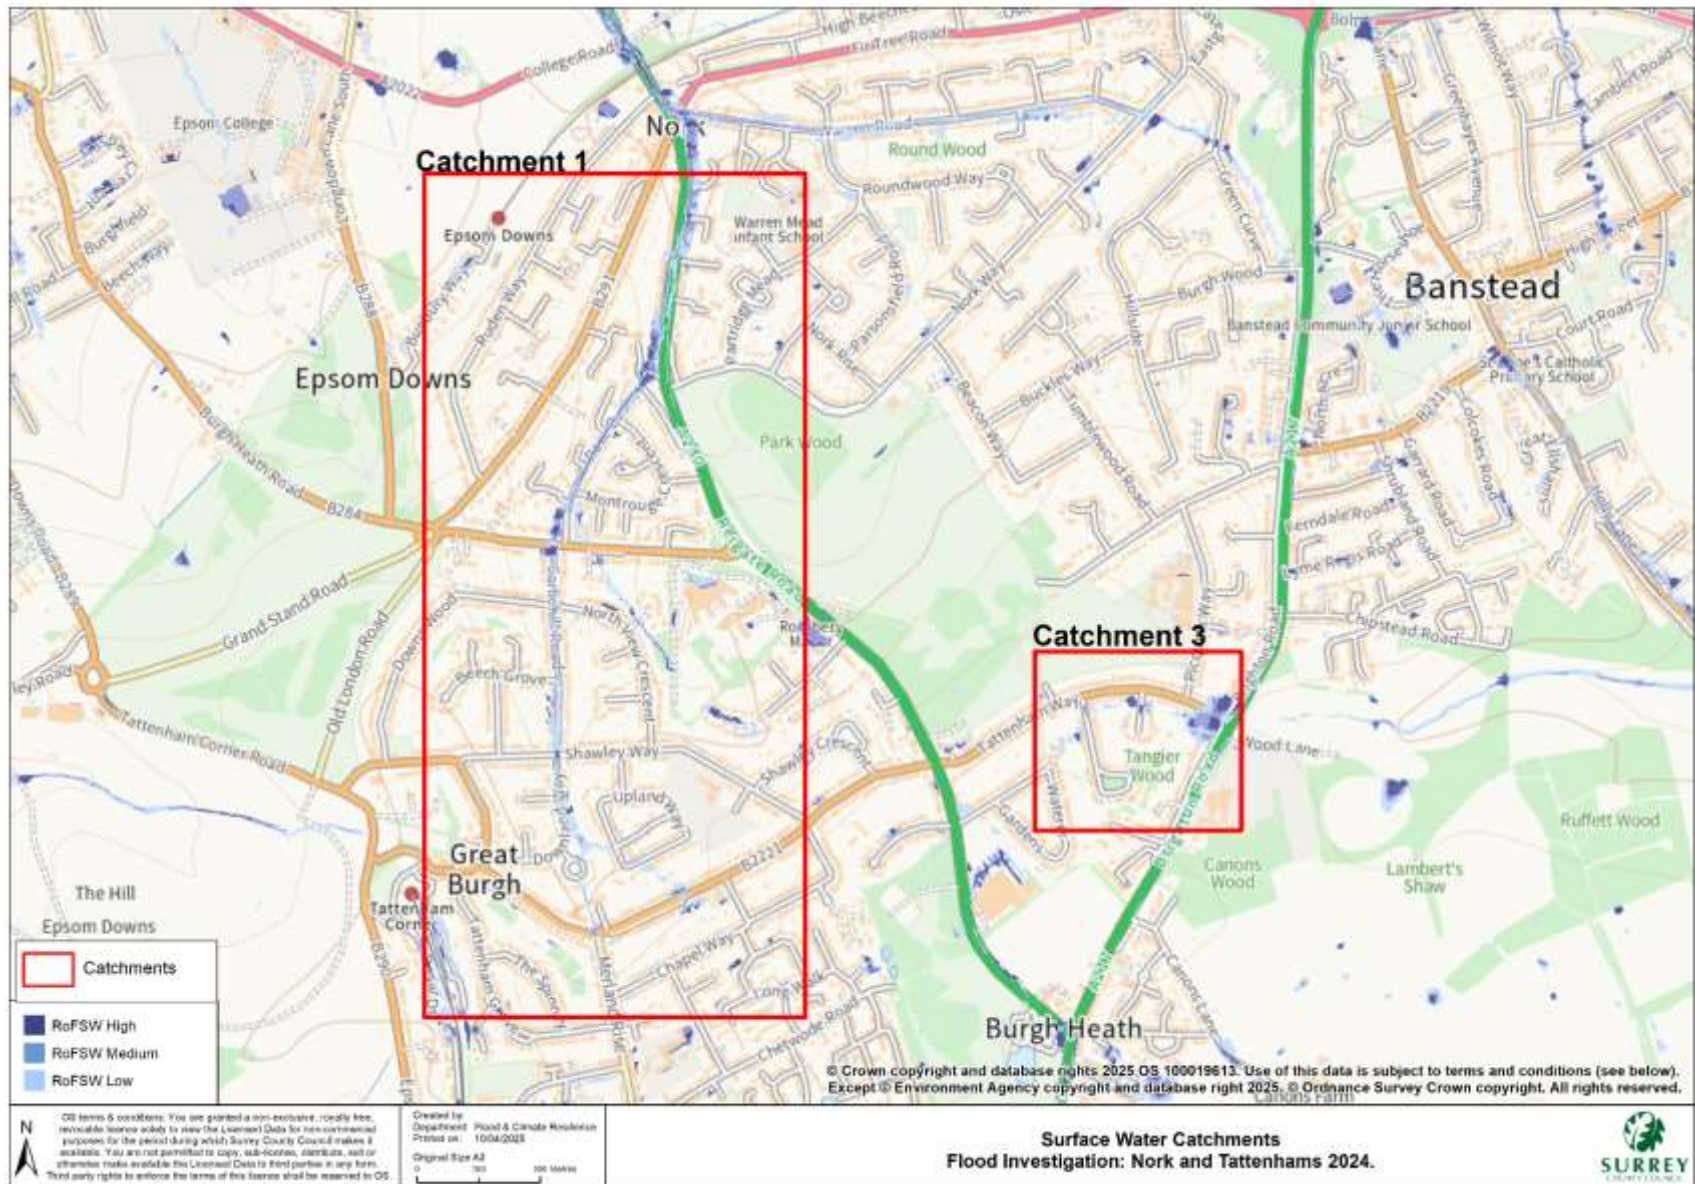
Annex A: Catchment Map

Each location that has been reported to be impacted by flooding has been broken down into catchment areas as detailed in the 2021 Section 19 report. Please note, only two of the four catchments highlighted in the previous report were affected again – these are Catchment 1 and 3.
